## 7 Site Management: Cleaning and Reconstruction of the Balustrade around the Naos of Petosiris (GB 50) – Some Observations

### 7.1 *The balustrade*

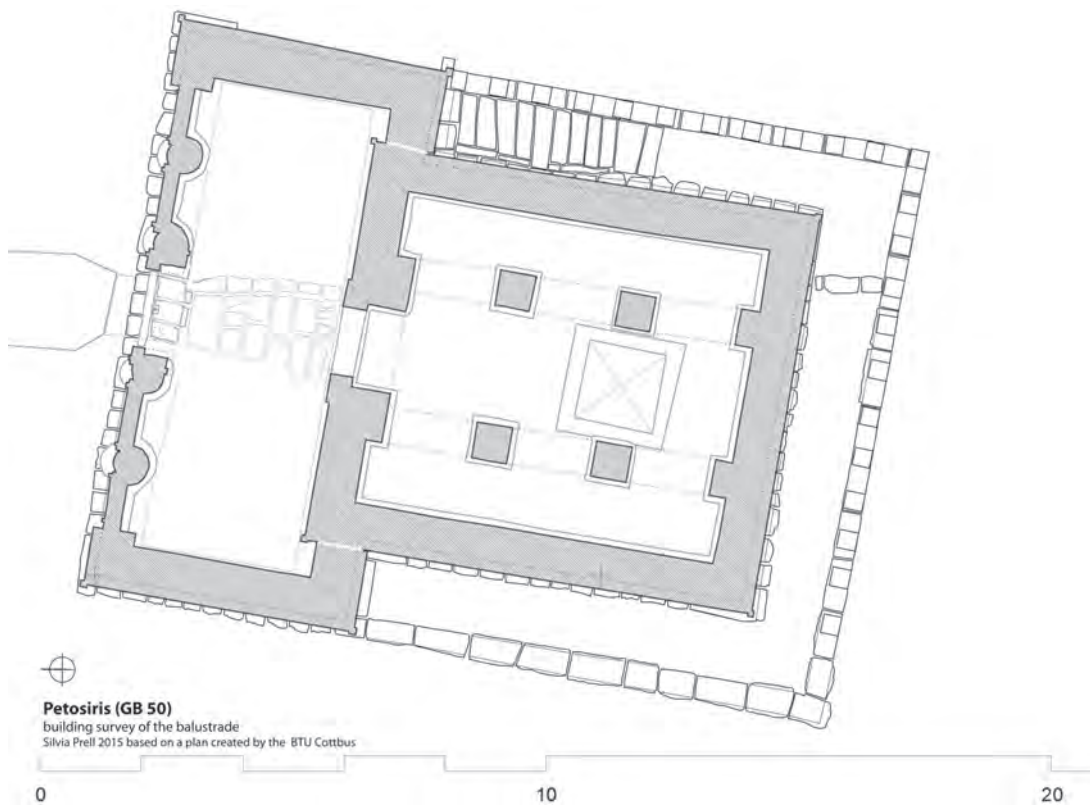
The foundation of the balustrade consists of local limestone blocks laid out in a U-shape around the naos, leaving an open space between them and the foundations of the temple tomb of about 110 cm (fig. 2 a–b). A new discovery in 2015, even if not unexpected, was the foundation of the balustrade in the west mentioned neither by Gustave Lefebvre in 1923/1924<sup>3</sup> nor by Sami Gabra and his colleagues<sup>4</sup>. Furthermore, Paul Perdrizet emphasised in 1941 that the balustrade was absent in the west<sup>5</sup>.

Along the eastern wall of the naos of the tomb of Petosiris, eleven blocks of local limestone are left of the pavement between the naos and the balustrade. Another block of this pavement is preserved in the southeast, all of them joining the tomb with the balustrade (fig. 2 a–b). They are 100–120 cm long, 25–56 cm wide and 15 cm high<sup>12</sup>. The top edge of the pavement lies 5 cm lower than the top

Fig. 2 a: Plan of the balustrade and its foundations; 2015

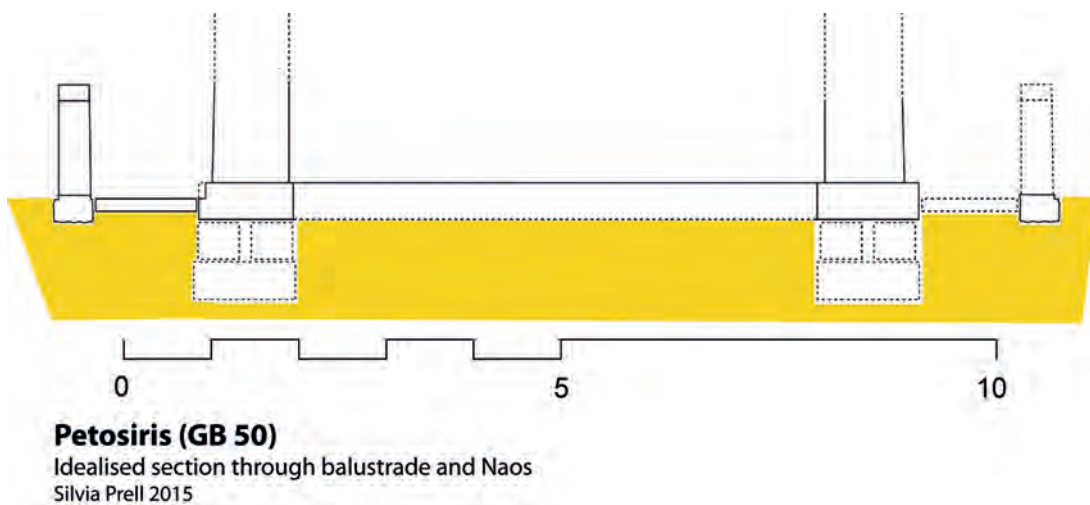
The blocks used for the foundation are generally 100–110 cm long; shorter ones, for example in the corners, measure at least 60 cm. All of the blocks are about 30 cm thick, as selectively checked at the inner south-western corner, with a levelled surface, plane and smoothed by charring. Only the uppermost parts (3–5 cm) of the sides of the blocks are worked more carefully, below they are very roughly shaped, because they were covered by sand and hence invisible. The smoothed surface is 35 cm wide, while the raw block is actually broader (fig. 2 b and 3).

Fig. 2 b: Idealised section through balustrade and tomb building; 2015

edge of the foundation blocks. The uppermost layer of the foundation of the naos, the euthynteria, however, has been chiselled off about 18 cm in certain places to match the height of the pavement (fig. 2 b and 5). Therefore, although the euthynteria seems to protrude only about 10–15 cm from the rising masonry of the tomb, it is actually wider. The length of the blocks of the euthynteria must have originally varied, because some of the blocks were not chopped off, while others protrude up to 20 cm further east below the pavement. Gaps in the pavement caused by the unevenness of the uppermost foundation layer were closed with smaller pieces or longer slabs (fig. 2 a and 5). As far as could be checked during cleaning, the

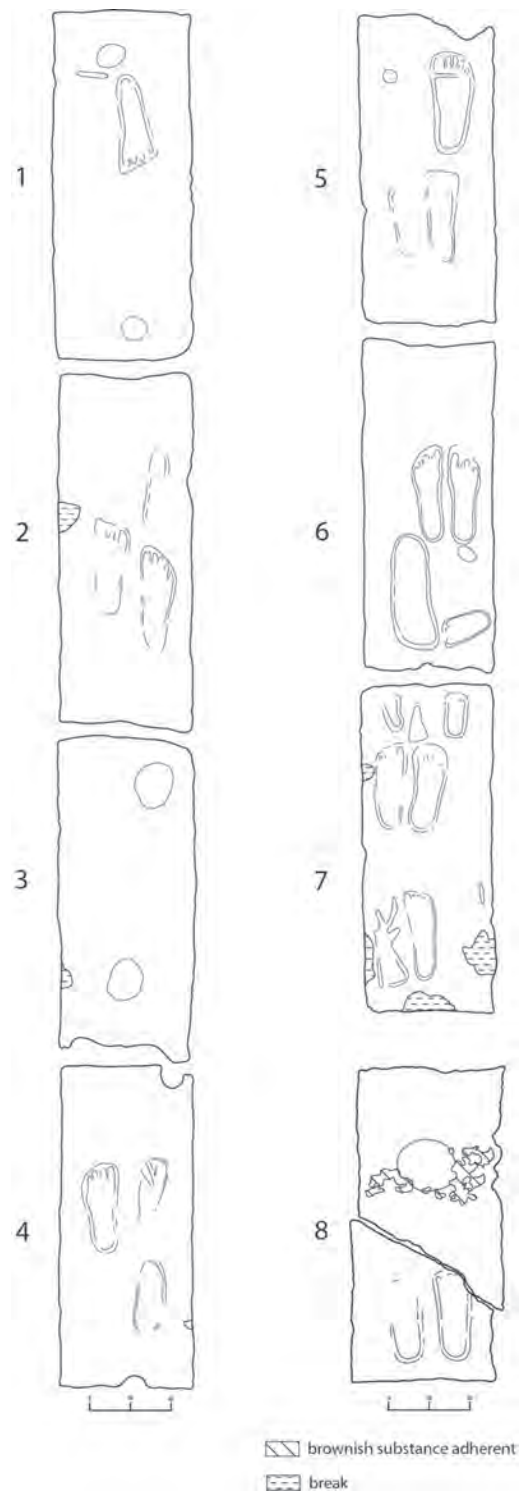
in length and 17 cm in thickness<sup>8</sup>. Seven of these slabs are still complete, two are broken in two pieces, and several further fragments have been found during cleaning the surroundings from sand. On seven of those slabs (six are complete and one is broken) the outline of a single foot or of a pair of feet is incised (fig. 4)<sup>9</sup>. They are of different sizes, and some smaller ones appear to belong to children. The toes are not always indicated; on a single foot on slab no. 5 a sandal seems to be indicated by a horizontal line incised directly below the toes. Most of the incised feet are pointing north, only two feet (slabs nos. 1 and 6) are pointing south<sup>10</sup> and another foot (slab no. 6) is the only one pointing west. A pair of feet on slabs nos. 4 and 7 seems to be unfinished, which is suggested by the weak and incomplete incision of the second foot.

In addition, five slabs show offering moulds (fig. 4). Similar moulds appeared also at the euthyneria of GB 51 and the tomb of Padjkam (GB 54)<sup>11</sup>. It is so far unclear, if those offering moulds were part of the funerary cult for Petosiris himself or if they belong to later burials that once surrounded the tomb.

Fig. 4: The seven complete slabs and one of the broken slabs once supported by the pillars, showing incised outlines of feet and offering moulds; 2015

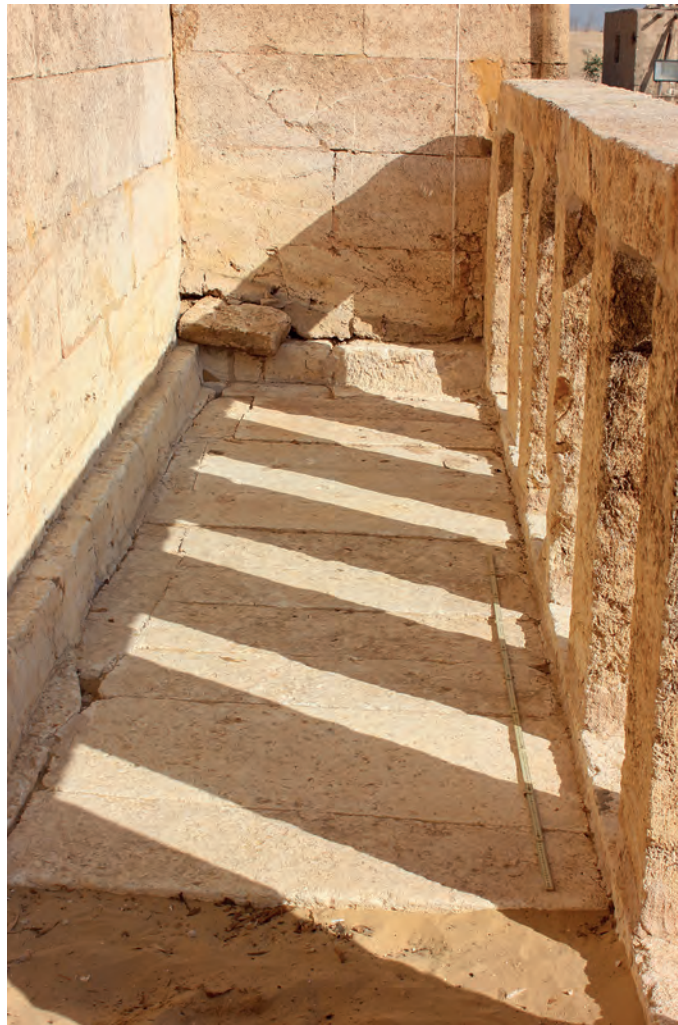
Fig. 5: Preserved pavement between naos and balustrade; 2015

Along the outside of the southern wall of the tomb of Petosiris and on parts of the eastern wall of the temple tomb, the remains of a floor consisting of lime mixed with pulverised red bricks and sand was discovered (fig. 5). This floor apparently belonged to a later phase, when in the Roman period ad-

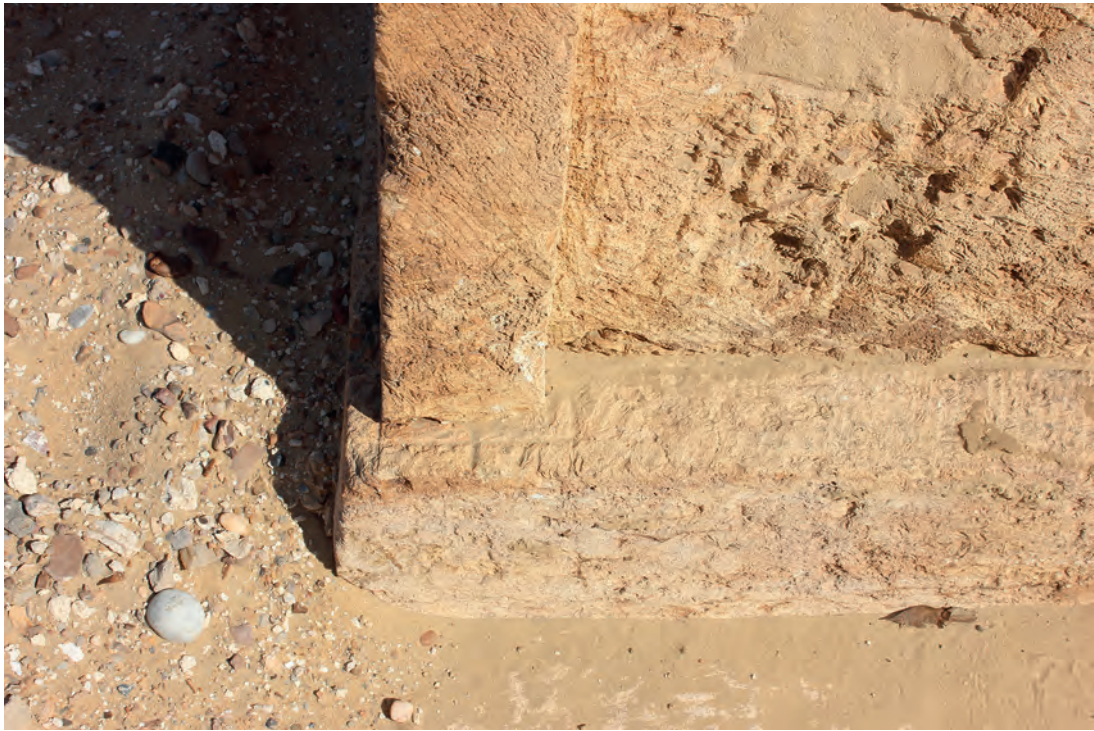
While the euthynteria of the naos shows incised marks for the positioning of the blocks of the walls including the round bars at the corners (fig. 6)<sup>15</sup>, the uppermost foundation layer of the pronaos – although the joints of the ma-

Fig. 6: Incision on top of the euthynteria indicating the future position of the round bar of the southwestern corner of the naos; 2015

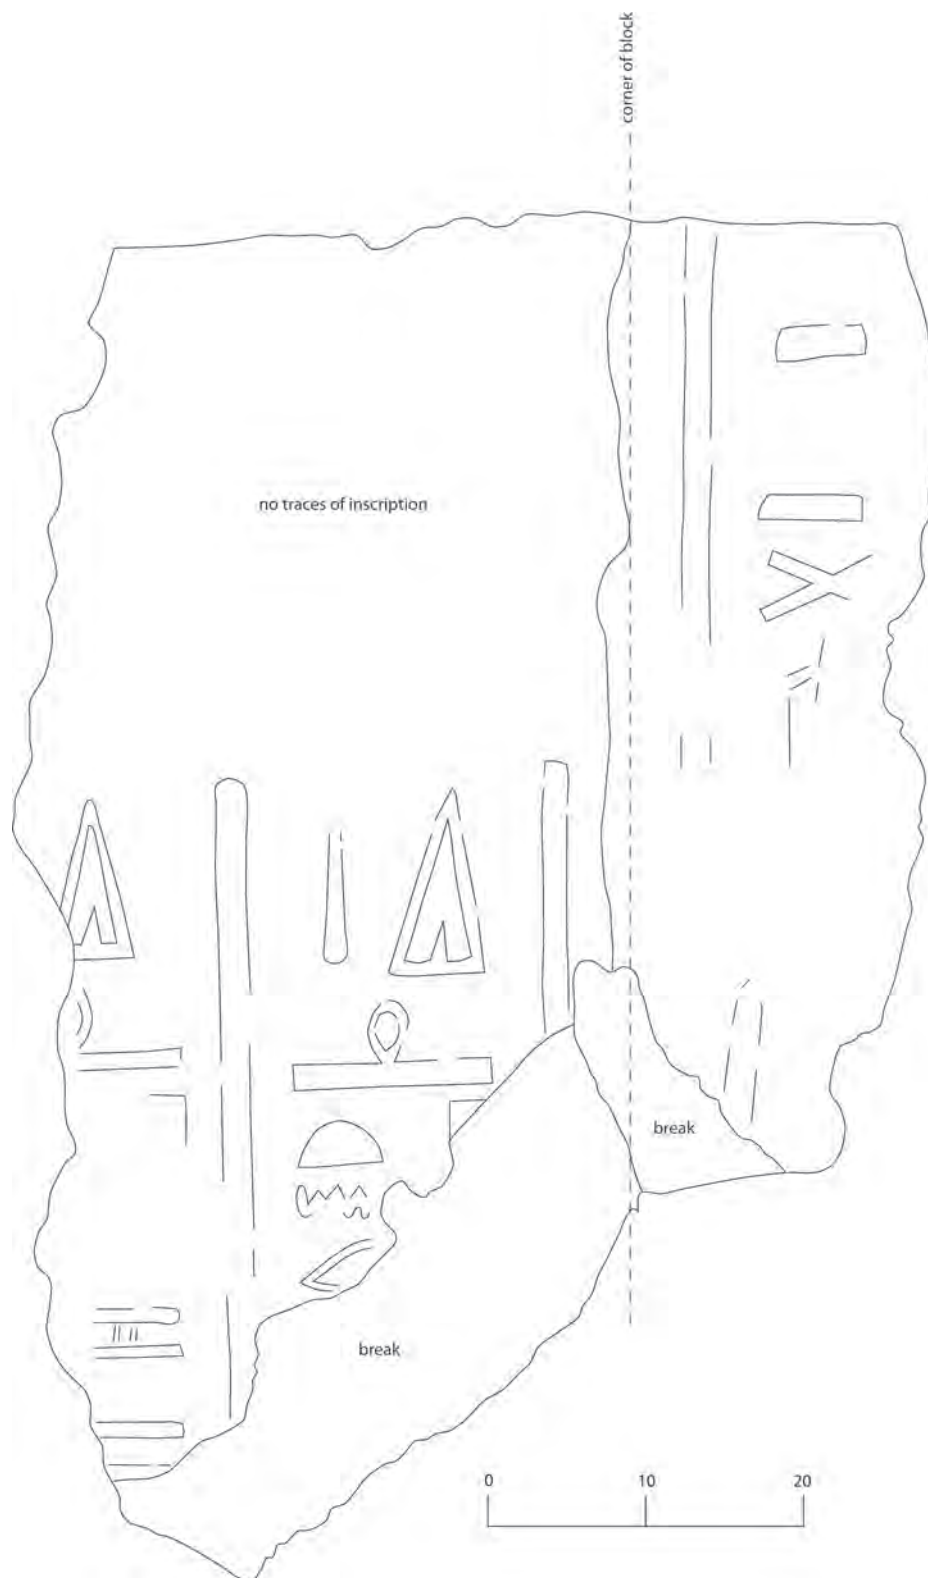
On the southern side, two fragmented blocks with hieroglyphic inscriptions in sunk relief were found among the scattered blocks. Most likely, they belong to the tomb of Petosiris (GB 50) and were part of the architraves once supporting the ceiling blocks. Both preserve an original edge of the block and bear traces of hieroglyphic inscriptions arranged in columns on two sides (fig. 7–9).

Fig. 7: Drawing of one block bearing a hieroglyphic inscription; 2015

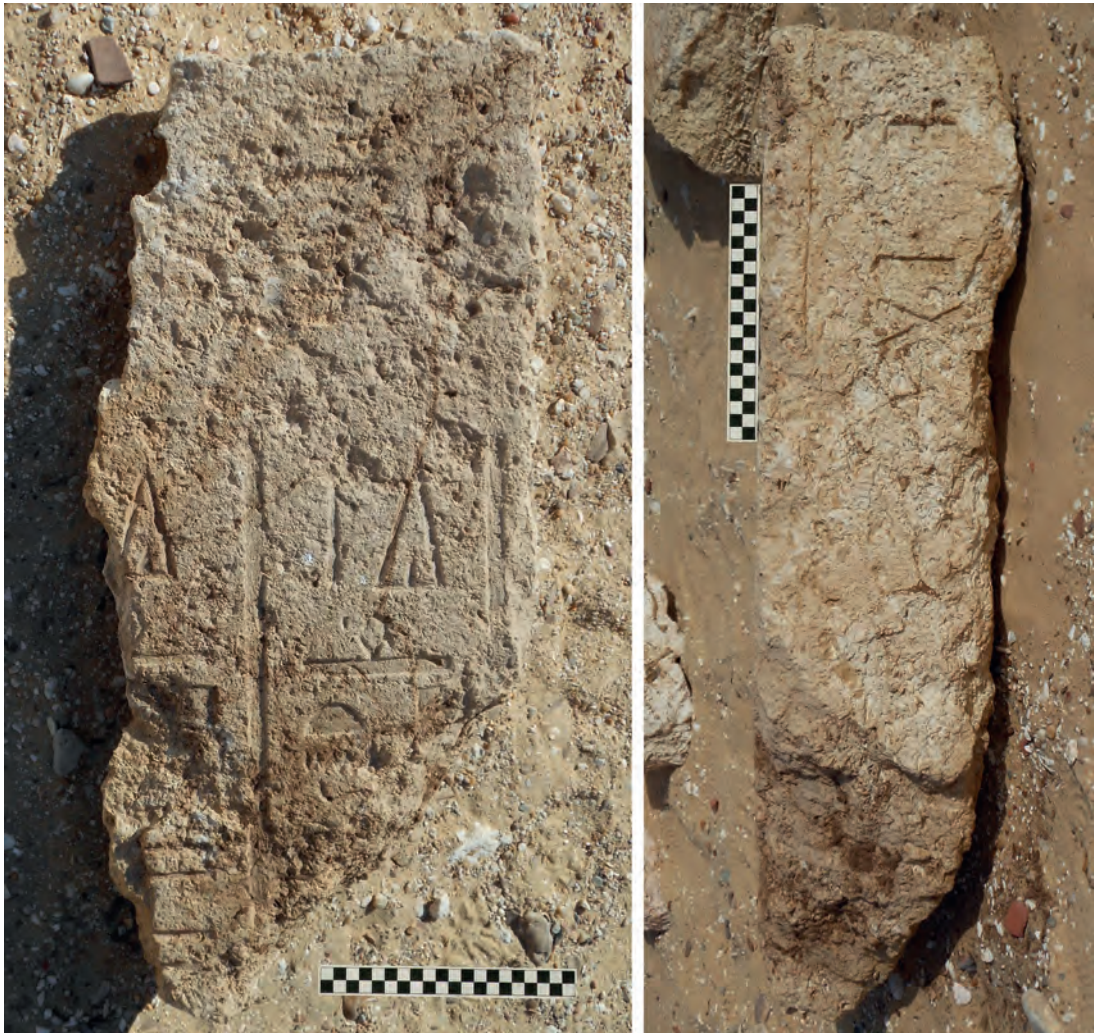
Fig. 8: Photo of the same block bearing a hieroglyphic inscription; 2015

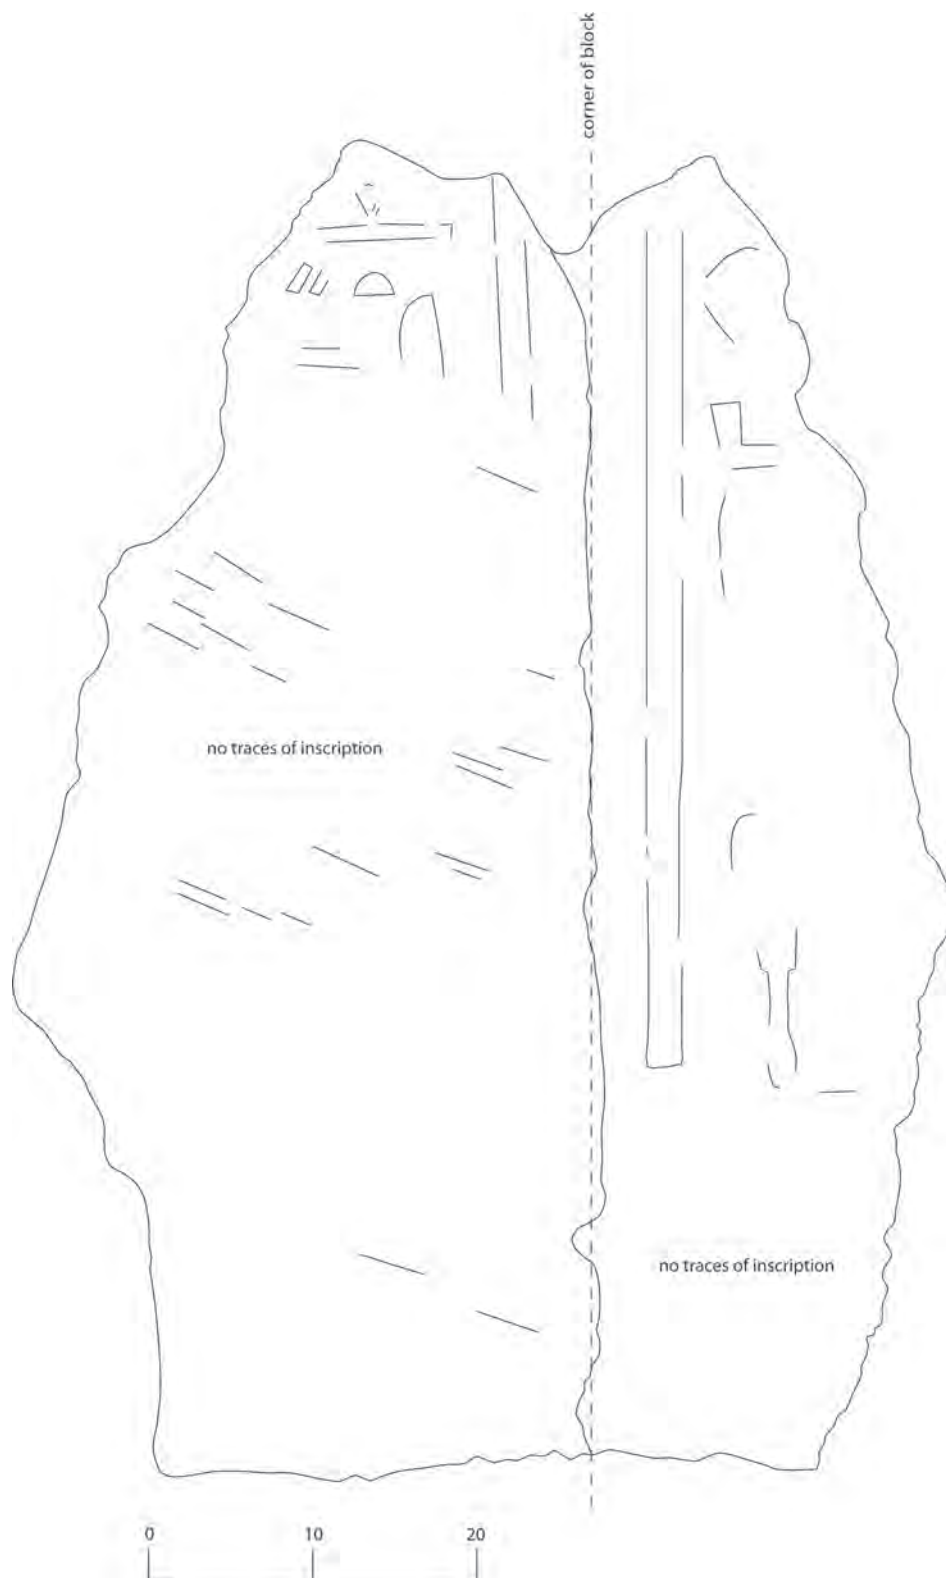
Fig. 9: Drawing of a second block bearing a hieroglyphic inscription; 2015

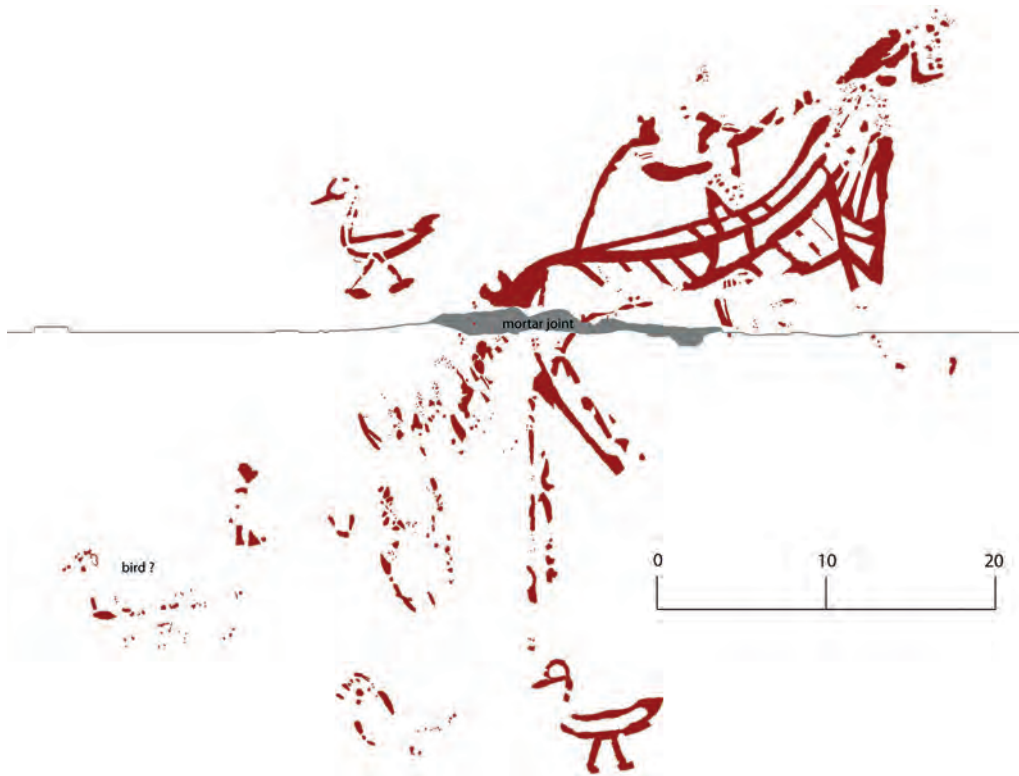
At the bottom part of the eastern wall near the corner of the hall, graffiti in red ink of a horseman (?) facing to the right and of at least two small birds facing to the left were found (fig. 10), which had not been documented by

Fig. 10: Graffito depicting a horseman (?) and some birds; 2015

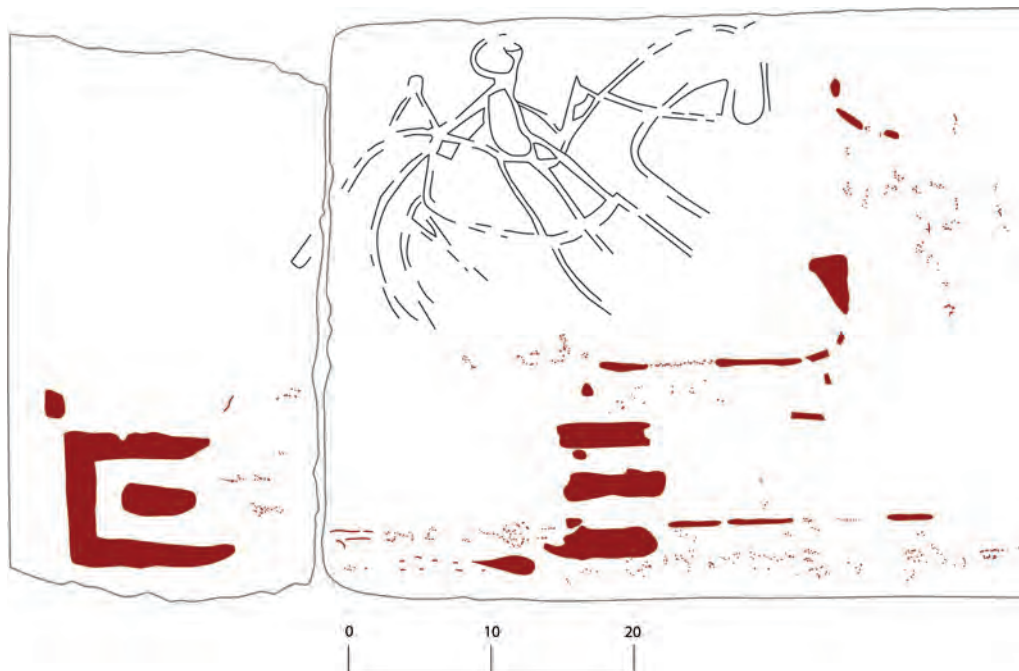
Lefebvre nor by Gabra. Another incised depiction of a horseman (fig. 11) and traces of red paint were found on the eastern wall of the pronaos of the temple tomb of Padjkam (GB 54)<sup>19</sup>.

Fig. 11: Temple tomb of Padjkam (GB 54), eastern wall of the pronaos, graffito depicting a horseman; 2015

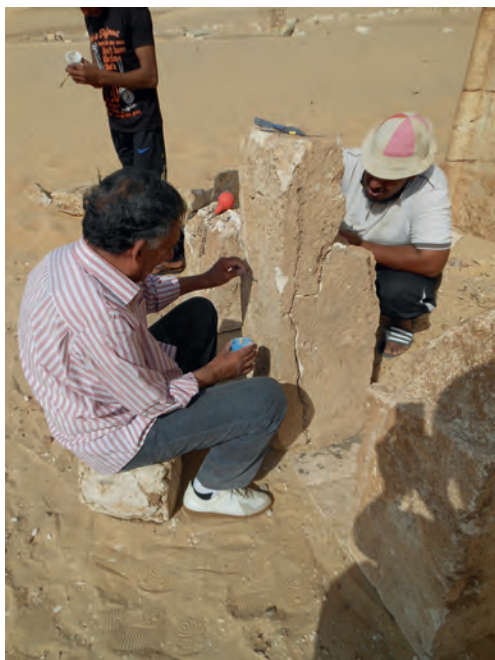
Fig. 12: Cleaning the surfaces of the stones; 2015

- Cleaning the stone surfaces by spraying limewater onto the stones until they are saturated.
- Consolidating the natural stone with approved materials. Chipped and broken areas of the stones are repaired by patching the void with mortar (fig. 12–13) that consists of lime and sand (relation 1 : 2) with some drops of Primal (emulsion of paraloid). Ground particles of the same or similar stone are added to ensure a close colour match (fig. 14). This method is suitable when no stone for replacement is available or the void is less than 25 mm deep.
- Resurfacing the exfoliated surfaces.

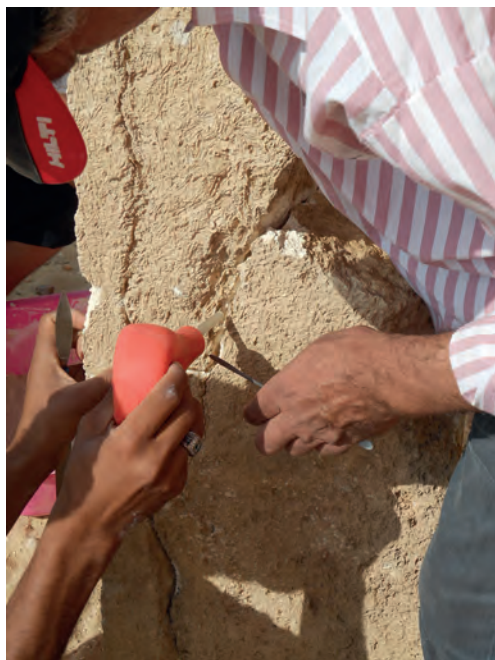
Fig. 13: Closing gaps with the help of lime mortar; 2015

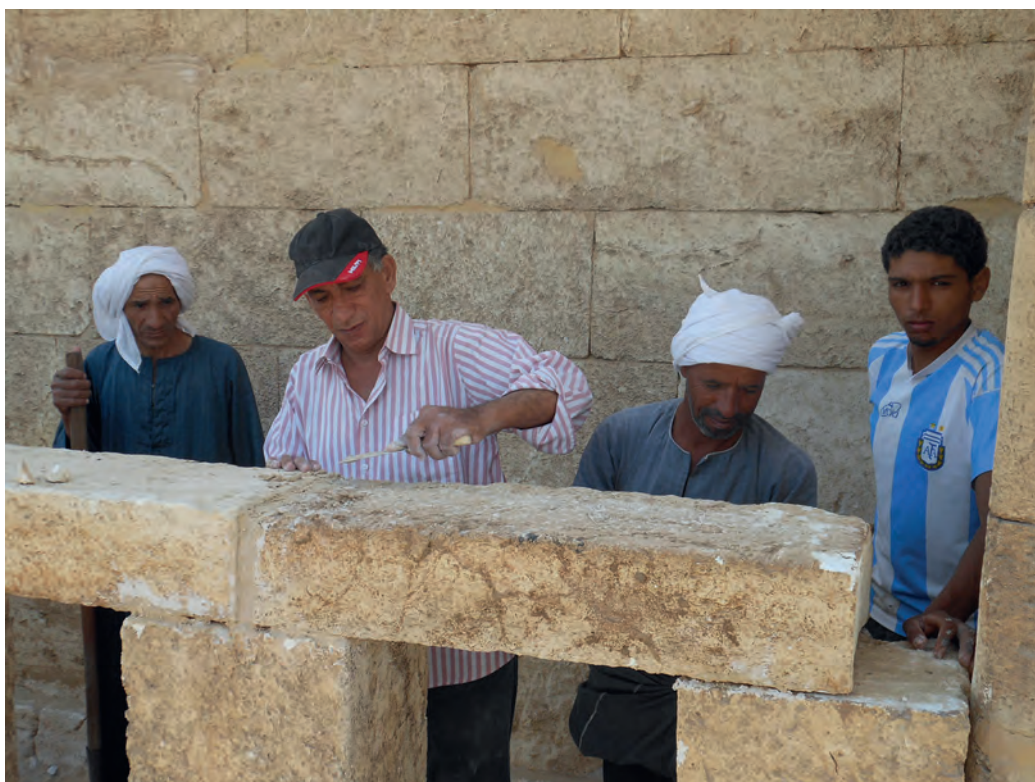
Fig. 14: Re-erection of balustrade with the help of lime mortar; 2015

In 2015, another restoration of the balustrade was accomplished using the following techniques:
