7 Site Management: Cleaning and Reconstruction of the Balustrade around the Naos of Petosiris (GB 50) – Some Observations

7.1 *The balustrade*

7.3 The restoration of the balustrade

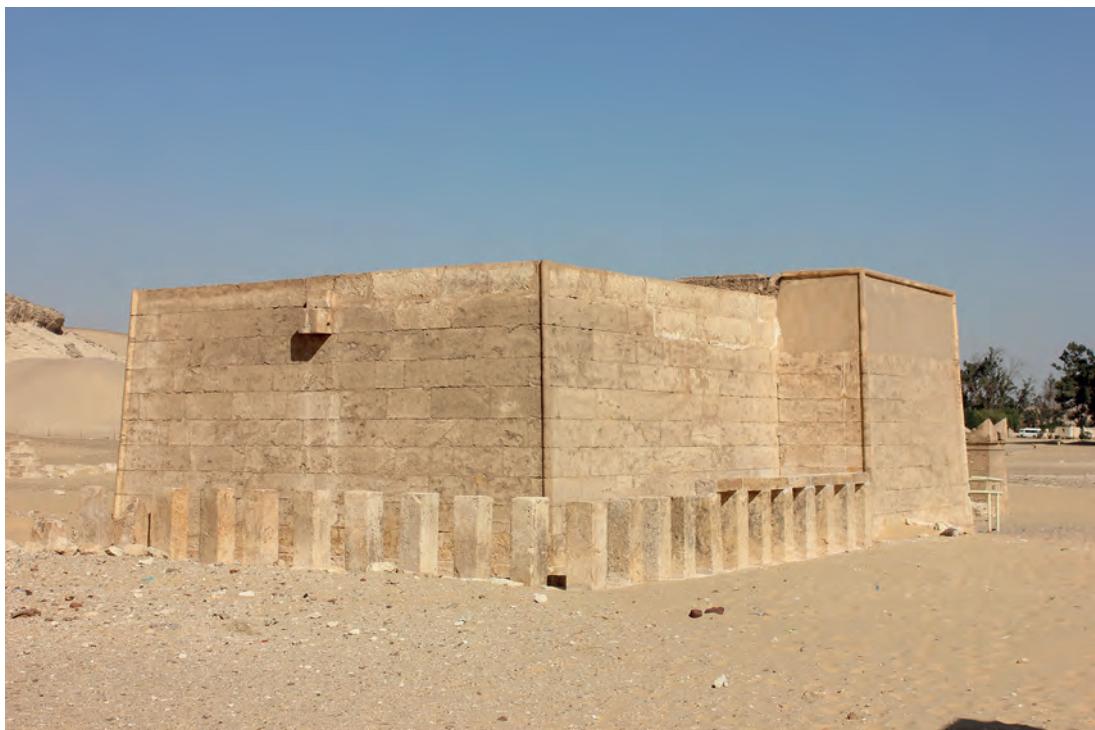
Fig. 1: The re-erected balustrade on the eastern and southern side of the tomb of Petosiris (GB 50); 2015

During the field school for restorers in October 2015¹ the area around the tomb of Petosiris (GB 50) was cleaned from sand in order to reconstruct the balustrade surrounding the rear part of the tomb (fig. 1). On the southern side most of the blocks were lying almost in their original position, while on the eastern side some of the upright pillars remained standing still *in situ*, but all of the horizontal slabs placed on top of them were collapsed. On the

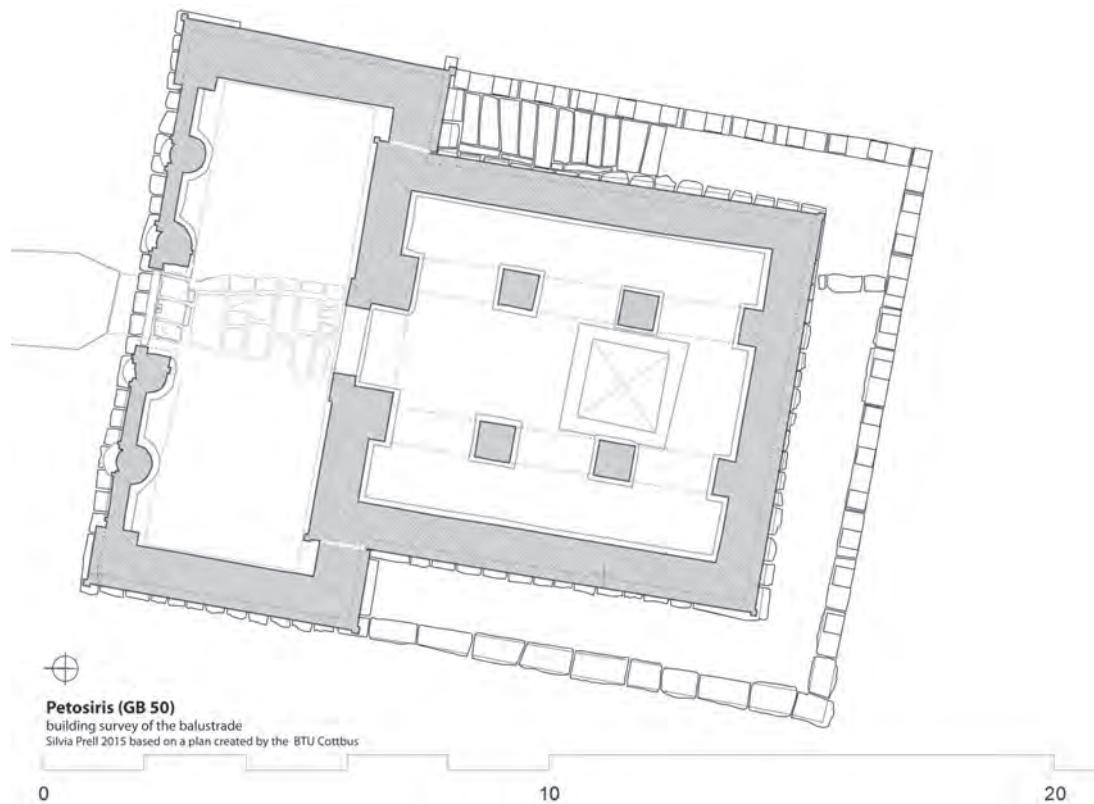
Fig. 2 a: Plan of the balustrade and its foundations; 2015

The foundation of the balustrade consists of local limestone blocks laid out in a U-shape around the naos, leaving an open space between them and the foundations of the temple tomb of about 110 cm (fig. 2 a–b). A new discovery in 2015, even if not unexpected, was the foundation of the balustrade in the west mentioned neither by Gustave Lefebvre in 1923/1924³ nor by Sami Gabra and his colleagues⁴. Furthermore, Paul Perdrizet emphasised in 1941 that the balustrade was absent in the west⁵.

Along the eastern wall of the naos of the tomb of Petosiris, eleven blocks of local limestone are left of the pavement between the naos and the balustrade. Another block of this pavement is preserved in the southeast, all of them joining the tomb with the balustrade (fig. 2 a–b). They are 100–120 cm long, 25–56 cm wide and 15 cm high¹². The top edge of the pavement lies 5 cm lower than the top

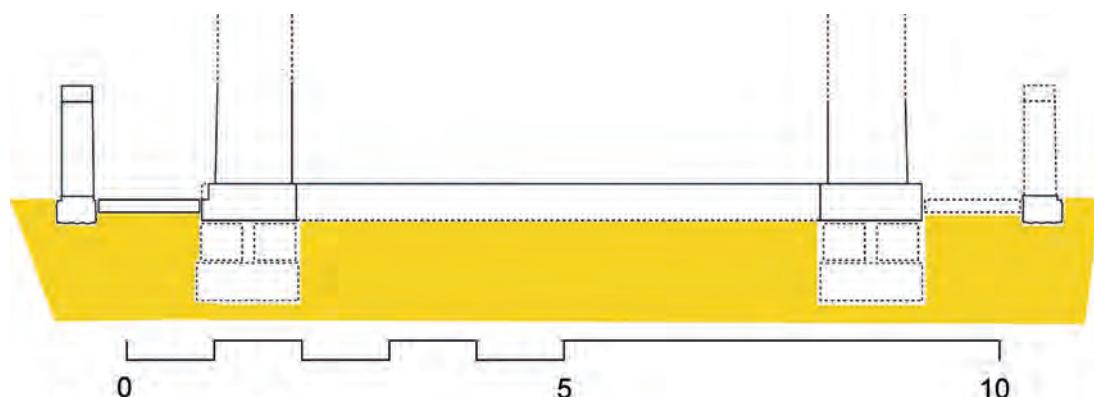
Petosiris (GB 50)
Idealised section through balustrade and Naos
Silvia Prell 2015

Fig. 2 b: Idealised section through balustrade and tomb building; 2015

The blocks used for the foundation are generally 100–110 cm long; shorter ones, for example in the corners, measure at least 60 cm. All of the blocks are about 30 cm thick, as selectively checked at the inner south-western corner, with a levelled surface, plane and smoothed by charring. Only the uppermost parts (3–5 cm) of the sides of the blocks are worked more carefully, below they are very roughly shaped, because they were covered by sand and hence invisible. The smoothened surface is 35 cm wide, while the raw block is actually broader (fig. 2 b and 3).

edge of the foundation blocks. The uppermost layer of the foundation of the naos, the euthynteria, however, has been chiselled off about 18 cm in certain places to match the height of the pavement (fig. 2 b and 5). Therefore, although the euthynteria seems to protrude only about 10–15 cm from the rising masonry of the tomb, it is actually wider. The length of the blocks of the euthynteria must have originally varied, because some of the blocks were not chopped off, while others protrude up to 20 cm further east below the pavement. Gaps in the pavement caused by the unevenness of the uppermost foundation layer were closed with smaller pieces or longer slabs (fig. 2 a and 5). As far as could be checked during cleaning, the

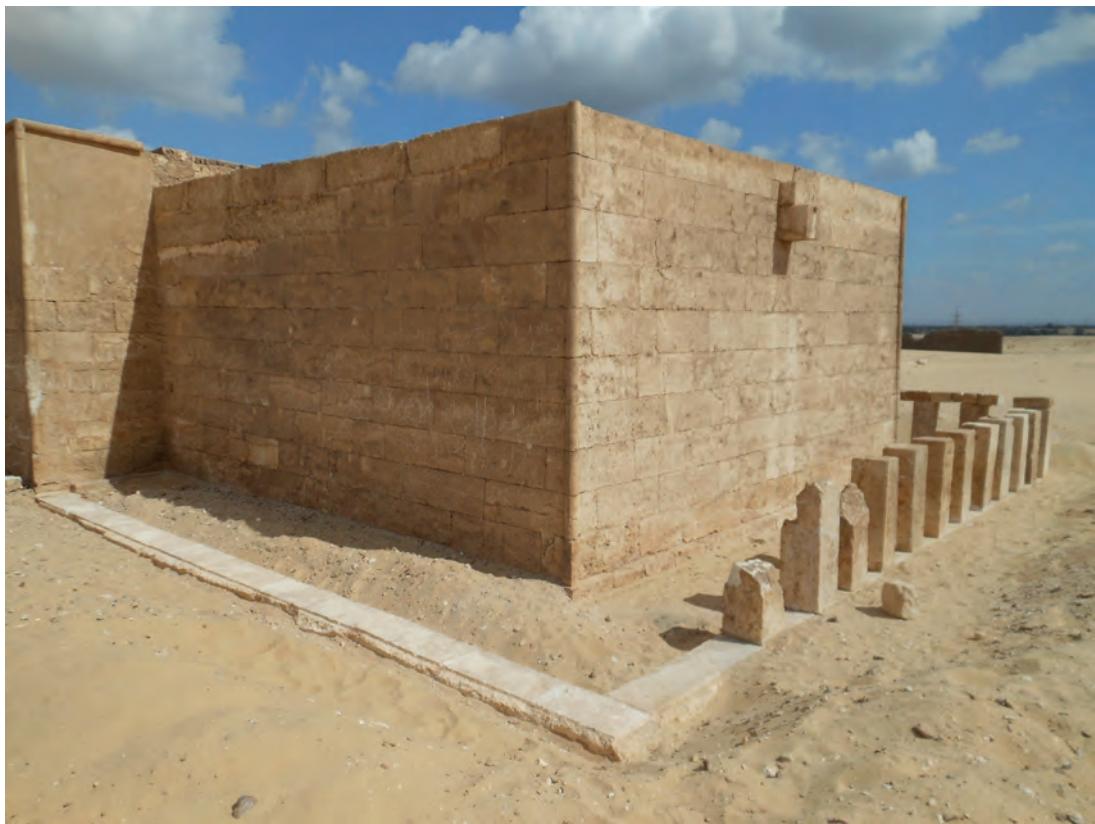
Fig. 3: The foundation of the balustrade in the west and south; 2015

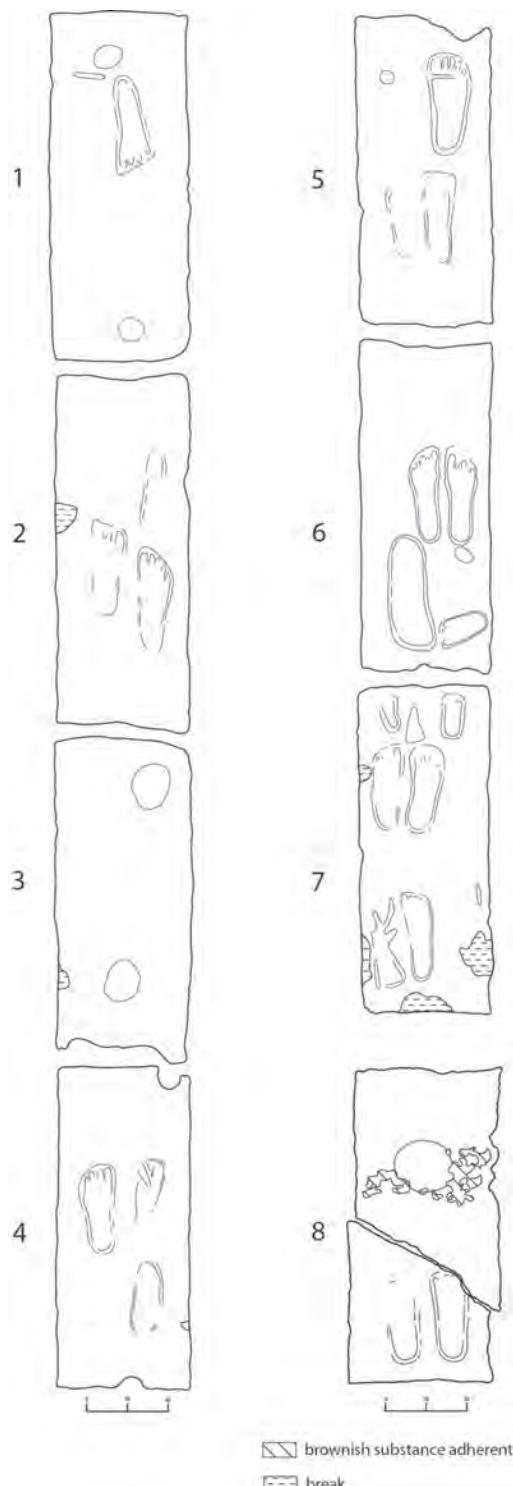
Fig. 4: The seven complete slabs and one of the broken slabs once supported by the pillars, showing incised outlines of feet and offering moulds; 2015

in length and 17 cm in thickness⁸. Seven of these slabs are still complete, two are broken in two pieces, and several further fragments have been found during cleaning the surroundings from sand. On seven of those slabs (six are complete and one is broken) the outline of a single foot or of a pair of feet is incised (fig. 4)⁹. They are of different sizes, and some smaller ones appear to belong to children. The toes are not always indicated; on a single foot on slab no. 5 a sandal seems to be indicated by a horizontal line incised directly below the toes. Most of the incised feet are pointing north, only two feet (slabs nos. 1 and 6) are pointing south¹⁰ and another foot (slab no. 6) is the only one pointing west. A pair of feet on slabs nos. 4 and 7 seems to be unfinished, which is suggested by the weak and incomplete incision of the second foot.

In addition, five slabs show offering moulds (fig. 4). Similar moulds appeared also at the euthynteria of GB 51 and the tomb of Padjkam (GB 54)¹¹. It is so far unclear, if those offering moulds were part of the funerary cult for Petosiris himself or if they belong to later burials that once surrounded the tomb.

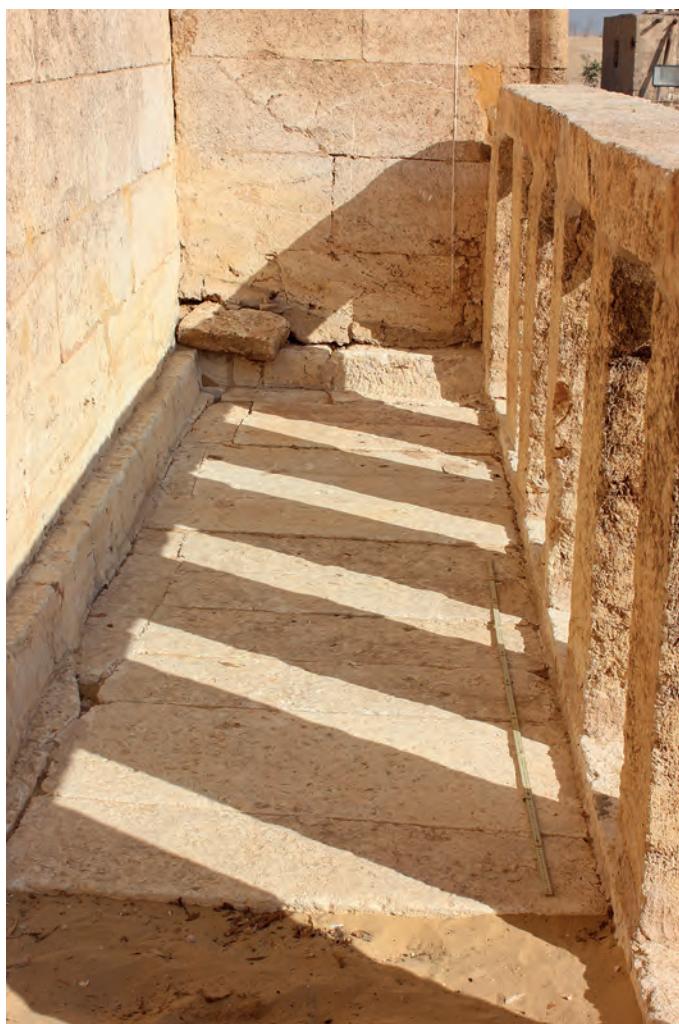
Fig. 5: Preserved pavement between naos and balustrade; 2015

Along the outside of the southern wall of the tomb of Petosiris and on parts of the eastern wall of the temple tomb, the remains of a floor consisting of lime mixed with pulverised red bricks and sand was discovered (fig. 5). This floor apparently belonged to a later phase, when in the Roman period ad-

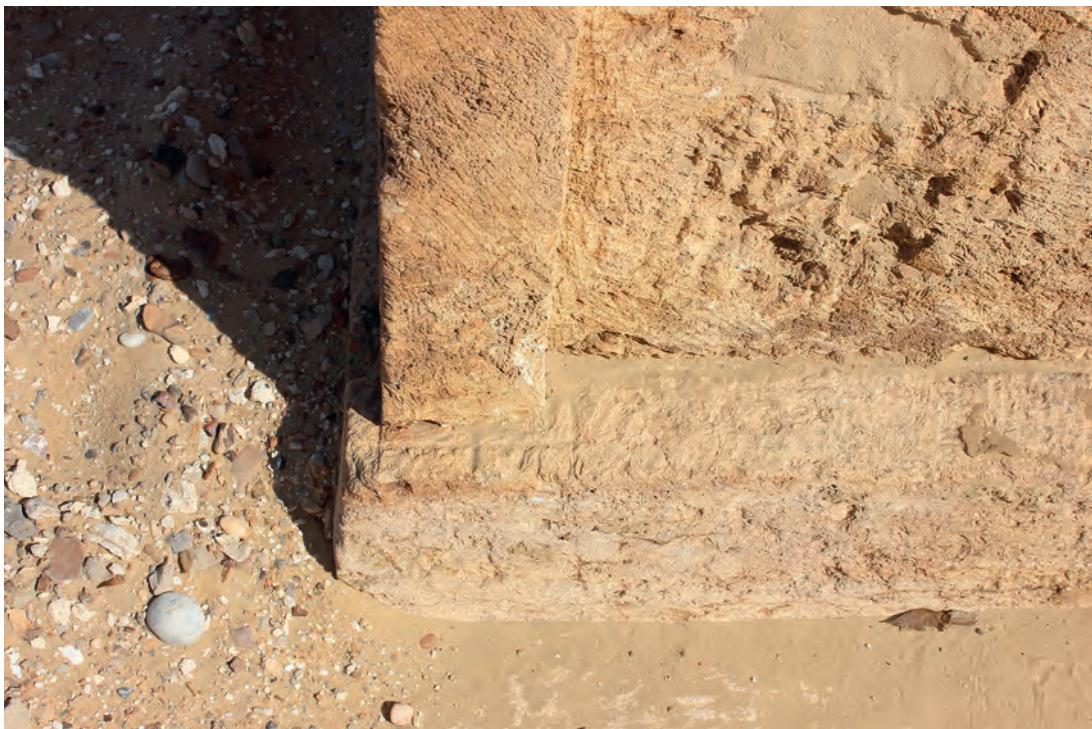
Fig. 6: Incision on top of the euthyneria indicating the future position of the round bar of the southwestern corner of the naos; 2015

While the euthynteria of the naos shows incised marks for the positioning of the blocks of the walls including the round bars at the corners (fig. 6)¹⁵, the uppermost foundation layer of the pronaos – although the joints of the ma-

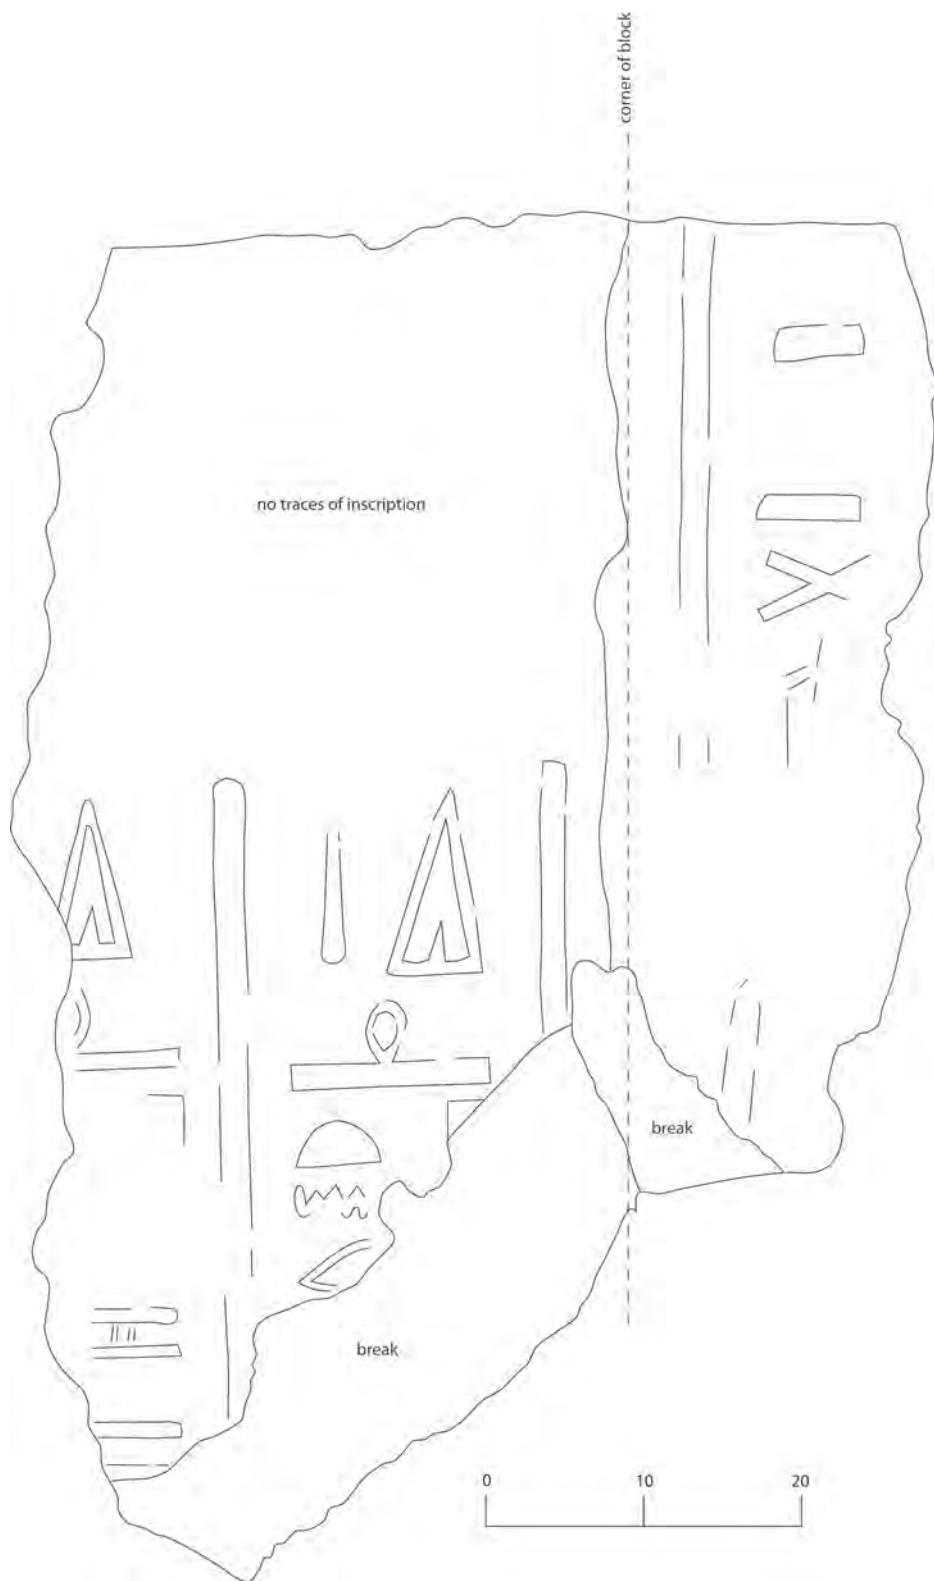
Fig. 7: Drawing of one block bearing a hieroglyphic inscription; 2015

On the southern side, two fragmented blocks with hieroglyphic inscriptions in sunk relief were found among the scattered blocks. Most likely, they belong to the tomb of Petosiris (GB 50) and were part of the architraves once supporting the ceiling blocks. Both preserve an original edge of the block and bear traces of hieroglyphic inscriptions arranged in columns on two sides (fig. 7–9).

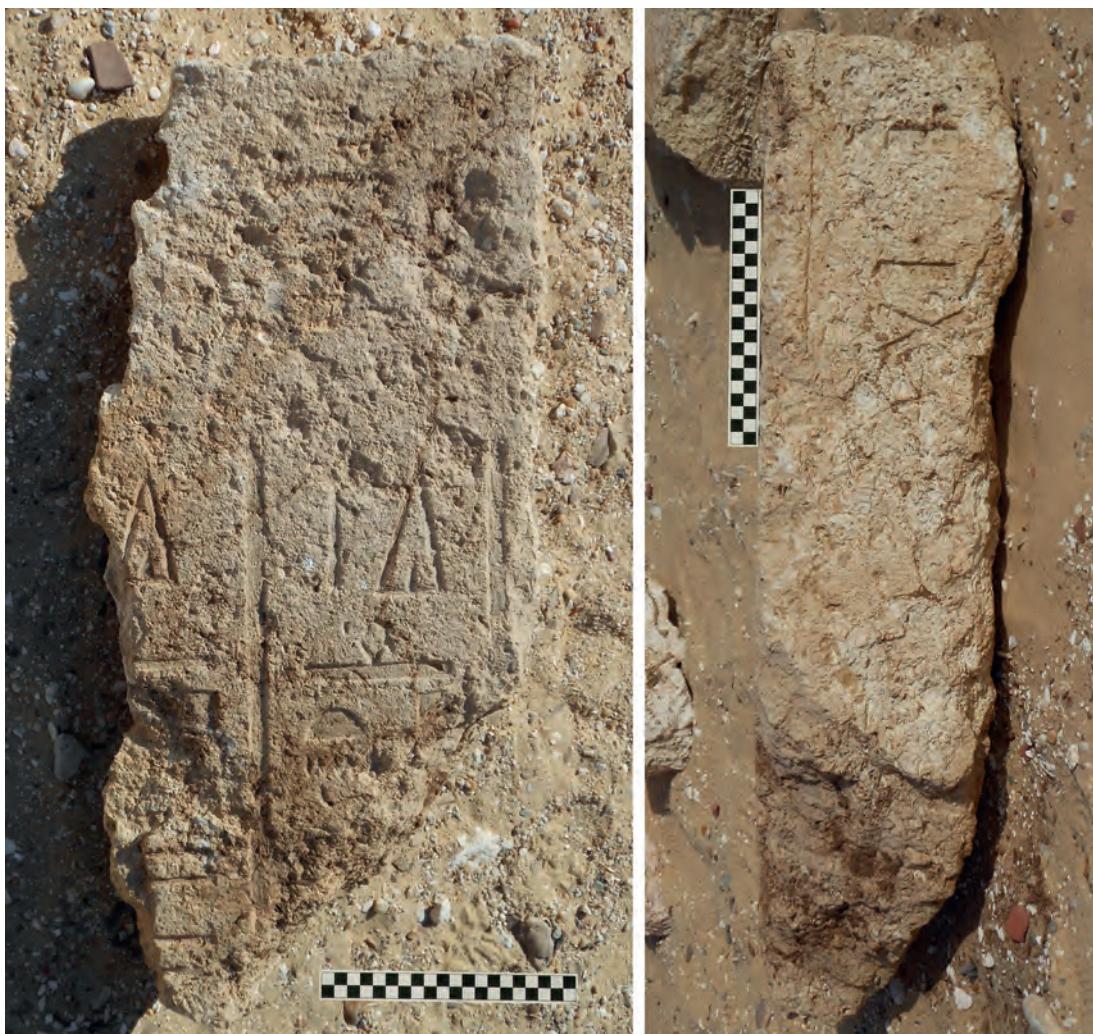
Fig. 8: Photo of the same block bearing a hieroglyphic inscription; 2015

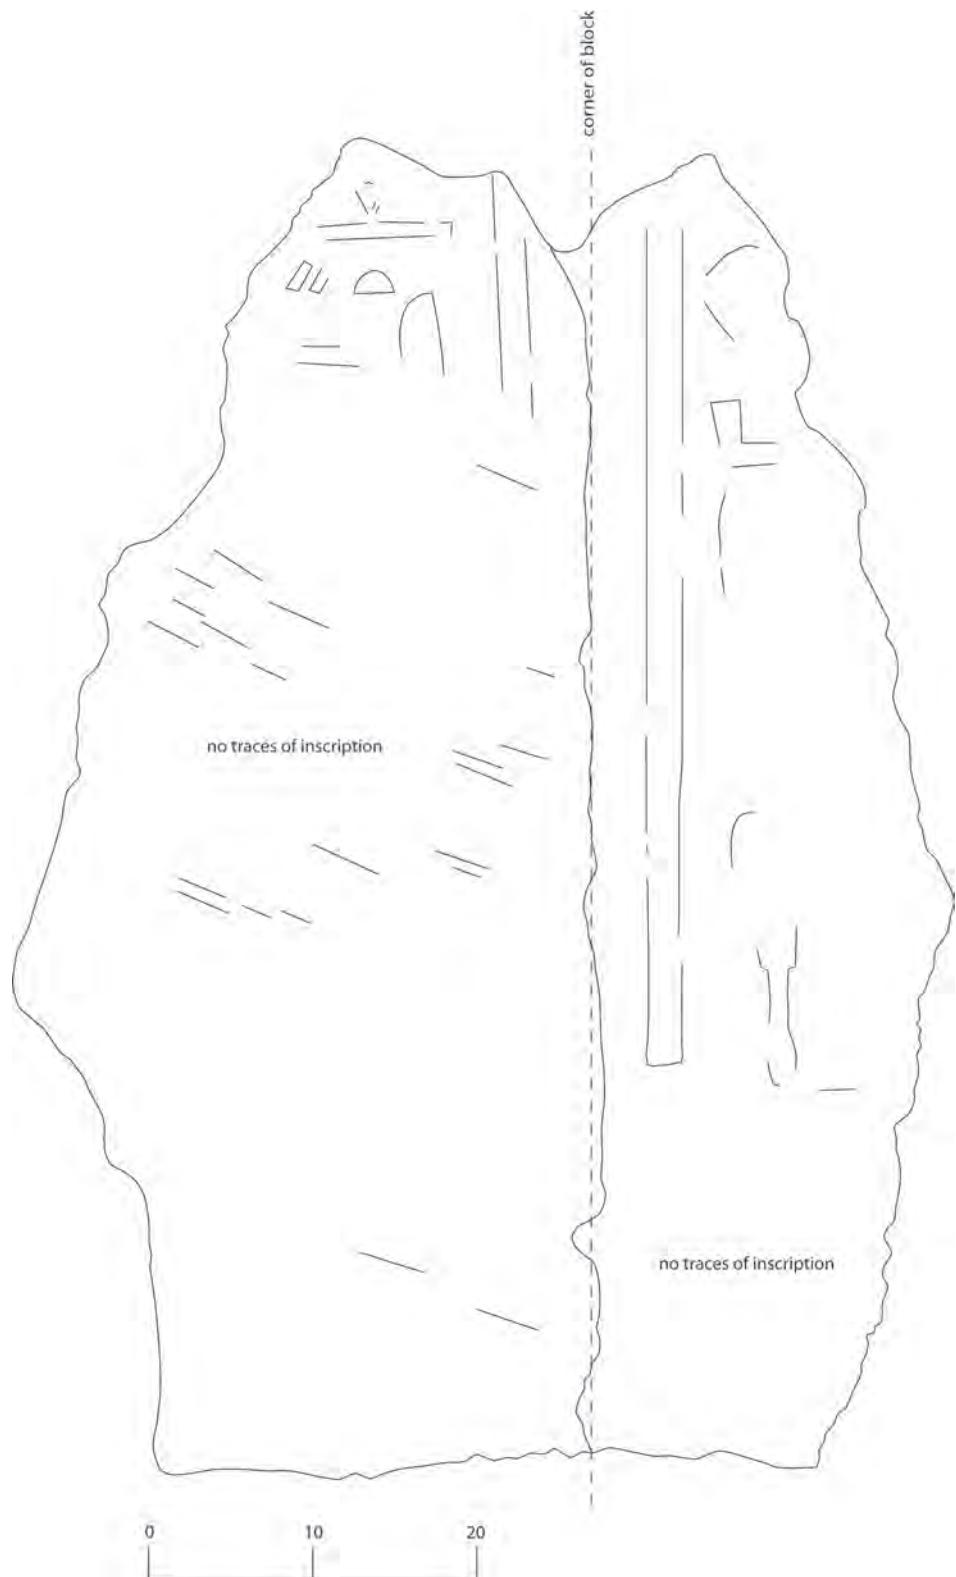
Fig. 9: Drawing of a second block bearing a hieroglyphic inscription; 2015

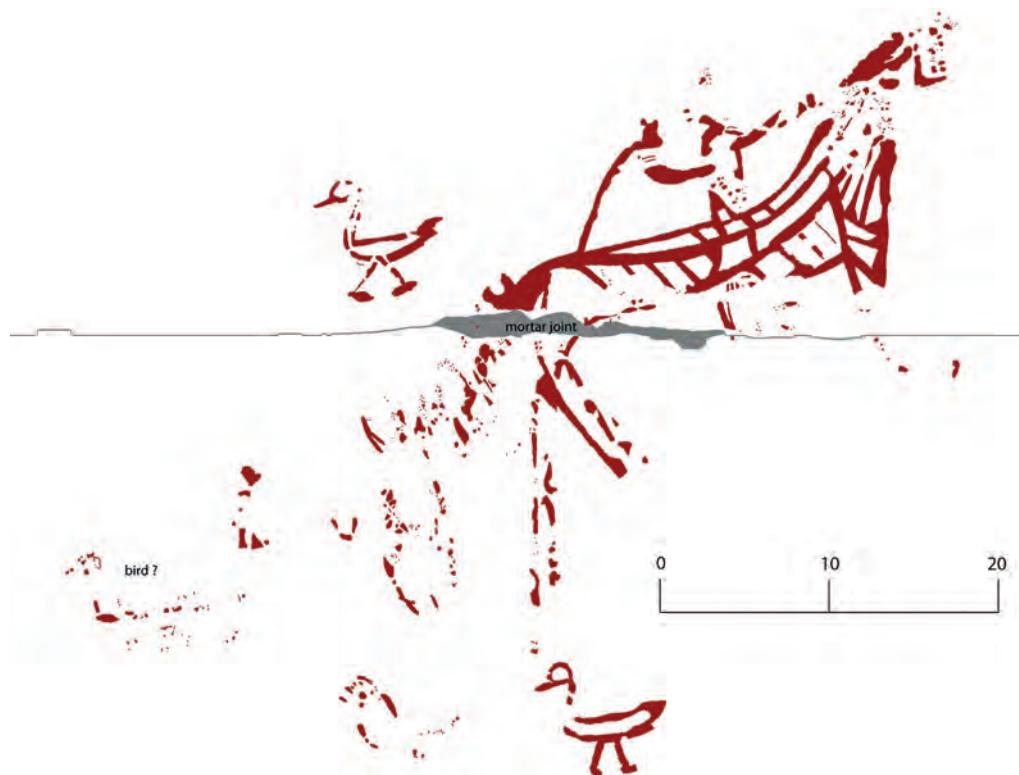
At the bottom part of the eastern wall near the corner of the hall, graffiti in red ink of a horseman (?) facing to the right and of at least two small birds facing to the left were found (fig. 10), which had not been documented by

Fig. 10: Graffito depicting a horseman (?) and some birds; 2015

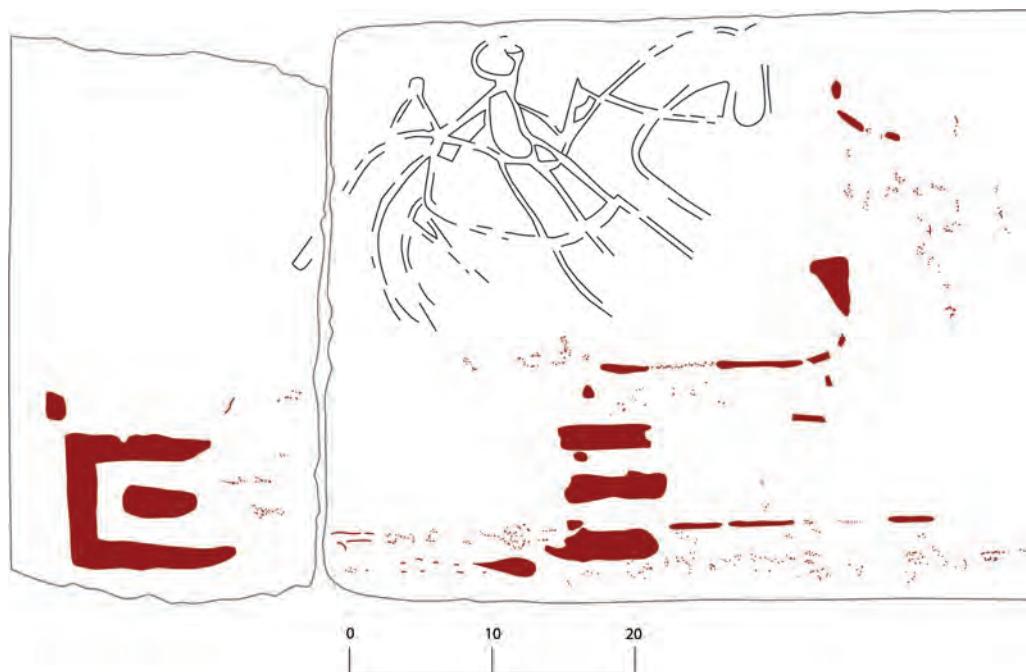
Lefebvre nor by Gabra. Another incised depiction of a horseman (fig. 11) and traces of red paint were found on the eastern wall of the pronaos of the temple tomb of Padjram (GB 54)¹⁹.

Fig. 11: Temple tomb of Padjkam (GB 54), eastern wall of the pronaos, graffito depicting a horseman; 2015

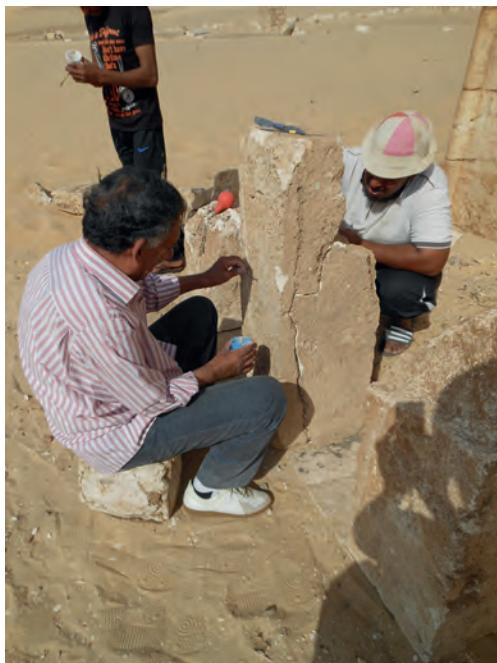
Fig. 12: Cleaning the surfaces of the stones; 2015

- Cleaning the stone surfaces by spraying limewater onto the stones until they are saturated.
- Consolidating the natural stone with approved materials. Chipped and broken areas of the stones are repaired by patching the void with mortar (fig. 12–13) that consists of lime and sand (relation 1 : 2) with some drops of Primal (emulsion of paraloid). Ground particles of the same or similar stone are added to ensure a close colour match (fig. 14). This method is suitable when no stone for replacement is available or the void is less than 25 mm deep.
- Resurfacing the exfoliated surfaces.

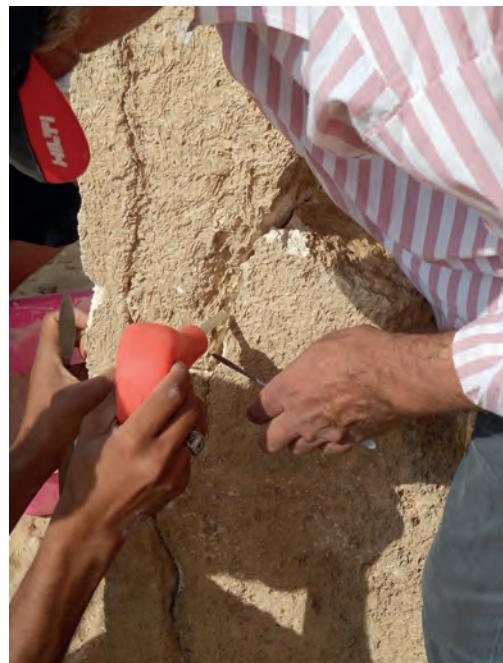
Fig. 13: Closing gaps with the help of lime mortar; 2015

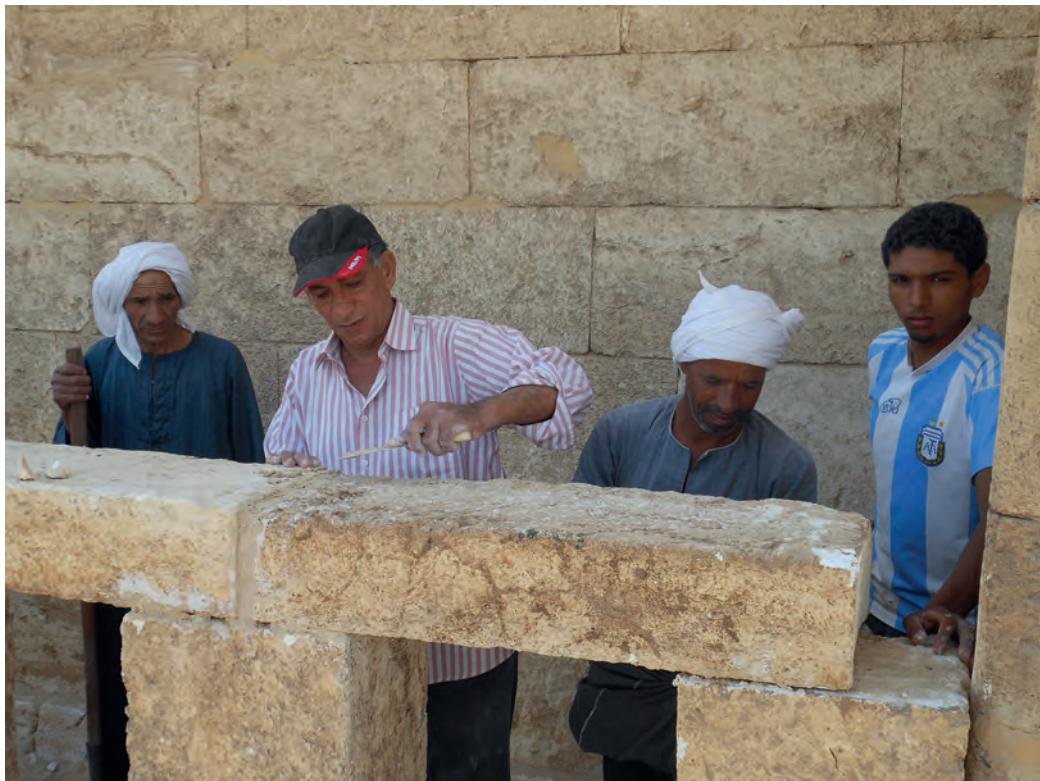
Fig. 14: Re-erection of balustrade with the help of lime mortar; 2015

In 2015, another restoration of the balustrade was accomplished using the following techniques:
