7 Site Management: Cleaning and Reconstruction of the Balustrade around the Naos of Petosiris (GB 50) – Some Observations

7.1 *The balustrade*

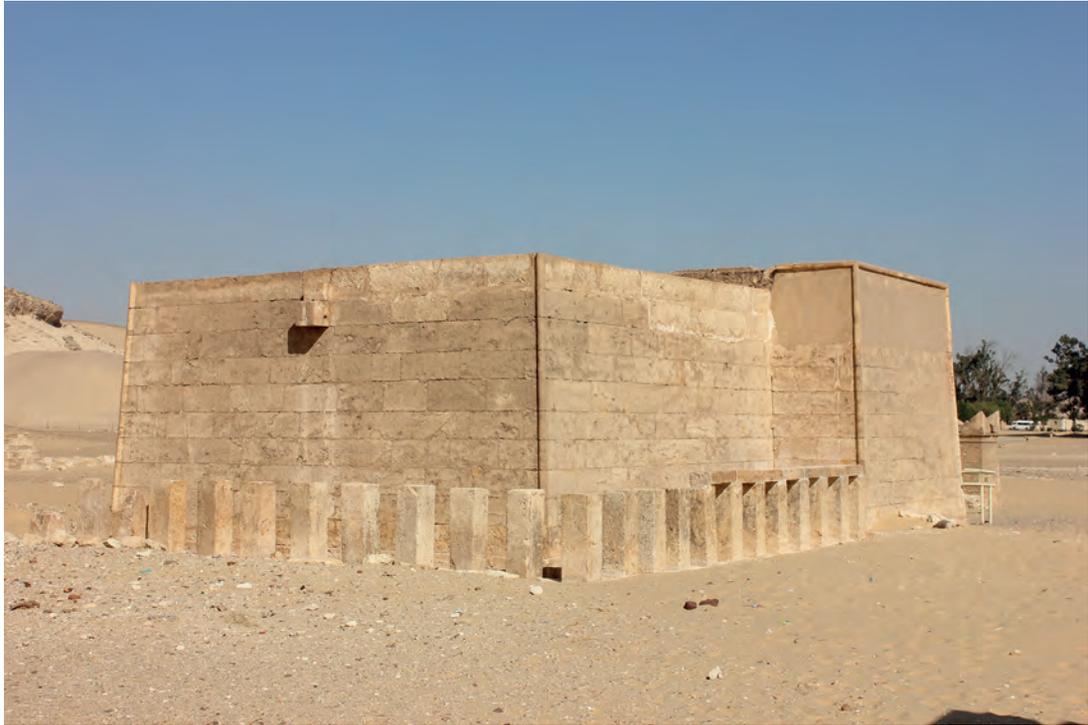
Fig. 1: The re-erected balustrade on the eastern and southern side of the tomb of Petosiris (GB 50); 2015

During the field school for restorers in October 2015¹ the area around the tomb of Petosiris (GB 50) was cleaned from sand in order to reconstruct the balustrade surrounding the rear part of the tomb (fig. 1). On the southern side most of the blocks were lying almost in their original position, while on the eastern side some of the upright pillars remained standing still in situ, but all of the horizontal slabs placed on top of them were collapsed. On the

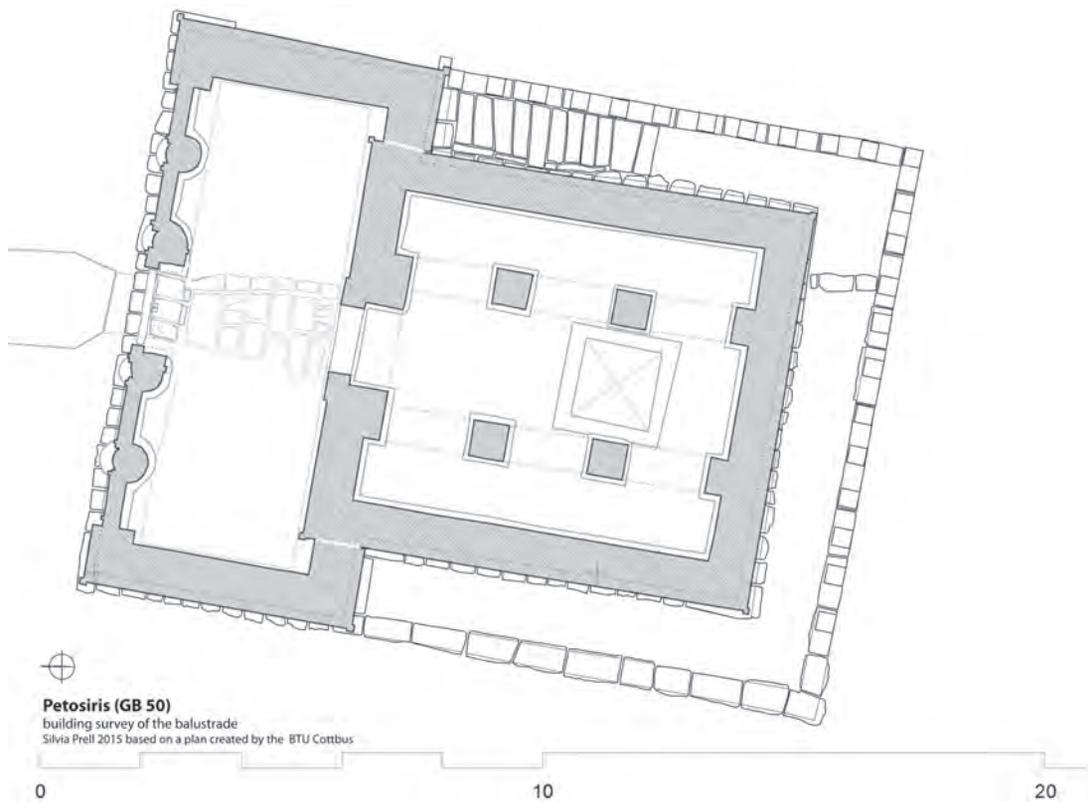
Fig. 2 a: Plan of the balustrade and its foundations; 2015

The foundation of the balustrade consists of local limestone blocks laid out in a U-shape around the naos, leaving an open space between them and the foundations of the temple tomb of about 110 cm (fig. 2 a–b). A new discovery in 2015, even if not unexpected, was the foundation of the balustrade in the west mentioned neither by Gustave Lefebvre in 1923/1924³ nor by Sami Gabra and his colleagues⁴. Furthermore, Paul Perdrizet emphasised in 1941 that the balustrade was absent in the west⁵.

Along the eastern wall of the naos of the tomb of Petosiris, eleven blocks of local limestone are left of the pavement between the naos and the balustrade. Another block of this pavement is preserved in the southeast, all of them joining the tomb with the balustrade (fig. 2 a–b). They are 100–120 cm long, 25–56 cm wide and 15 cm high¹². The top edge of the pavement lies 5 cm lower than the top

edge of the foundation blocks. The uppermost layer of the foundation of the naos, the euthynteria, however, has been chiselled off about 18 cm in certain places to match the height of the pavement (fig. 2 b and 5). Therefore, although the euthynteria seems to protrude only about 10–15 cm from the rising masonry of the tomb, it is actually wider. The length of the blocks of the euthynteria must have originally varied, because some of the blocks were not chopped off, while others protrude up to 20 cm further east below the pavement. Gaps in the pavement caused by the unevenness of the uppermost foundation layer were closed with smaller pieces or longer slabs (fig. 2 a and 5). As far as could be checked during cleaning, the

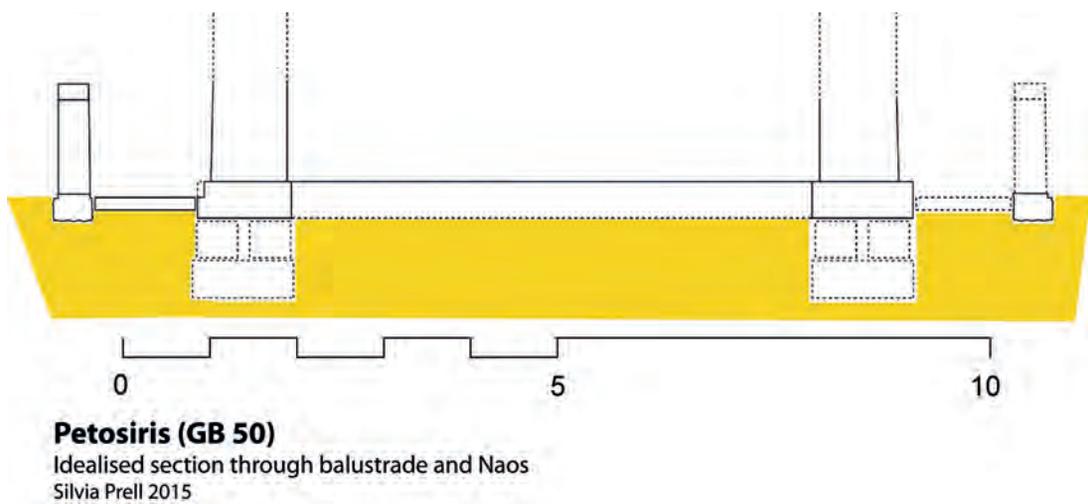
Fig. 2 b: Idealised section through balustrade and tomb building; 2015

The blocks used for the foundation are generally 100–110 cm long; shorter ones, for example in the corners, measure at least 60 cm. All of the blocks are about 30 cm thick, as selectively checked at the inner south-western corner, with a levelled surface, plane and smoothed by charring. Only the uppermost parts (3–5 cm) of the sides of the blocks are worked more carefully, below they are very roughly shaped, because they were covered by sand and hence invisible. The smoothed surface is 35 cm wide, while the raw block is actually broader (fig. 2 b and 3).

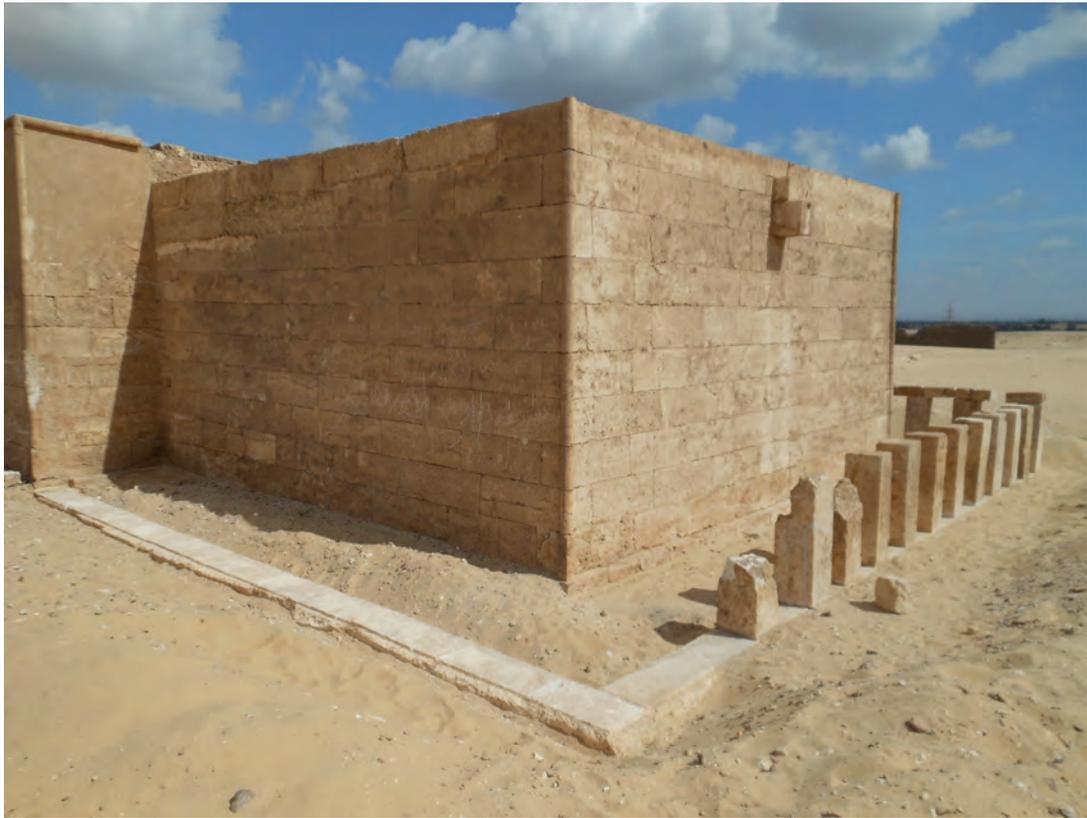
Fig. 3: The foundation of the balustrade in the west and south; 2015

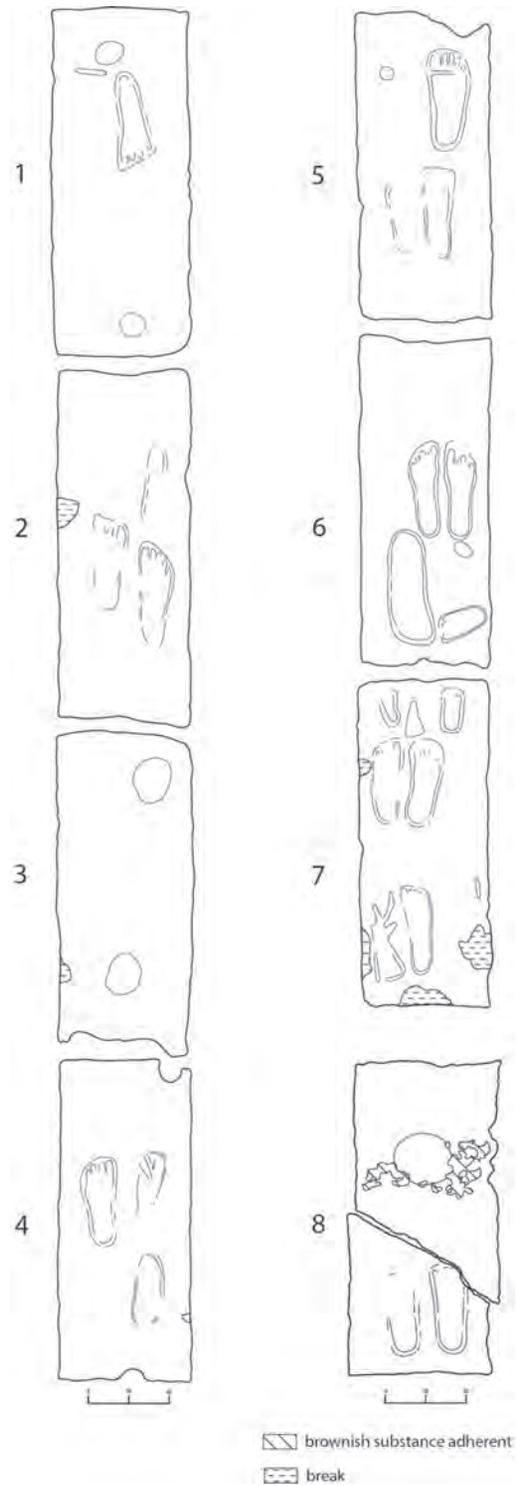
Fig. 4: The seven complete slabs and one of the broken slabs once supported by the pillars, showing incised outlines of feet and offering moulds; 2015

in length and 17 cm in thickness⁸. Seven of these slabs are still complete, two are broken in two pieces, and several further fragments have been found during cleaning the surroundings from sand. On seven of those slabs (six are complete and one is broken) the outline of a single foot or of a pair of feet is incised (fig. 4)⁹. They are of different sizes, and some smaller ones appear to belong to children. The toes are not always indicated; on a single foot on slab no. 5 a sandal seems to be indicated by a horizontal line incised directly below the toes. Most of the incised feet are pointing north, only two feet (slabs nos. 1 and 6) are pointing south¹⁰ and another foot (slab no. 6) is the only one pointing west. A pair of feet on slabs nos. 4 and 7 seems to be unfinished, which is suggested by the weak and incomplete incision of the second foot.

In addition, five slabs show offering moulds (fig. 4). Similar moulds appeared also at the euthyteria of GB 51 and the tomb of Padjkam (GB 54)¹¹. It is so far unclear, if those offering moulds were part of the funerary cult for Petosiris himself or if they belong to later burials that once surrounded the tomb.

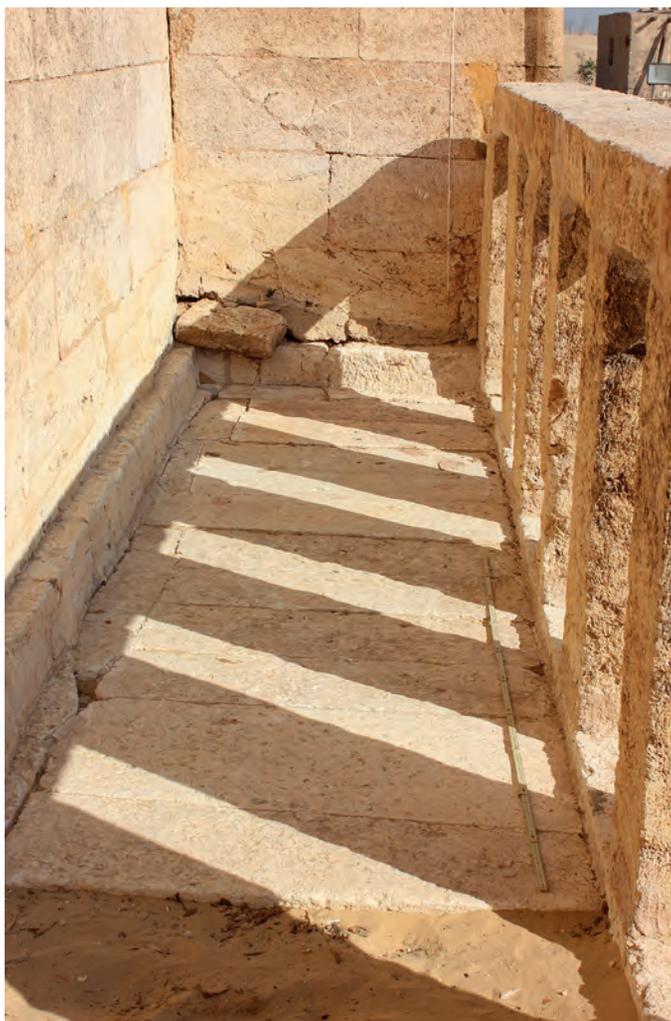
Fig. 5: Preserved pavement between naos and balustrade; 2015

Along the outside of the southern wall of the tomb of Petosiris and on parts of the eastern wall of the temple tomb, the remains of a floor consisting of lime mixed with pulverised red bricks and sand was discovered (fig. 5). This floor apparently belonged to a later phase, when in the Roman period ad-

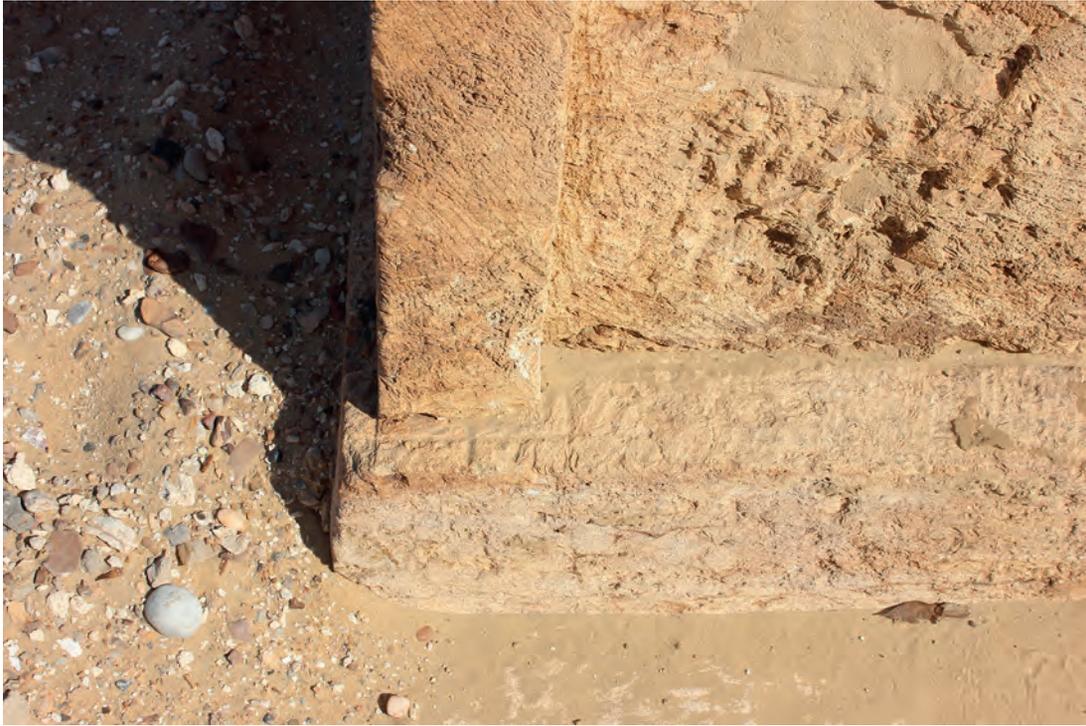
Fig. 6: Incision on top of the euthynteria indicating the future position of the round bar of the southwestern corner of the naos; 2015

While the euthynteria of the naos shows incised marks for the positioning of the blocks of the walls including the round bars at the corners (fig. 6)¹⁵, the uppermost foundation layer of the pronaos – although the joints of the ma-

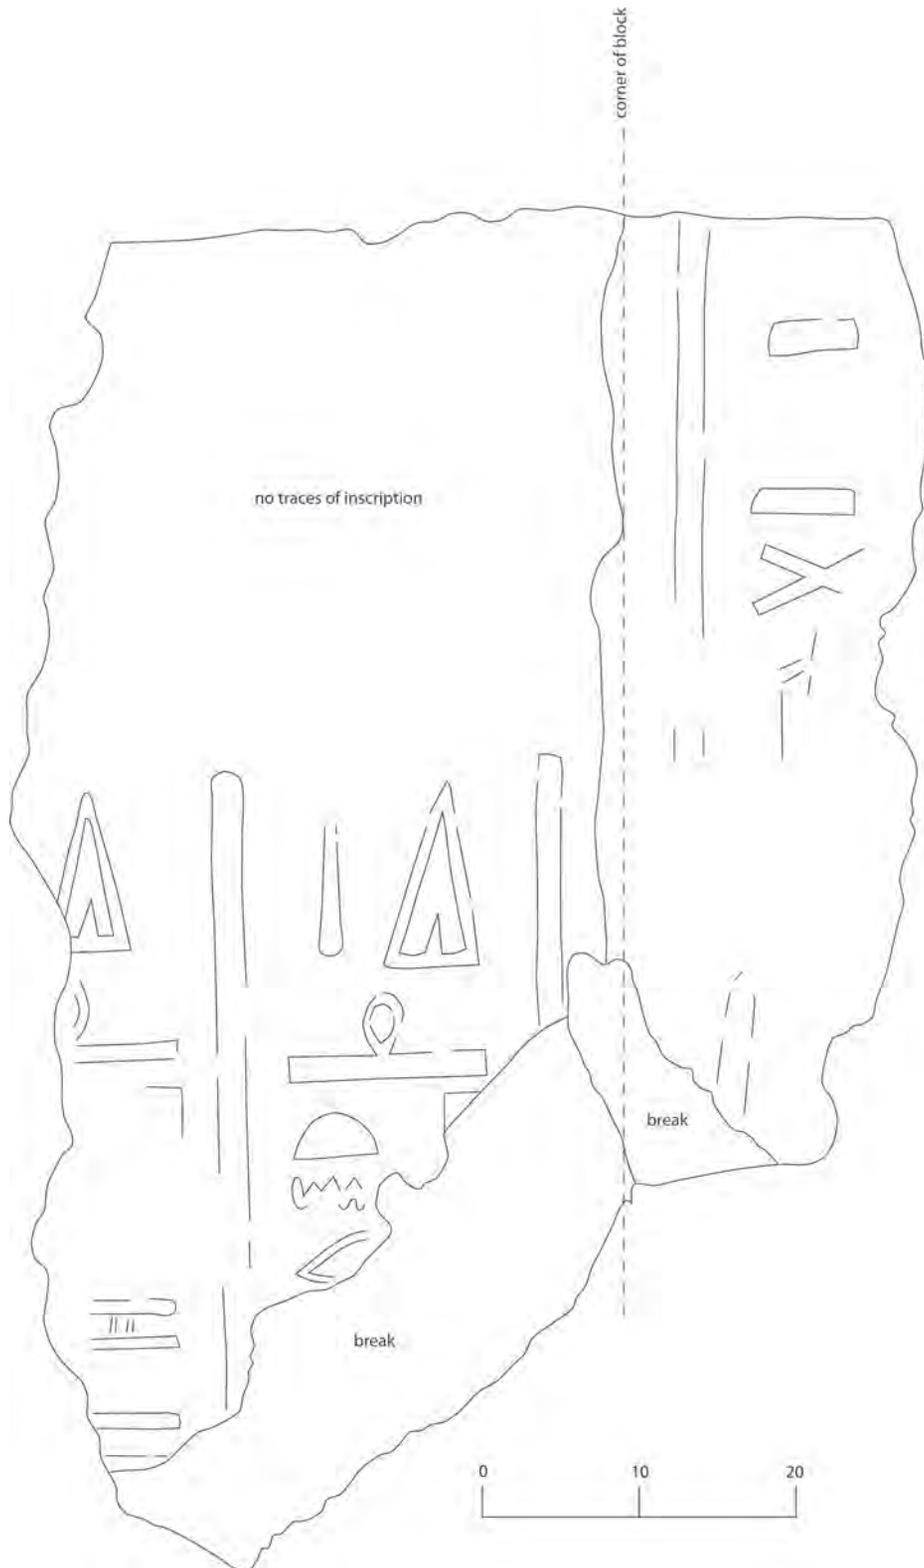
Fig. 7: Drawing of one block bearing a hieroglyphic inscription; 2015

On the southern side, two fragmented blocks with hieroglyphic inscriptions in sunk relief were found among the scattered blocks. Most likely, they belong to the tomb of Petosiris (GB 50) and were part of the architraves once supporting the ceiling blocks. Both preserve an original edge of the block and bear traces of hieroglyphic inscriptions arranged in columns on two sides (fig. 7–9).

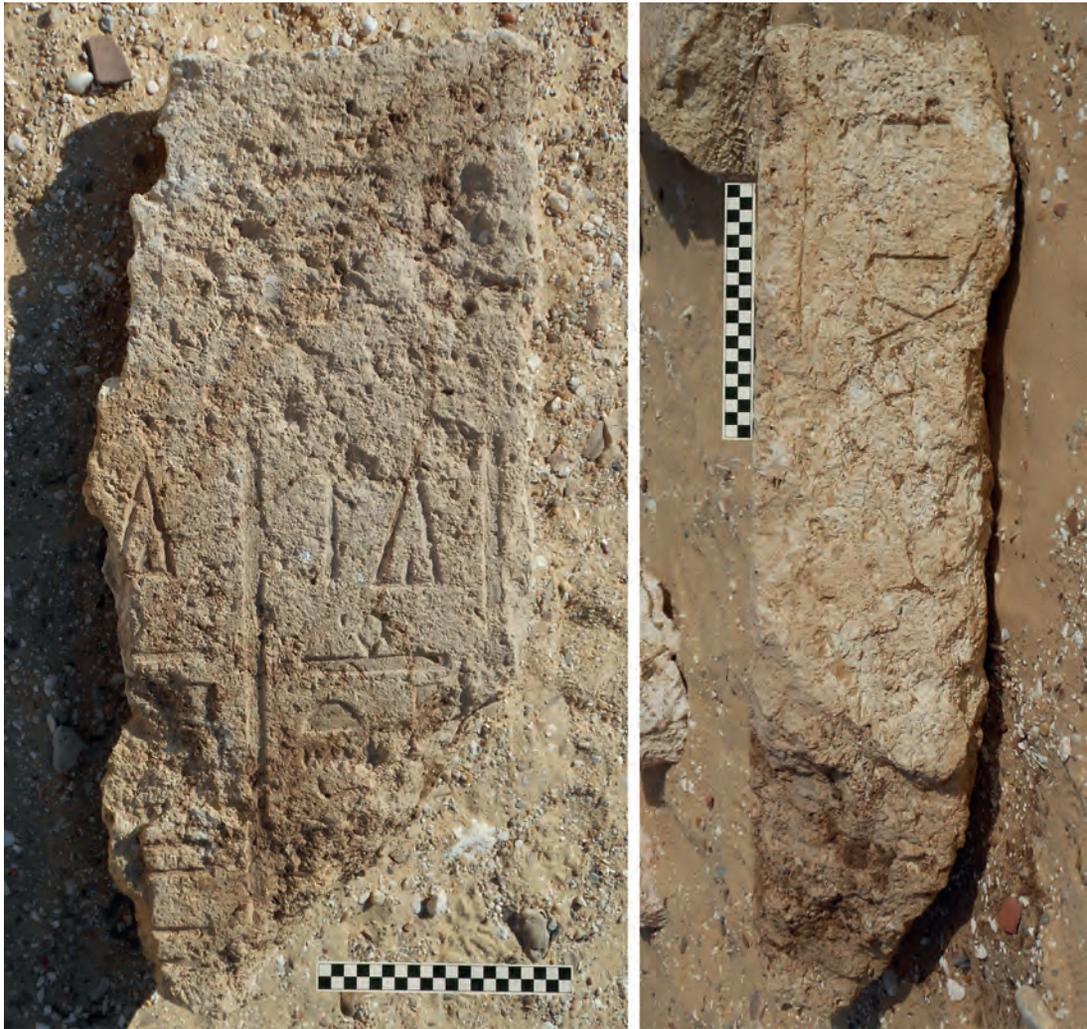
Fig. 8: Photo of the same block bearing a hieroglyphic inscription; 2015

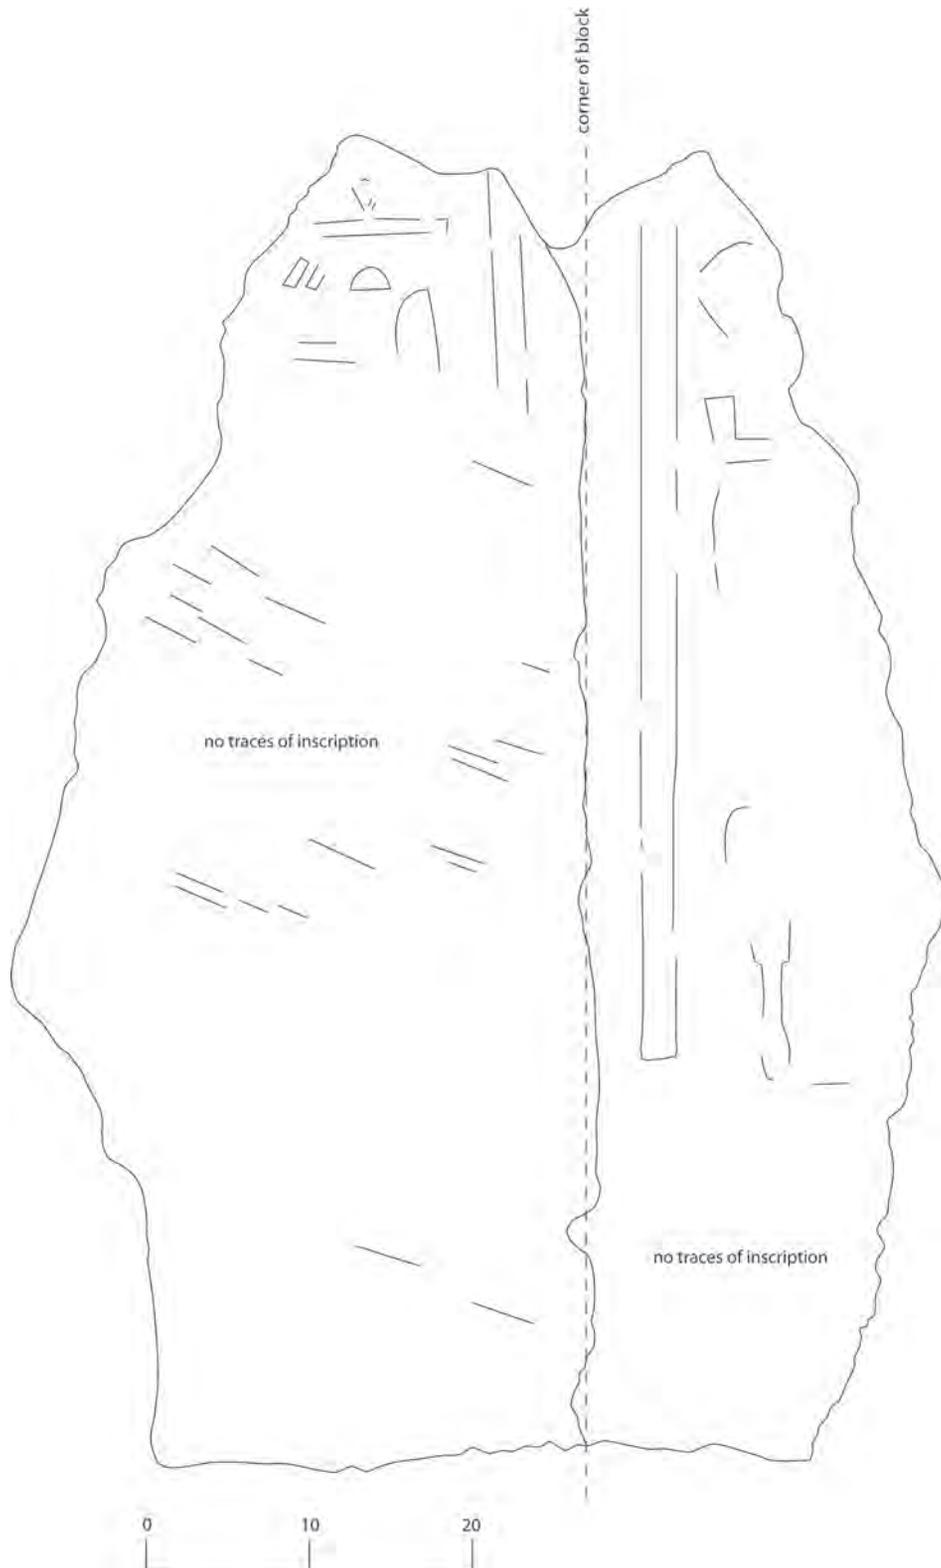
Fig. 9: Drawing of a second block bearing a hieroglyphic inscription; 2015

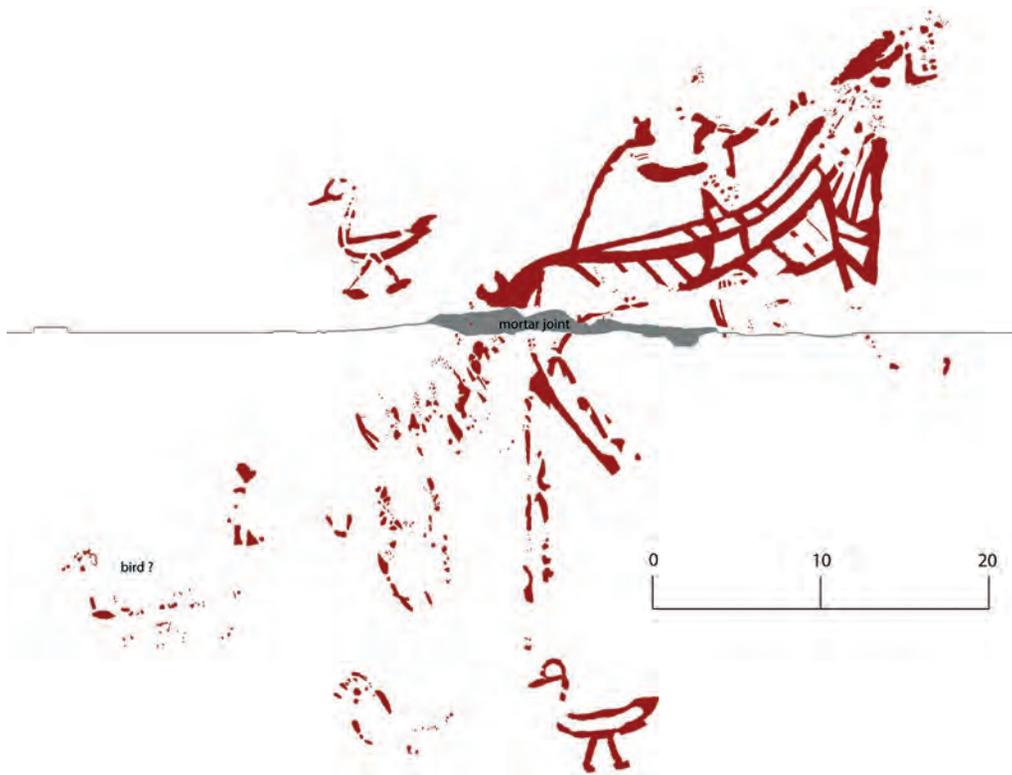
Fig. 10: Graffito depicting a horseman (?) and some birds; 2015

At the bottom part of the eastern wall near the corner of the hall, graffiti in red ink of a horseman (?) facing to the right and of at least two small birds facing to the left were found (fig. 10), which had not been documented by

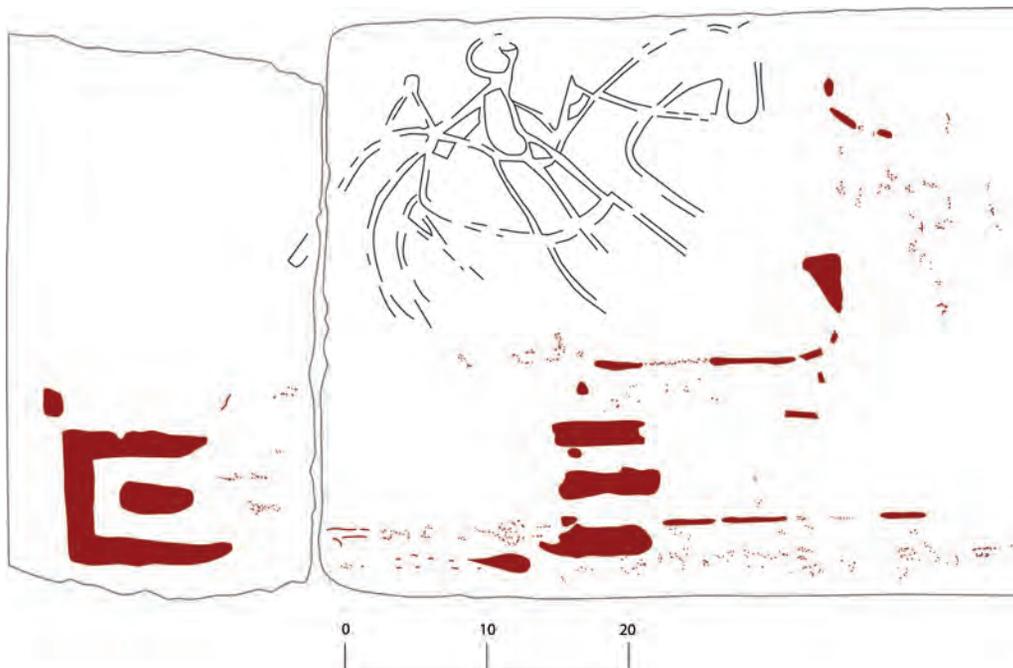
Fig. 11: Temple tomb of Padjkam (GB 54), eastern wall of the pronaos, graffito depicting a horseman; 2015

Lefebvre nor by Gabra. Another incised depiction of a horseman (fig. 11) and traces of red paint were found on the eastern wall of the pronaos of the temple tomb of Padjkam (GB 54)¹⁹.

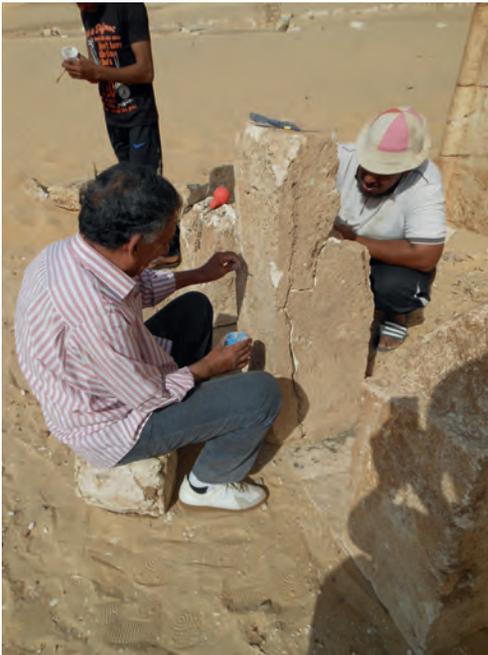
Fig. 12: Cleaning the surfaces of the stones; 2015

- Cleaning the stone surfaces by spraying limewater onto the stones until they are saturated.
- Consolidating the natural stone with approved materials. Chipped and broken areas of the stones are repaired by patching the void with mortar (fig. 12–13) that consists of lime and sand (relation 1 : 2) with some drops of Primal (emulsion of paraloid). Ground particles of the same or similar stone are added to ensure a close colour match (fig. 14). This method is suitable when no stone for replacement is available or the void is less than 25 mm deep.
- Resurfacing the exfoliated surfaces.

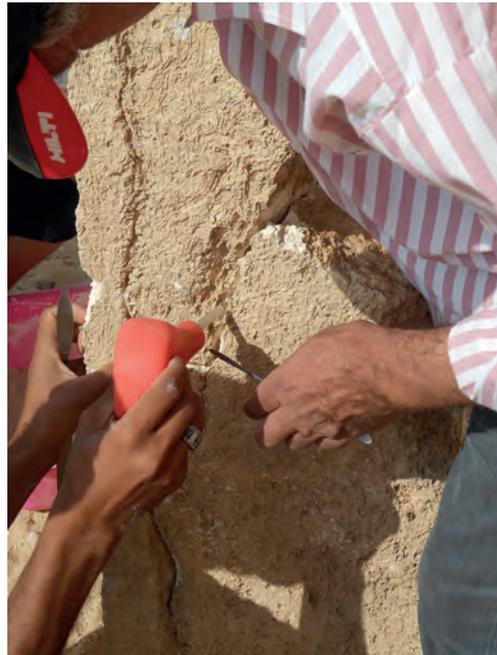
Fig. 13: Closing gaps with the help of lime mortar; 2015

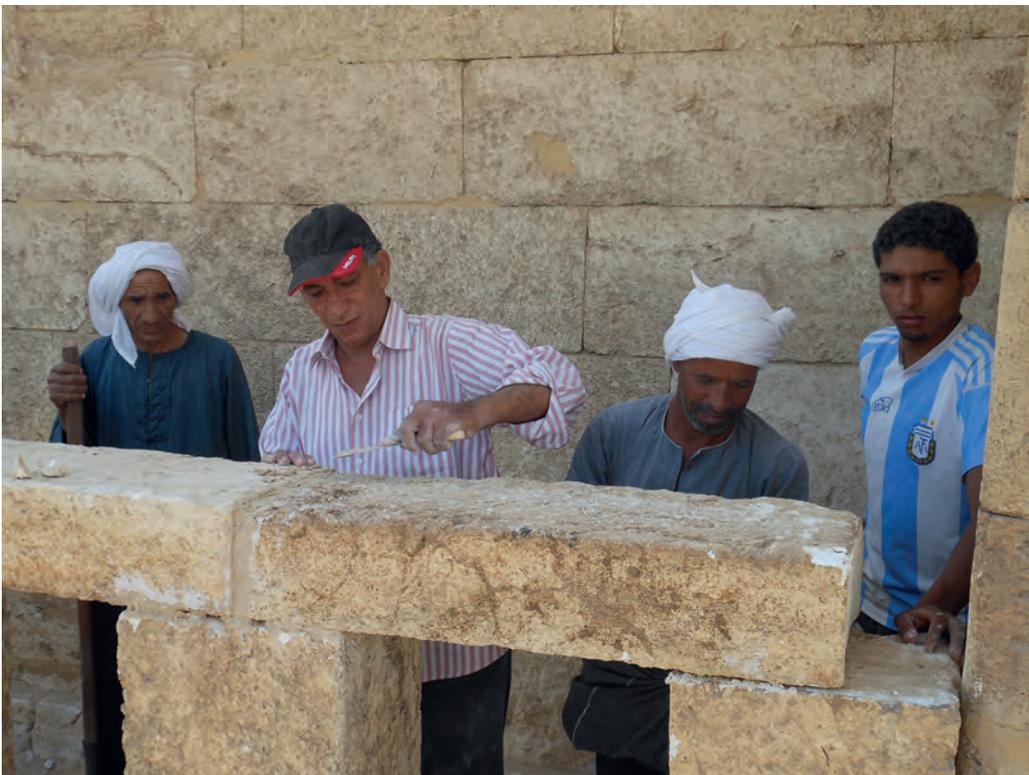
Fig. 14: Re-erection of balustrade with the help of lime mortar; 2015

In 2015, another restoration of the balustrade was accomplished using the following techniques:
