## 7 Site Management: Cleaning and Reconstruction of the Balustrade around the Naos of Petosiris (GB 50) – Some Observations

### 7.1 *The balustrade*

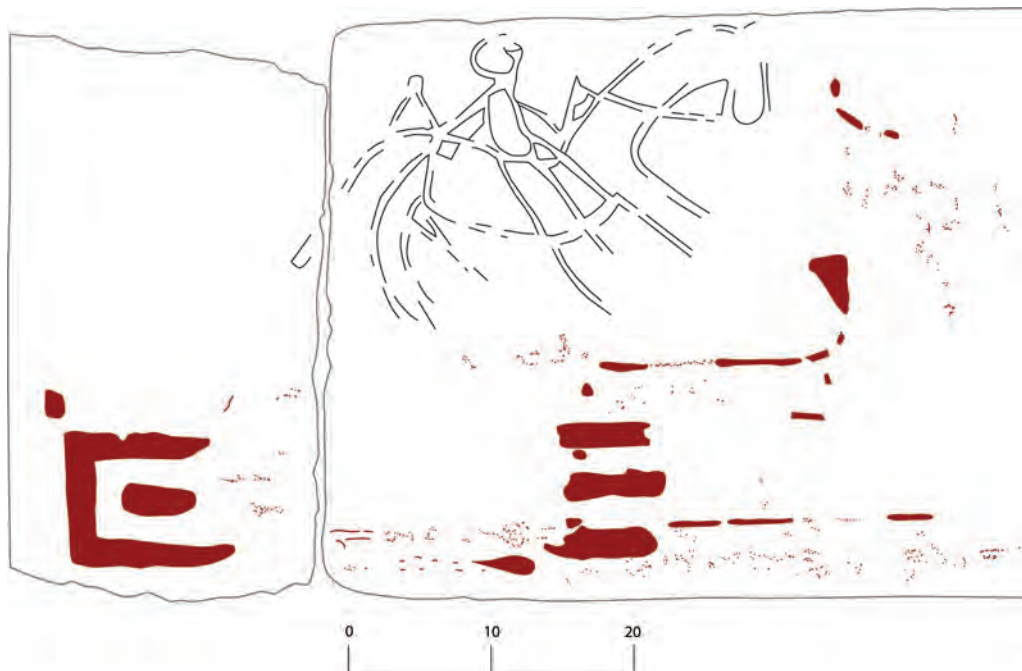
Lefebvre nor by Gabra. Another incised depiction of a horseman (fig. 11) and traces of red paint were found on the eastern wall of the pronaos of the temple tomb of Padjkam (GB 54)<sup>19</sup>.

Fig. 11: Temple tomb of Padjkam (GB 54), eastern wall of the pronaos, graffito depicting a horseman; 2015

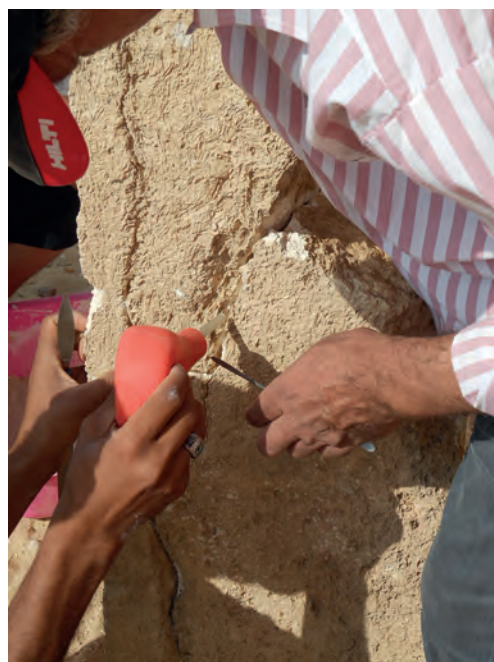
Fig. 13: Closing gaps with the help of lime mortar; 2015

- Cleaning the stone surfaces by spraying limewater onto the stones until they are saturated.
- Consolidating the natural stone with approved materials. Chipped and broken areas of the stones are repaired by patching the void with mortar (fig. 12–13) that consists of lime and sand (relation 1 : 2) with some drops of Primal (emulsion of paraloid). Ground particles of the same or similar stone are added to ensure a close colour match (fig. 14). This method is suitable when no stone for replacement is available or the void is less than 25 mm deep.
- Resurfacing the exfoliated surfaces.

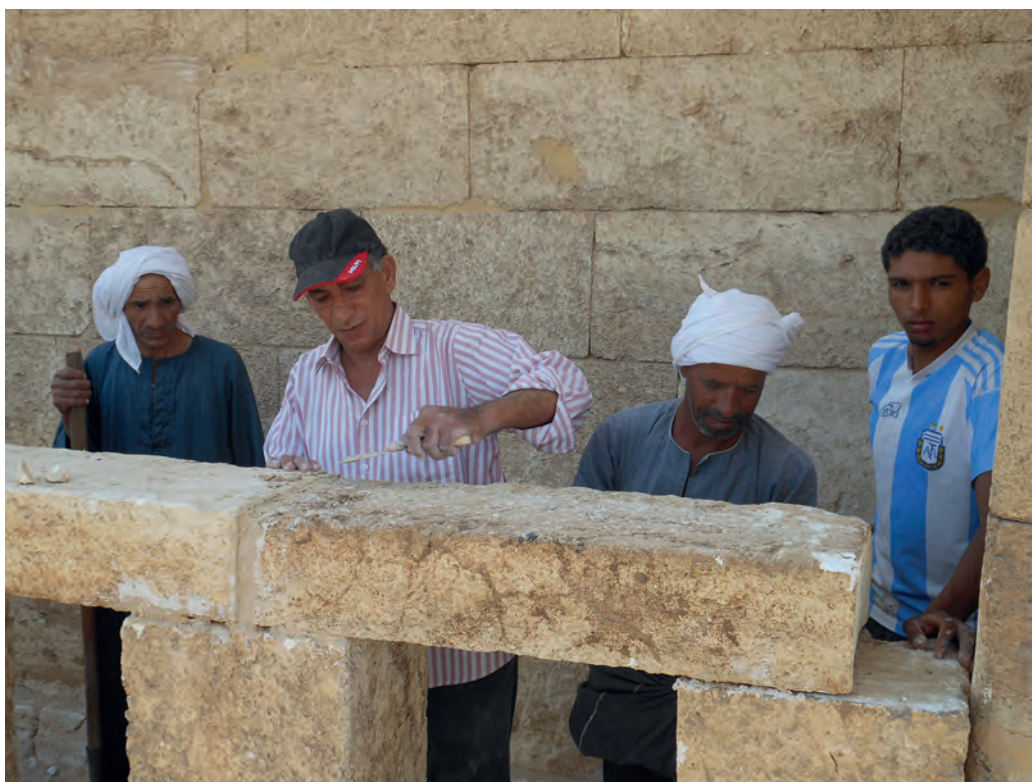
Fig. 14: Re-erection of balustrade with the help of lime mortar; 2015

In 2015, another restoration of the balustrade was accomplished using the following techniques:
