7 Site Management: Cleaning and Reconstruction of the Balustrade around the Naos of Petosiris (GB 50) – Some Observations

7.1 *The balustrade*

7.3 *The restoration of the balustrade*

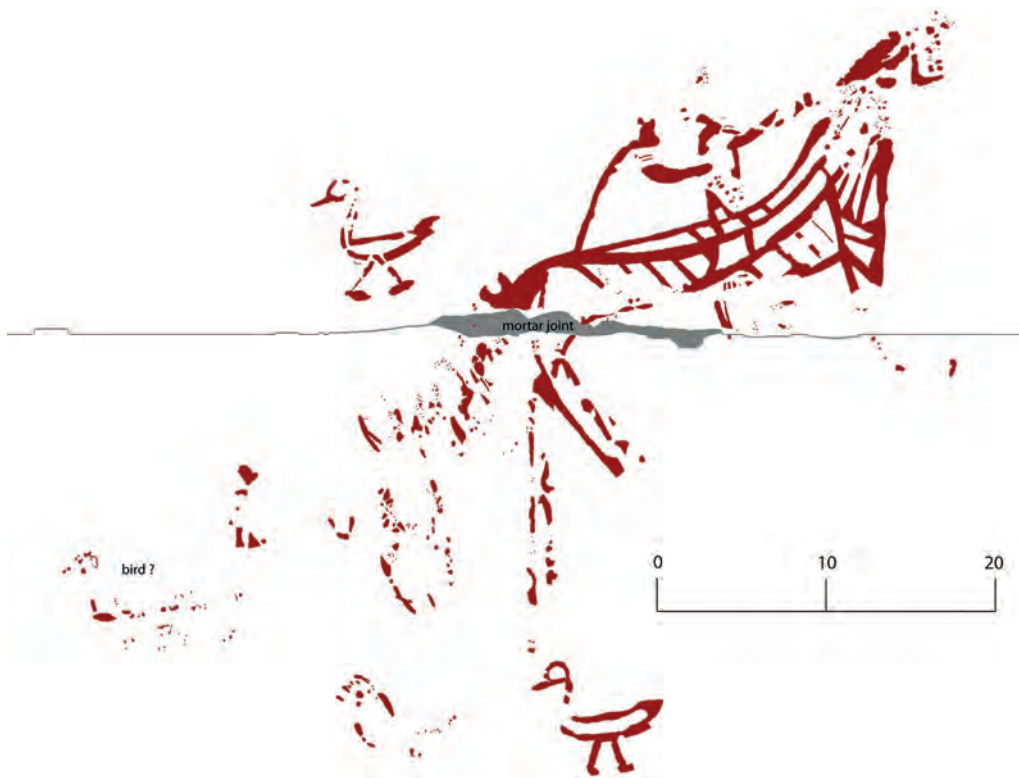
At the bottom part of the eastern wall near the corner of the hall, graffiti in red ink of a horseman (?) facing to the right and of at least two small birds facing to the left were found (fig. 10), which had not been documented by

Fig. 10: Graffito depicting a horseman (?) and some birds; 2015

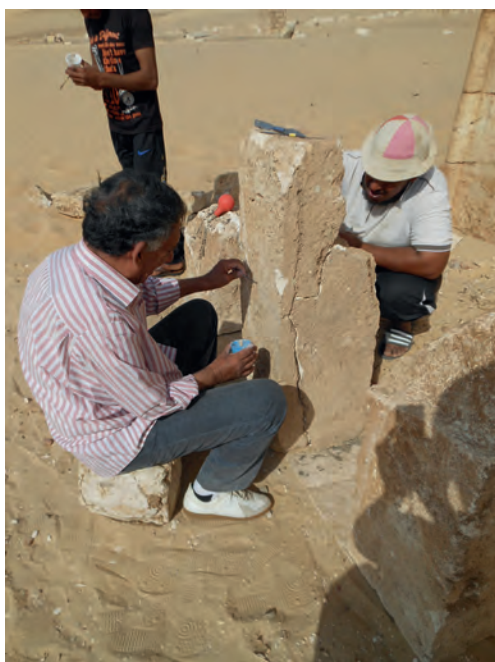
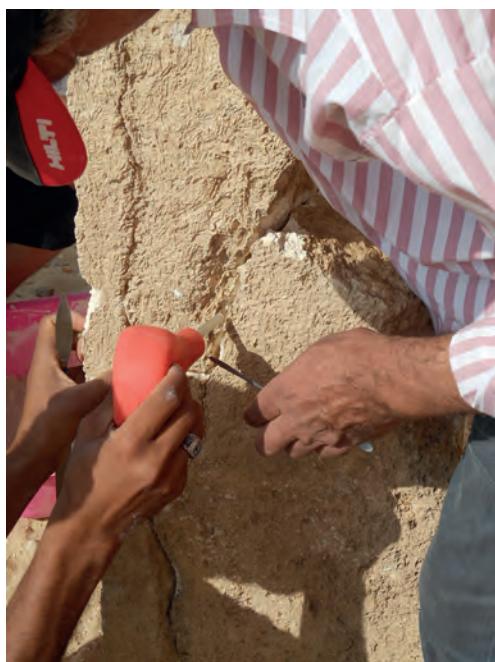
Fig. 12: Cleaning the surfaces of the stones;
2015

Fig. 13: Closing gaps with the help of lime mortar;
2015

- Cleaning the stone surfaces by spraying limewater onto the stones until they are saturated.
- Consolidating the natural stone with approved materials. Chipped and broken areas of the stones are repaired by patching the void with mortar (fig. 12–13) that consists of lime and sand (relation 1 : 2) with some drops of Primal (emulsion of paraloid). Ground particles of the same or similar stone are added to ensure a close colour match (fig. 14). This method is suitable when no stone for replacement is available or the void is less than 25 mm deep.
- Resurfacing the exfoliated surfaces.
