## A NOW-LOST FOURTEENTH-CENTURY AISLED BASE-CRUCK BUILDING AT KETSBY HOUSE FARM, LINCOLNSHIRE, AND ITS CONTEXT

MARK GARDINER and JENNE PAPE

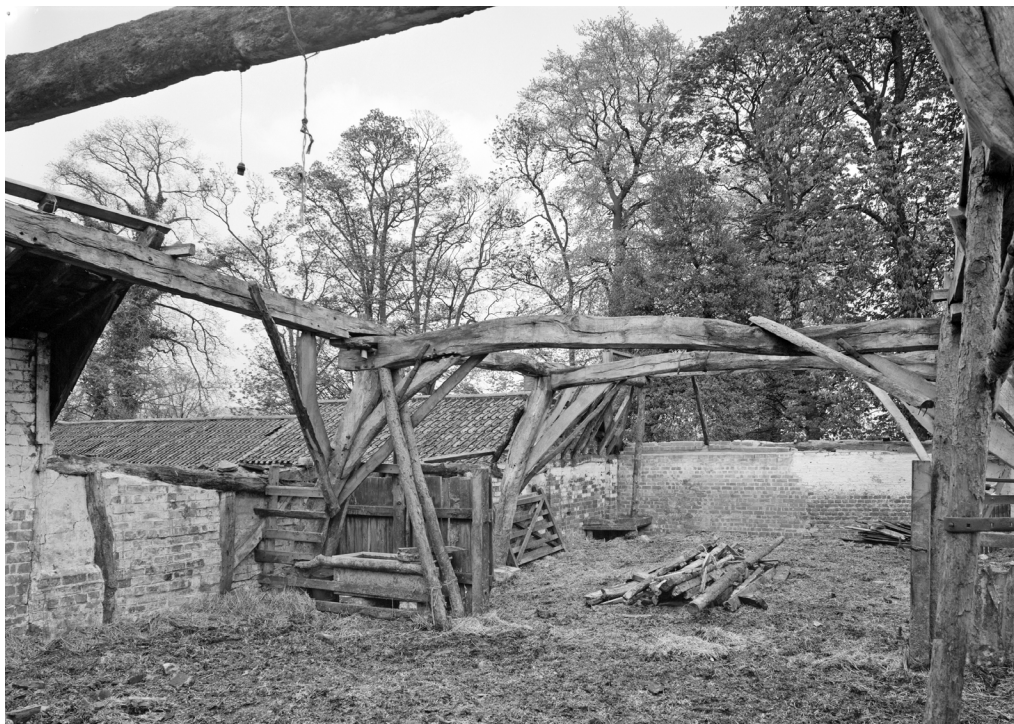
Figure 8.1. Building at Ketsby, Lincolnshire, UK. A view looking eastwards to the north side. Photographer unknown, 1966. Historic England Archive. Reproduced with permission.

The timber used was waney almost throughout. The timbers were not straight-grown and came from hedgerow trees (Figure 8.1). The presence of bark on timbers indicates how small the trees used were; the carpenters were very economical with their use of timber, preferring to leave sapwood and occasionally bark on the trees, rather than reduce the scantling further by removing it. Inevitably this meant that much of the timber was heavily eroded by the time the building was demolished. Some of the braces and ties were no more than small branches. In most parts of the country, timber of this type would have been considered of very inadequate quality. The timbers were converted in two ways. Flat pieces, such as the arcade braces and some of the larger timbers, were sawn. Other members were hewn with an adze or axe. Some timbers show evidence of both methods of conversion. The smallest surviving timbers, including the aisle ties and the aisle rafters, were used in the round and not squared up at all. It appears that the carpenters had a diameter in mind for each piece, and they squared off anything which was greater than this diameter, thus producing timbers which were squared heartwood at one end but complete trunks at the other. It is therefore possible to identify which “way up” many of the timbers are. The cruck timbers at Ketsby were used with the root end uppermost, although Meeson has suggested that was not common practice in England.<sup>22</sup> The arcade posts were also used with the butt end up. Squared wood was favoured around the scarf joints for the arcade-plate because of their critical nature. The tiebeam at Truss 1 appears to have been a little more than half a tree; the eastern face is carefully squared and prepared, while the western face at the southern end appears to have the round profile of the trunk.
