# **WALL PAINTINGS IN THE CHÂTEAU DE GERMOLLES: AN INTERDISCIPLINARY PROJECT FOR THE REDISCOVERY OF A UNIQUE FOURTEENTH-CENTURY DECORATION**

CHRISTIAN DEGRIGNY and FRANCESCA PIQUÉ

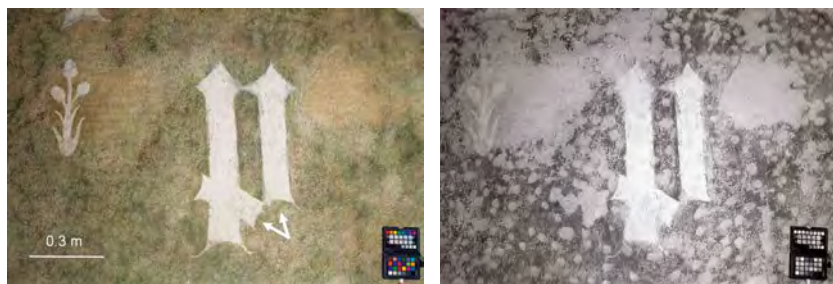
**Figure 4.4.** VIS and IR (approx. 830–1000 nm) photographic images of the letter P highlighted in figure 4.3. Arabesques in the lower part of the letter P are indicated in the VIS image. They seem to disappear in the IR image. Photos: Francesca Piqué, 2016.

high IR reflection, while the authentic copper-based green which remained in the original portions of the plaster, had low IR reflection (high absorption) (fig. 4.4).

Furthermore, the embellishments (such as the arabesques) at the lower extremities of the P, in figure 4.4, are less visible in the IR image. Hyperspectral imaging was used to investigate these embellishments further. The CCD camera (HS-XX-V10E), developed by SPECIM, has a  $1600 \times 840$  pixel resolution, a spectral resolution of 2.8 nm and a wavelength range between 400 to 1000 nm. The wall paintings were illuminated by two halogen lamps oriented at  $45^\circ$ . The data processed with ENVI 5.2 + IDL software produced an RGB image ( $R = 650$  nm;  $G = 540$  nm;  $B = 450$  nm) and grayscale images at wavelengths ranging from 500 to 1000 nm. These pictures were used to indicate specific features such as the original profile of the P letters (a dotted white line in the image at 1000 nm, in fig. 4.5) and their embellishment by the medieval artists (dotted red line on RGB image, in fig. 4.5). The arabesques were added over the original green background and each letter P was embellished differently.

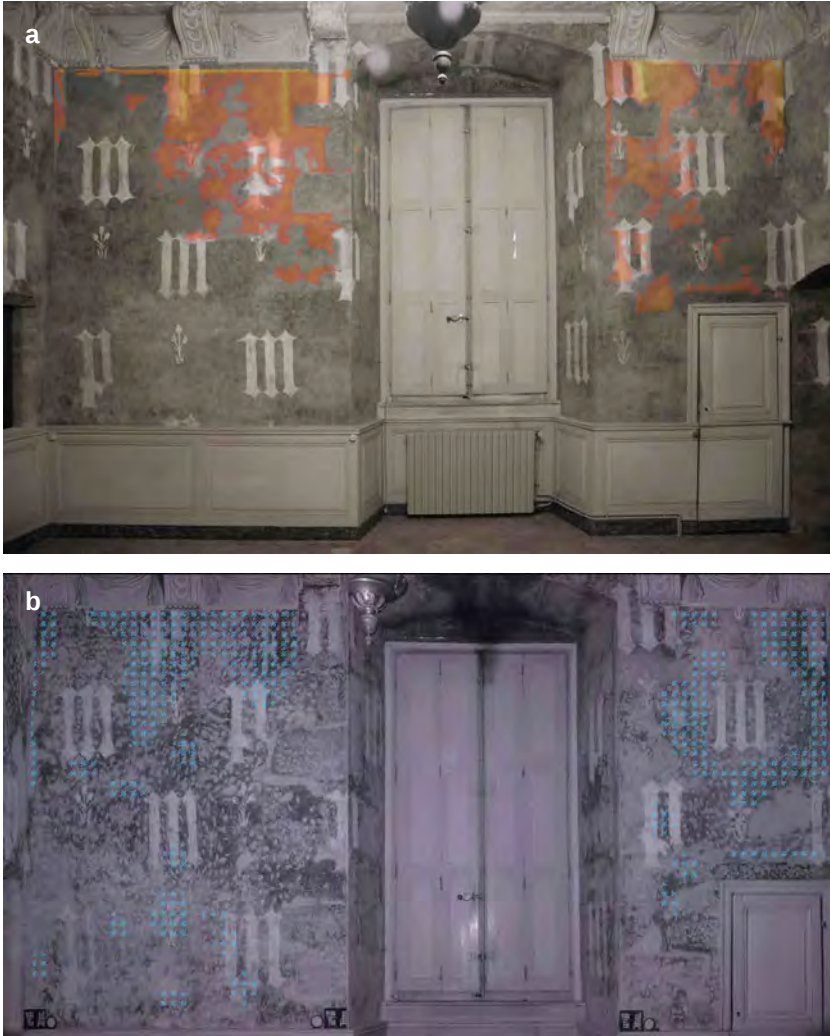
**Figure 4.13. (a) Graphical representation through IRT of areas of detachment in the north wall of room dn; (b) representation (overlaid onto an IR image) of similar areas, in blue, as recorded by tactile assessment (knocking method). Photos: (a) Cristina Tedeschi and Marco Cucchi; (b) Nutsa Papiashvili, 2015.**

the detached zones heat up faster and could be distinguished with respect to the sound zone. A digital threshold filter was used to retain only pixels which are above a certain temperature and to remove all the others. Figure 4.13a shows the results achieved in room dn, on the north wall. When compared to the graphical representation of the tactile assessment (knocking tests), both results were very

similar (fig. 4.13b). The same results were achieved on the other walls, indicating that detachment problems occur on all four walls of the room (Tedeschi 2016).

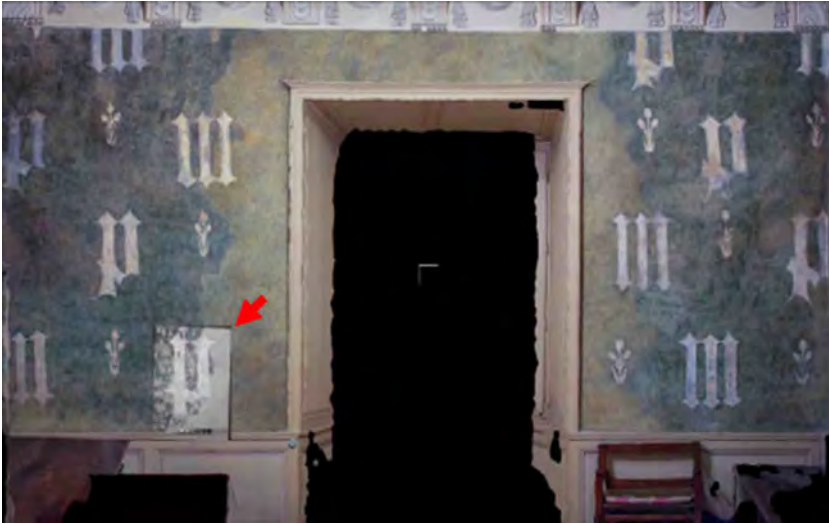
**Figure 4.15.** Snapshot from the SIVT application tested on Germolles case study data. The rectified and registered IR image of the P (red arrow) is displayed on top of the orthophotography of room dn south wall.  
**Photos:** Stefanie Wefers and Tobias Reich, 2016 and Francesca Piqué, 2013.

Another promising application, Spatial Image analysis and Viewing Tool (SIVT) (Wefers 2016) was tested to provide a combined visualization and analysis of images of the details of the Germolles wall paintings. Different 3D data sets, including orthophotograph of room dn south wall, were registered and integrated into SIVT as basemaps. Images of the details of the wall painting (such as an IR image of the same P as in fig. 4.14) were semi-automatically registered, allowing a combined visualization of the orthophotograph and detailed images (fig. 4.15). This alignment process may potentially enable locating pictures of the wall details, taken during a conservation campaign for documentation, condition monitoring, or conservation intervention.
