## 8. Contingencies in rooftop extensions on multifamily buildings from the 1950s and 1960s in Hamburg

*Kathrin Meyer*

### **Context and ecological relevance of rooftop extensions in post-war housing stock**

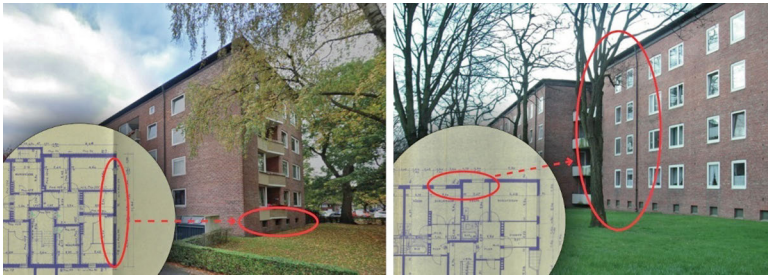
One example is a multifamily building on Diedenhofer Straße. According to the available floor plans, the building was designed with a setback at the rear. However, this setback does not exist in the actual structure. Additionally, several window openings were identified on-site that are not reflected in the planning documents, including basement windows and an additional row of windows on the north side of the building. This was verified by comparing recent photographs, Google Street View images, digital orthophotos from Hamburg's State Office for Geoinformation and Surveying (Landesbetrieb Geoinformation und Vermessung), and an on-site visit (Figure 2). In this case, the simpler building geometry (without a setback) in the existing structure is advantageous for planning a rooftop extension and retrofitting. Discrepancies are particularly relevant for rooftop extension projects when they involve structural elements. However, such discrepancies should become evident early in the planning process through detailed on-site analysis and be taken into account accordingly.

*Figure 2: Example of Diedenhofer Straße; discrepancies between planning documents and actual building.*

A second contingency is based on *discrepancies in building documentation*. Research found that building plans in Hamburg often do not align with the actual constructed buildings. This applied not only to the original construction phase but also to subsequent modifications and renovations that are not recorded in the building documentation. Differences between original construction drawings and the final buildings frequently include design simplifications, material

reductions, or on-site improvisations. Commonly identified discrepancies involve variations in dimensions and façade configurations. In some cases, balconies and loggias were constructed differently than originally planned, and windows were positioned or sized differently.
