Mahdi Hayatrouhi

# Strengthening of reinforced concrete beam-column joints to increase seismic resistance

des Instituts für Massivbau der Leibniz Universität Hannover  
Herausgeber:  
Univ.-Prof. Dr.-Ing. Steffen Marx  
Leibniz Universität Hannover – Institut für Massivbau  
Heft 9, Februar 2014

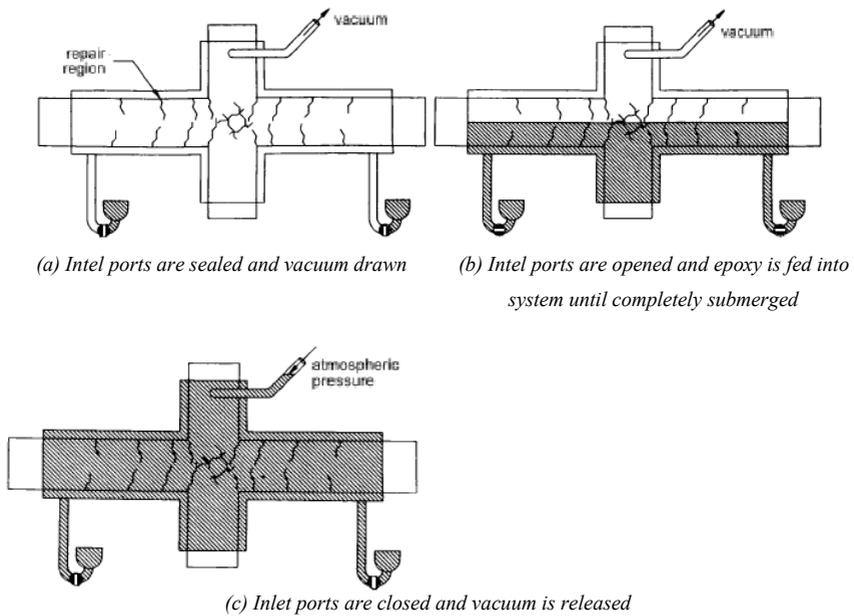
Fig. 2.1: Vacuum impregnation procedure [French et al.-90]

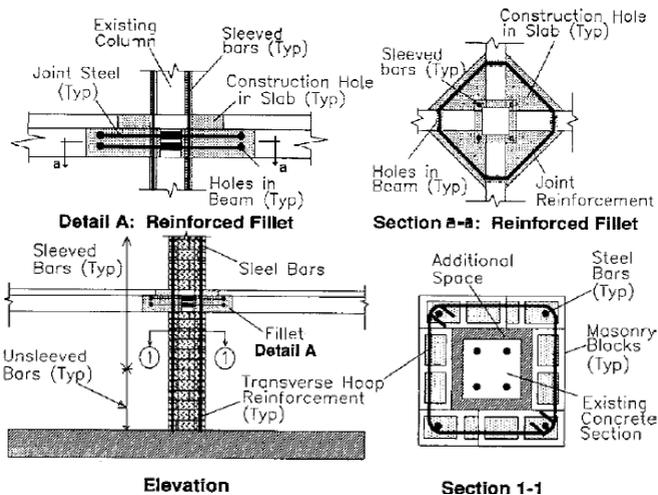
Fig. 2.2: Masonry block jacketing technique [Bracci et al.-95-2]

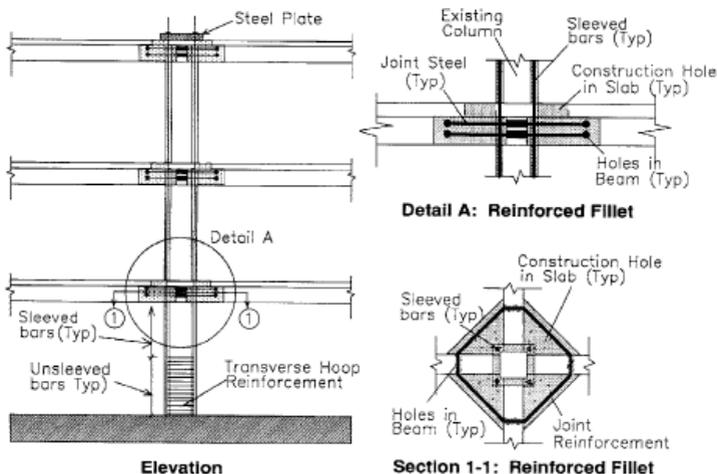
Fig. 2.4: Prestressed concrete jacketing technique [Bracci et al.-95-2]

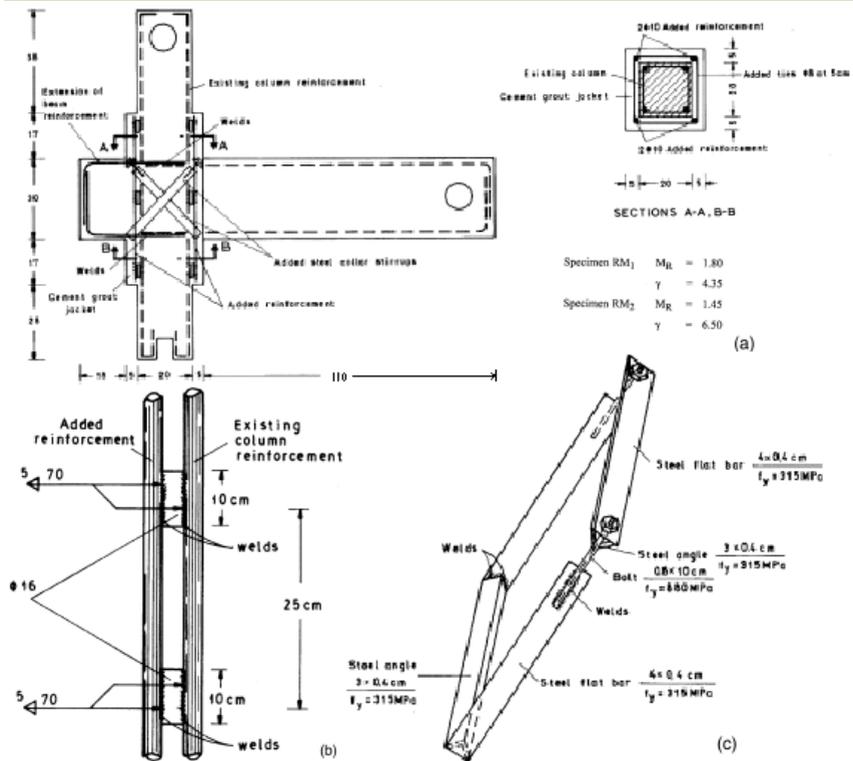
Fig. 2.5: a) Concrete jacketing using UNIDO strengthening technique; b) welding of new reinforcement to existing column reinforcement; c) details of steel collar stirrup. [Tsonos-99]

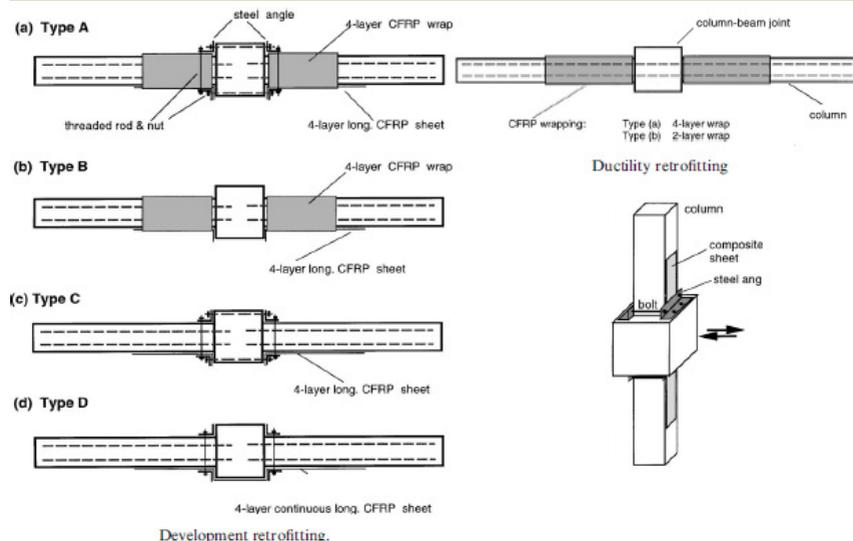
Fig. 2.8: CFRP ductility and development retrofitting of beam-column joint [Gen et al. -98]

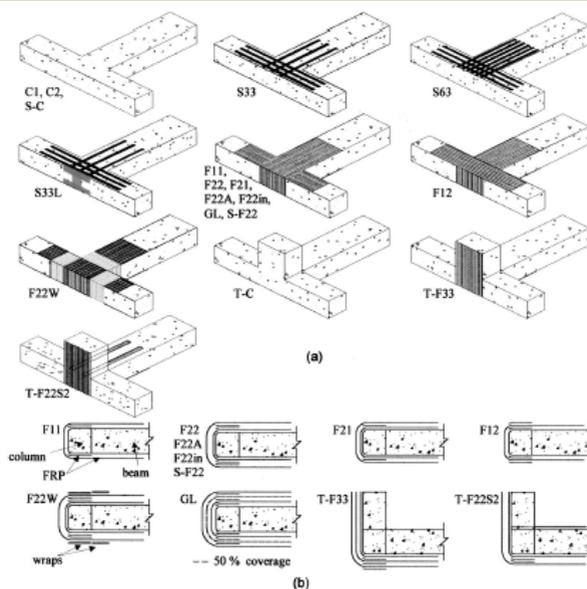
Fig. 2.9: a) Description of specimens and strengthening alternatives; b) layout of FRP layers [Antonopoulos -03]

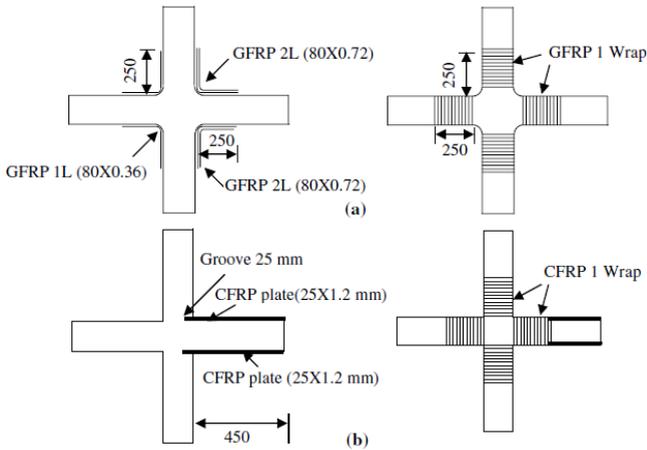
Fig. 2.10: a) CFRP or GFRP strengthening; b) Strengthening of repaired specimens [Mukherjee-05]

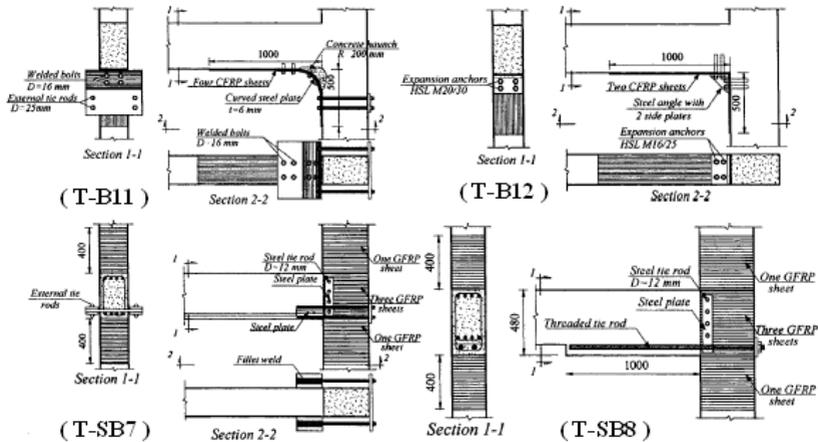
Fig. 2.11: Rehabilitation schemes [Ghobarah-05]

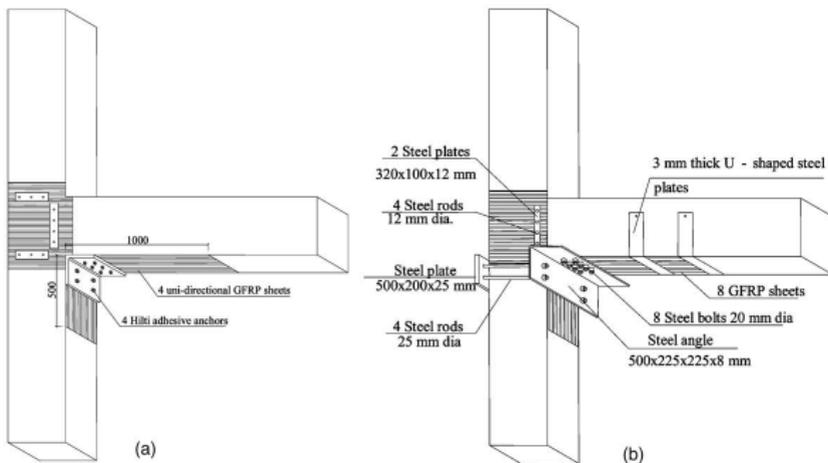
Fig. 2.15: Typical rehabilitation schemes: a) TR1; b) TR2 [El-Amoury-02]

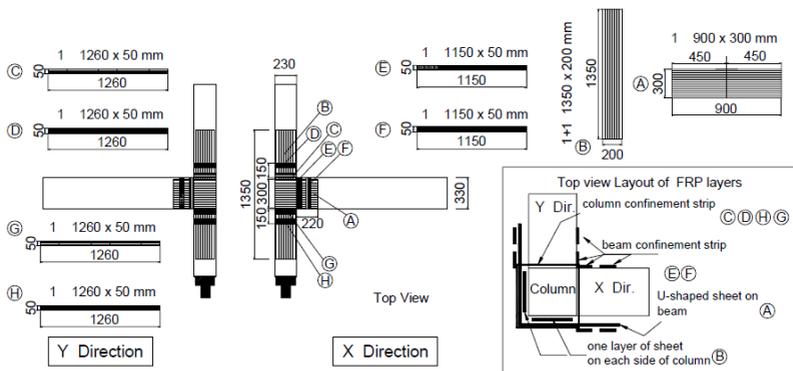
Fig. 2.17: GFRP retrofit configuration for the 3D corner joint specimen [Pampanin et al.-07]

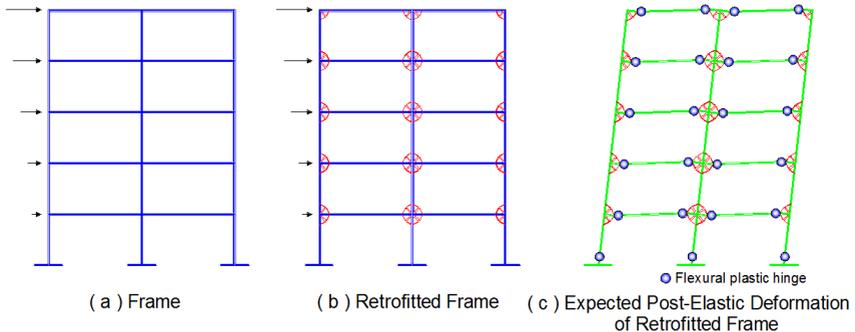
Fig. 3.3: Retrofitting of the vulnerable existing frames by developing the beam plastic hinges

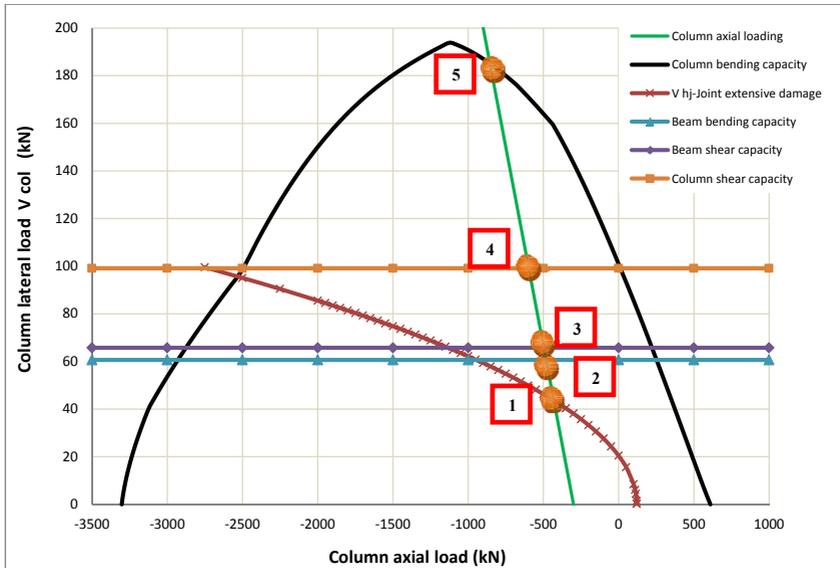
Fig. 3.7: Proposed Strength and Failure Sequence Diagram (SFSD) in a beam-column joint in  $V_{col}$ -N performance domain

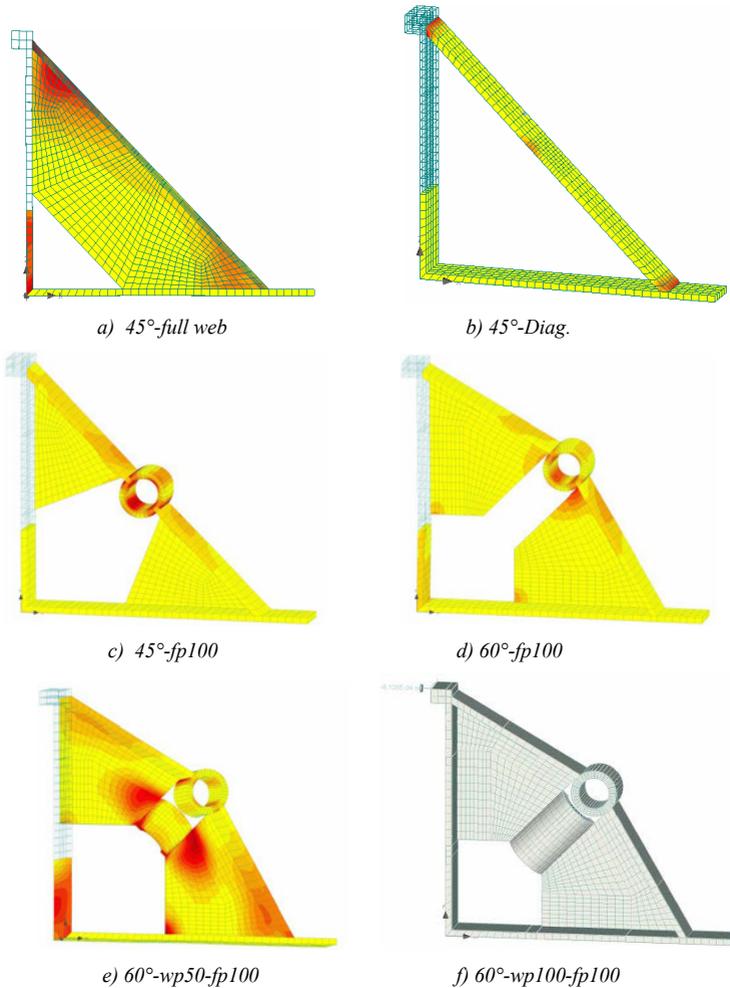
has not a ductile form. As can be seen, 45°-Diag. model lose suddenly the bearing capacity under compression after the initial cycles but the other specimens can preserve their hysteretic behavior to the end. The maximum lateral resistance belongs to 60°-wp100-fp100 and the minimum is related to 45°-full-web and 45°-Diag.

Fig. 3.9: Different forms of Multi Functional Corbel (HMFC) and their FEM mesh patterns

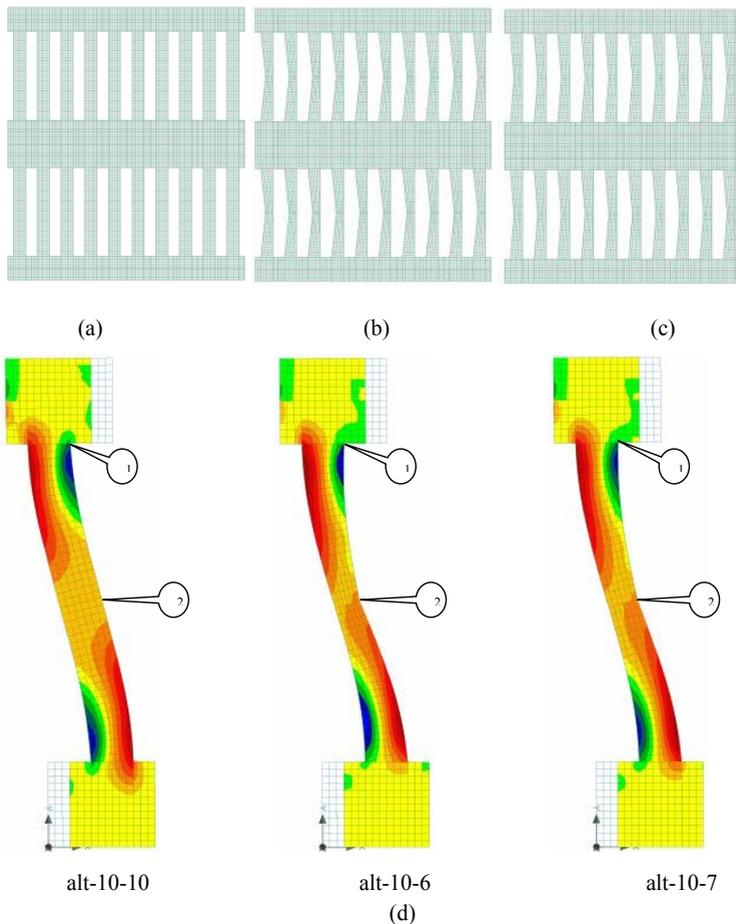
longitudinal direction of the arms. The type alt-10-10 has a uniform width of 10 mm in overall length of the arm but the others, alt-10-6 and alt-10-7, have 6 and 7 mm widths in the middle of the arms, respectively. The variations of hysteretic diagram are shown in Fig. 3.17. and displacement-strain diagrams for points 1 at the end of the arms and points 2 at the middle of the arms are displayed in Fig. 3.18. As can be seen, the type alt-10-10 has the maximum strength and energy dissipation capacity but the type alt-10-6 has the closest strains at the points of 1 and 2 for -15 mm imposed displacement among the others. Therefore, it can be resulted that in alt-10-6 the strains are uniformly distributed and different parts of the arm simultaneously yield.

Fig. 3.16: Three different alternatives of innovative Harmonica Damper Plate

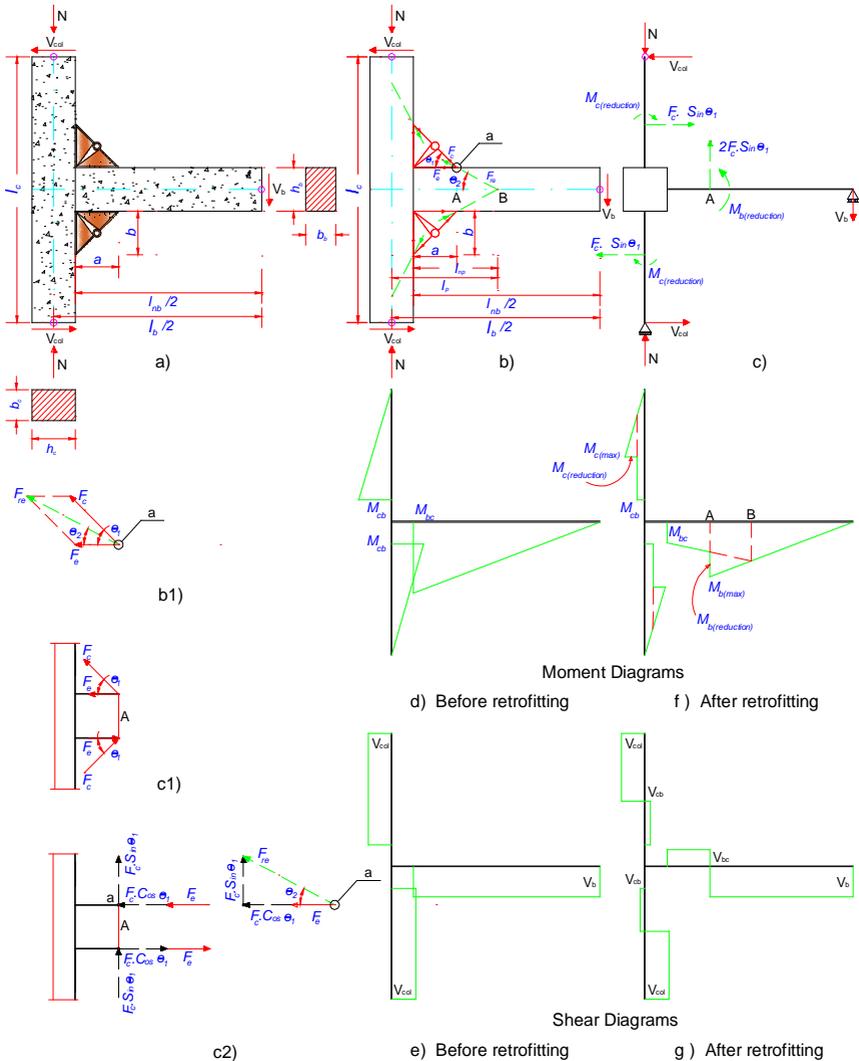
Fig. 3.21: Internal forces in strengthened exterior beam-column joint with Multi Functional Corbel, Retrofitting Technique 1 (RT1)

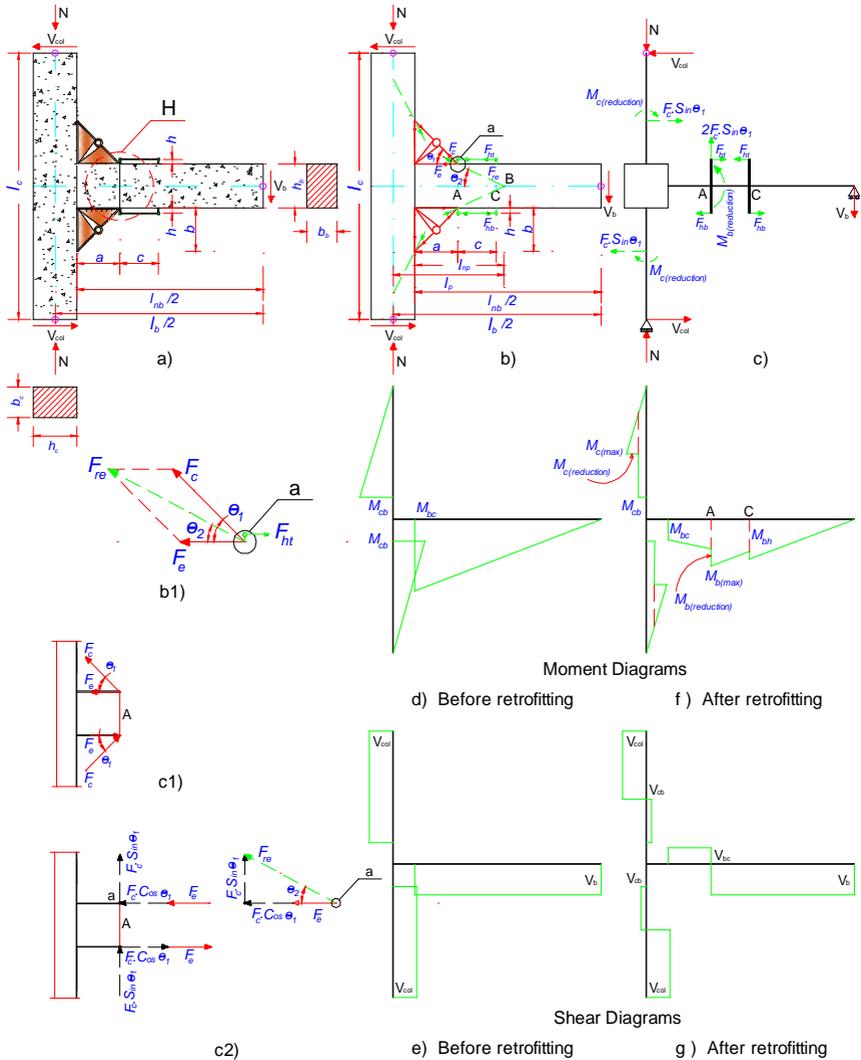
When the strengthening complex of Multi Functional Corbels (with the length of  $a$ , height of  $b$ , and toe angle of  $\theta_1$ ) and Harmonica Damper Plates (with the overall length of  $c$  and additional height of  $h$ ) are installed above and below the joint region, Fig. 3.23-a and b, the moments of beam and column at the joint zone interfaces can be dramatically reduced, Fig. 3.23-f while the Harmonica Damper Plates contribute to the beam bending moment between points A and C and enhance the overall moment capacity in this segment. The overall increased bending moment capacity at the end of corbels leads to enhancement of story shear and energy dissipation through the beam hinge and elasto-plastic behaviour of Harmonica Damper Plates. Moreover, the maximum moments in the beam and column are transferred away from the critical joint interfaces, Fig. 3.23-d and f. Consequently, if the system is designed adequately, the beam-joint moment,  $M_{bc}$ , is reduced and subsequently the brittle failure of the joint is eliminated, furthermore, the maximum moment of the beam and column is migrated inside the members away from the critical points and the ductile flexural hinge is developed at the end of the corbels.

Fig. 3.23: Internal forces in strengthened exterior beam-column joint with Multi Functional Corbel (HMFC) and Harmonica Damper Plates (HHDP), Retrofitting Technique 2 (RT2)

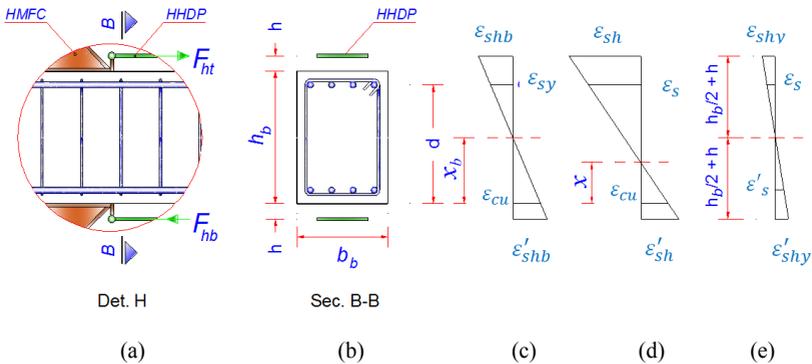
On the other hand, in the conditions that the strain in HHDP reaches the yield strain  $\varepsilon_{shy}$  and  $\varepsilon'_{shy}$ , Fig. 3.24-e, the strains of reinforcement and concrete are much smaller than the yield and ultimate strain, respectively. Consequently, although the RC section is in elasto-plastic domain, the plastic behaviour is exhibited by HHDP and therefore the energy dissipation is started through hysteretic performance while the main RC section shows elasto-plastic behaviour. This is a unique performance of HHDP to dissipation of imposed energy through bending moments smaller than the plastic capacity of the main section.

Fig. 3.24: Detail of H as referred to in Fig. 3.23 and assumed strain distribution in the strengthened beam section at the end of HMFC

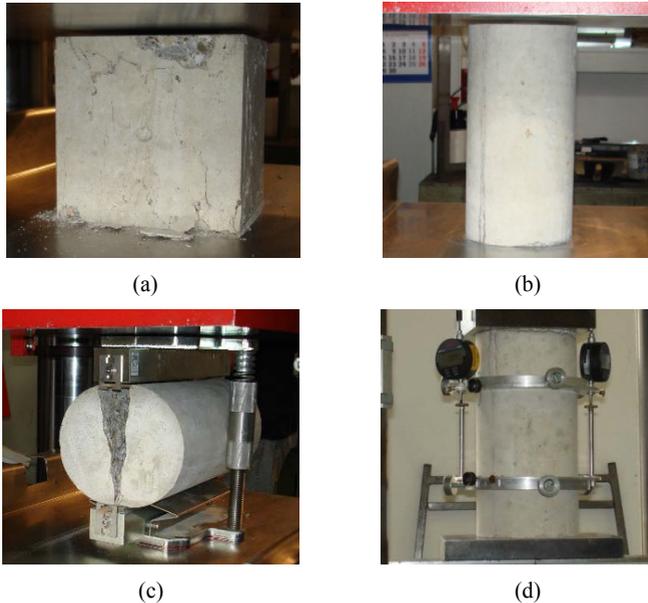
Fig 4.1: Test of concrete samples, tests of a) cubic compression, b) cylinder compression c) split, and d) modulus of elasticity

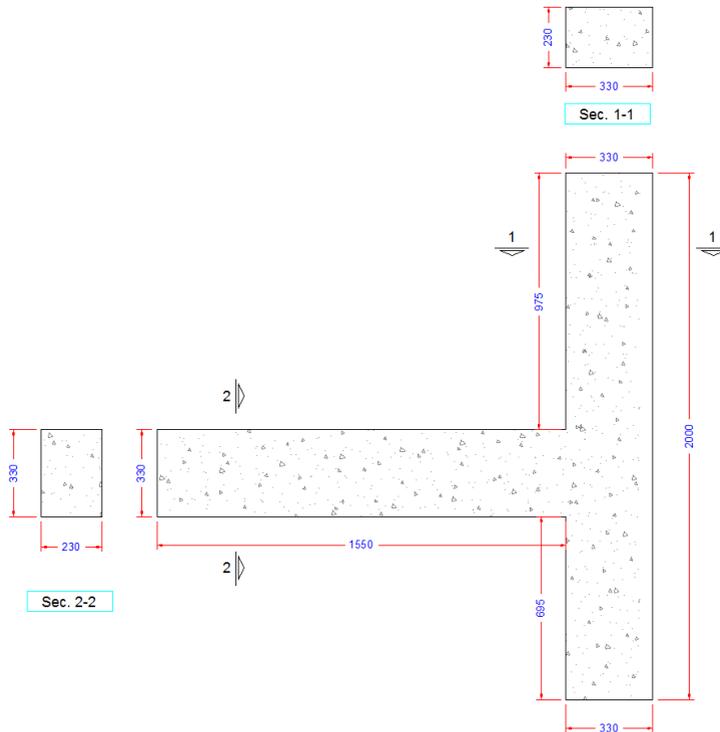
Fig. 4.2: The overall geometry of specimens

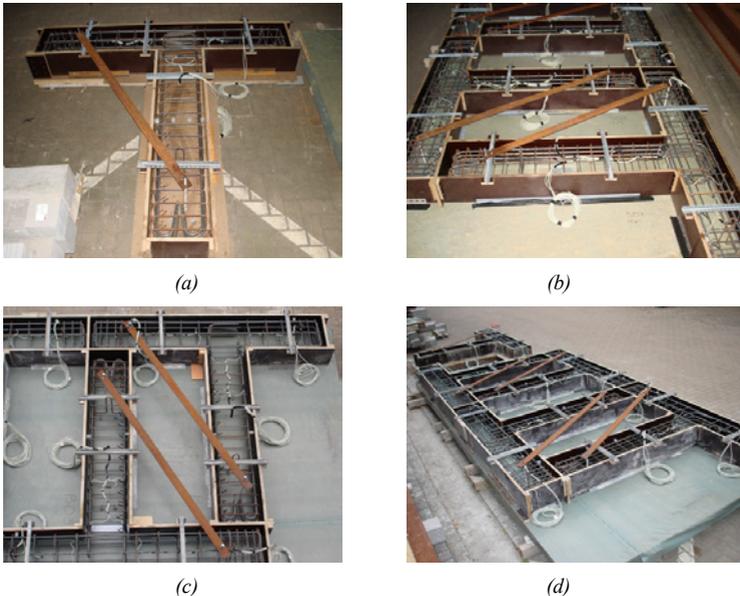
Fig. 4.9: Wiring the strain gauges and temporary bracing the test specimens

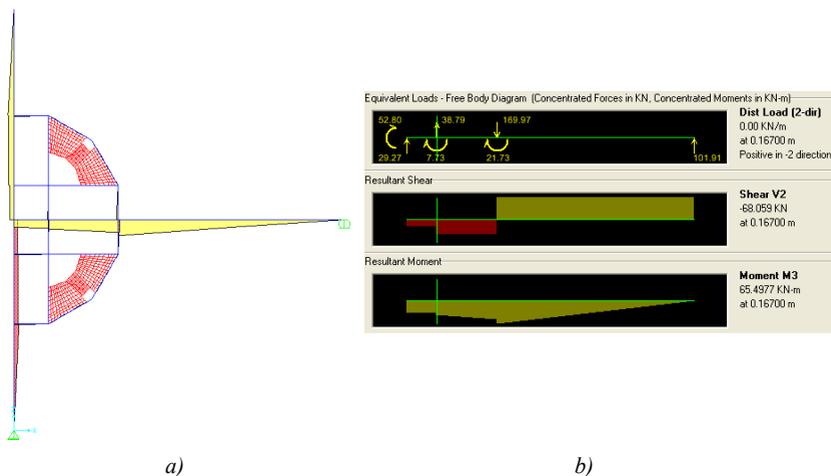
Fig. 4.25: Analysis of simplified structural retrofitted model BD-H1 under  $V_{col} = 79.78 \text{ kN}$ ,  
 a) Moment diagram of structural model; b) The results of beam analysis

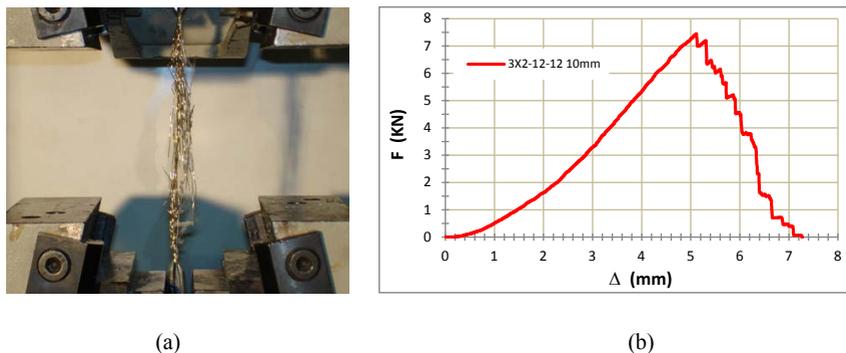
Fig. 4.26: Tension test of 3X2-12-12 Hardwire composite for 10 mm width

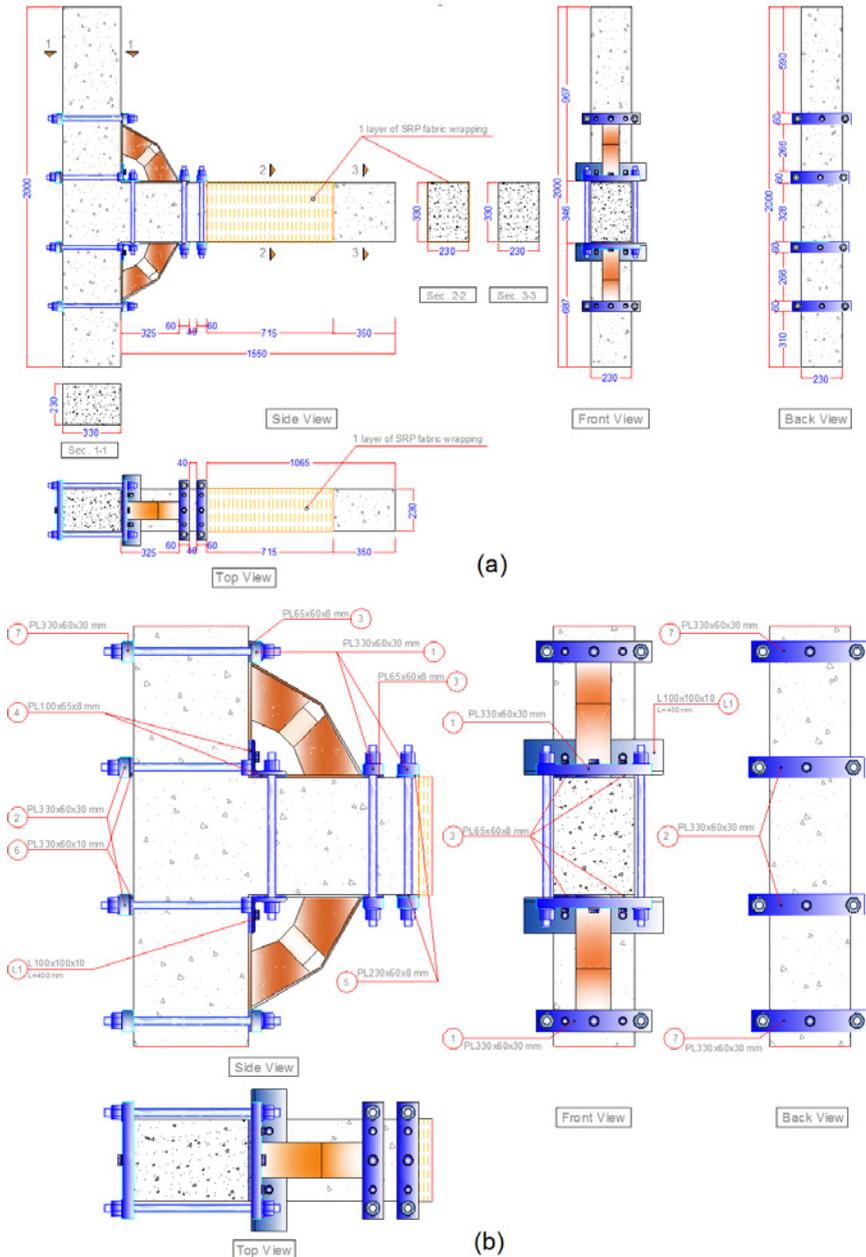
Fig. 4.28: Retrofitting of the Bond Deficient specimen (BD) by Multi Functional Corbel (HMFC) HI through RTI, (BD-HI)

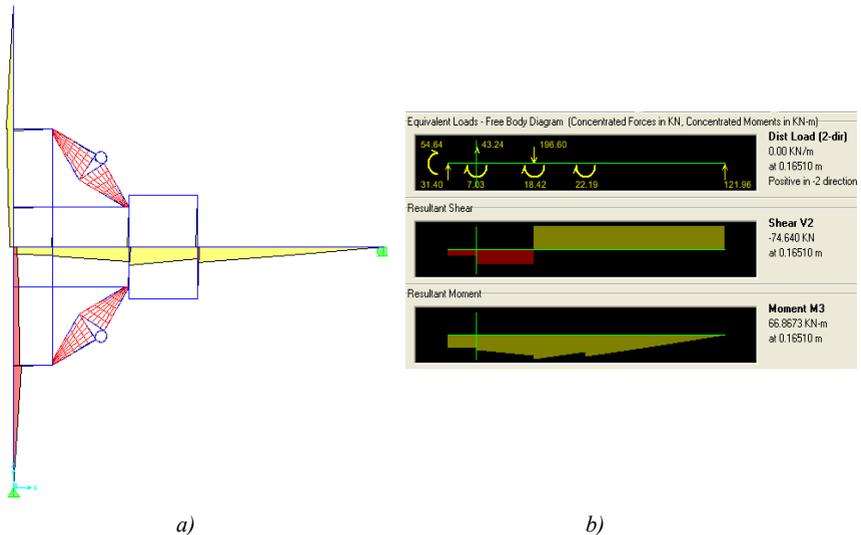
Fig. 4.34: Analysis of simplified structural retrofitted model SD-H2-D under  $V_{col} = 95.74 \text{ kN}$ ,  
a) Moment diagram of structural model; b) The results of beam analysis

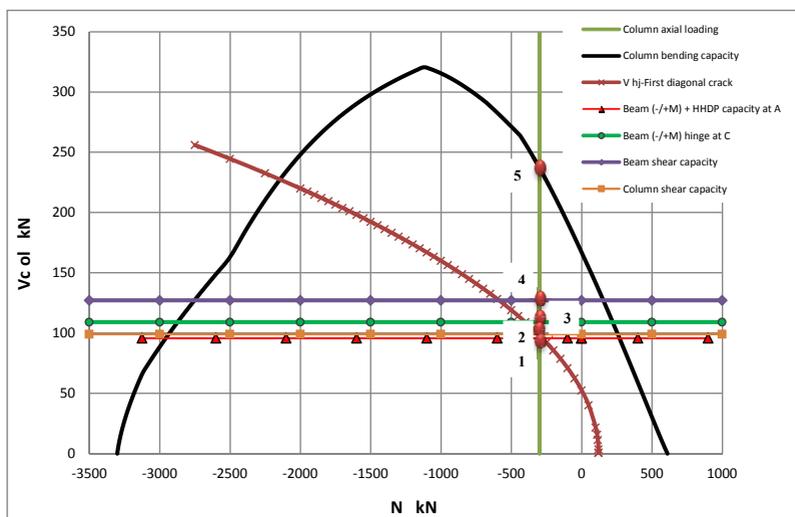
Fig. 4.35: Expected Strength and Failure Sequence Diagram (SFSD) for retrofitted specimen, SD-H2-D

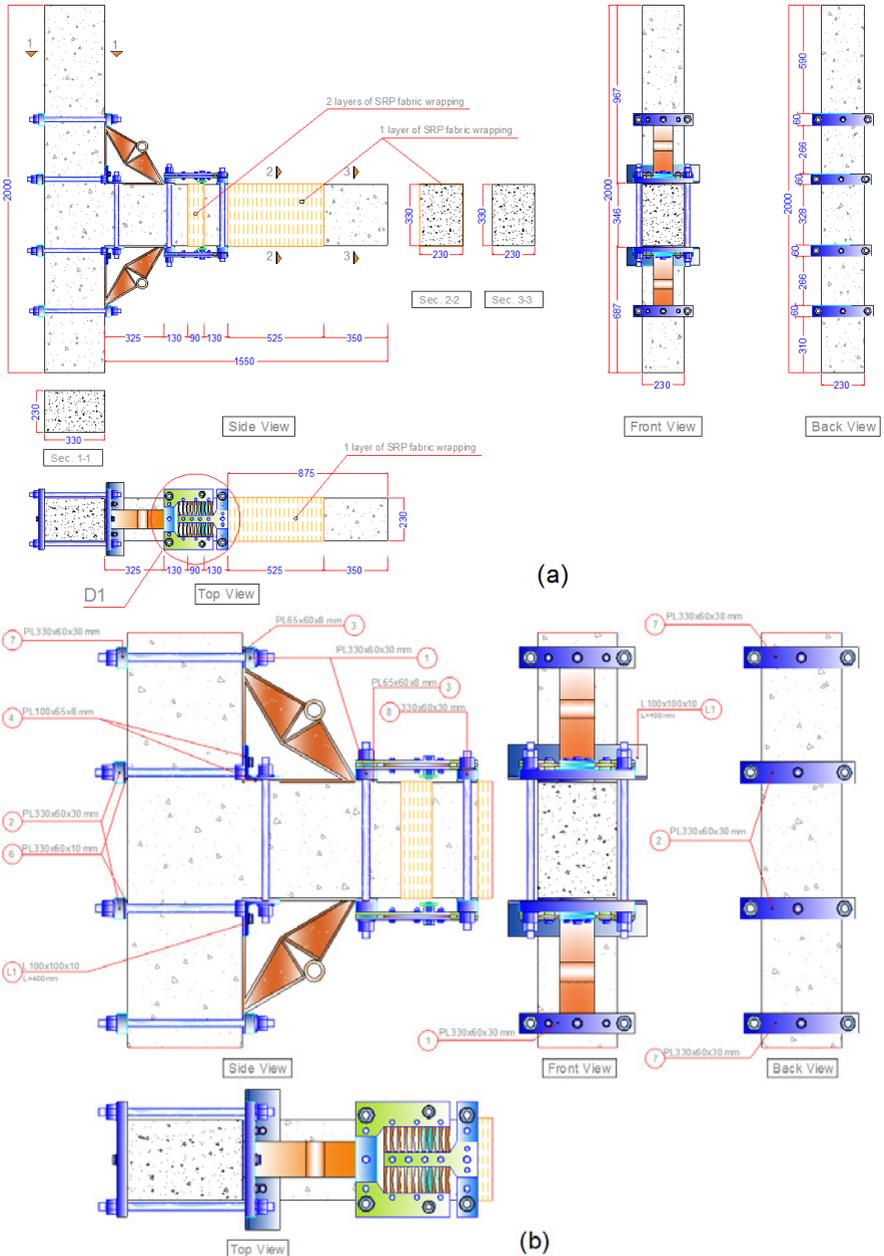
Fig. 4.36: Retrofitting of the Shear Deficient specimen (SD) by Multi Functional Corbels (HMFC) H2 and Harmonica Damper Plates (HHDP) D through RT2, (SD-H2-D)

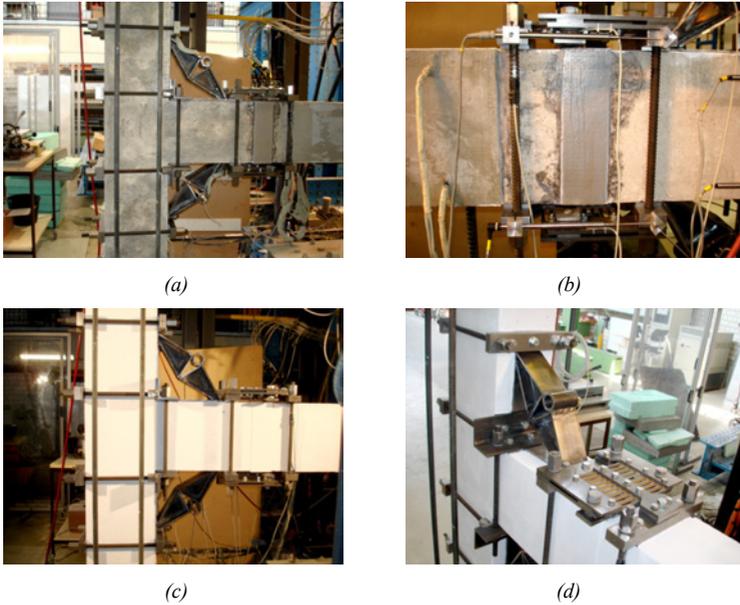
Fig. 4.37: Retrofitted specimen SD-H2-D

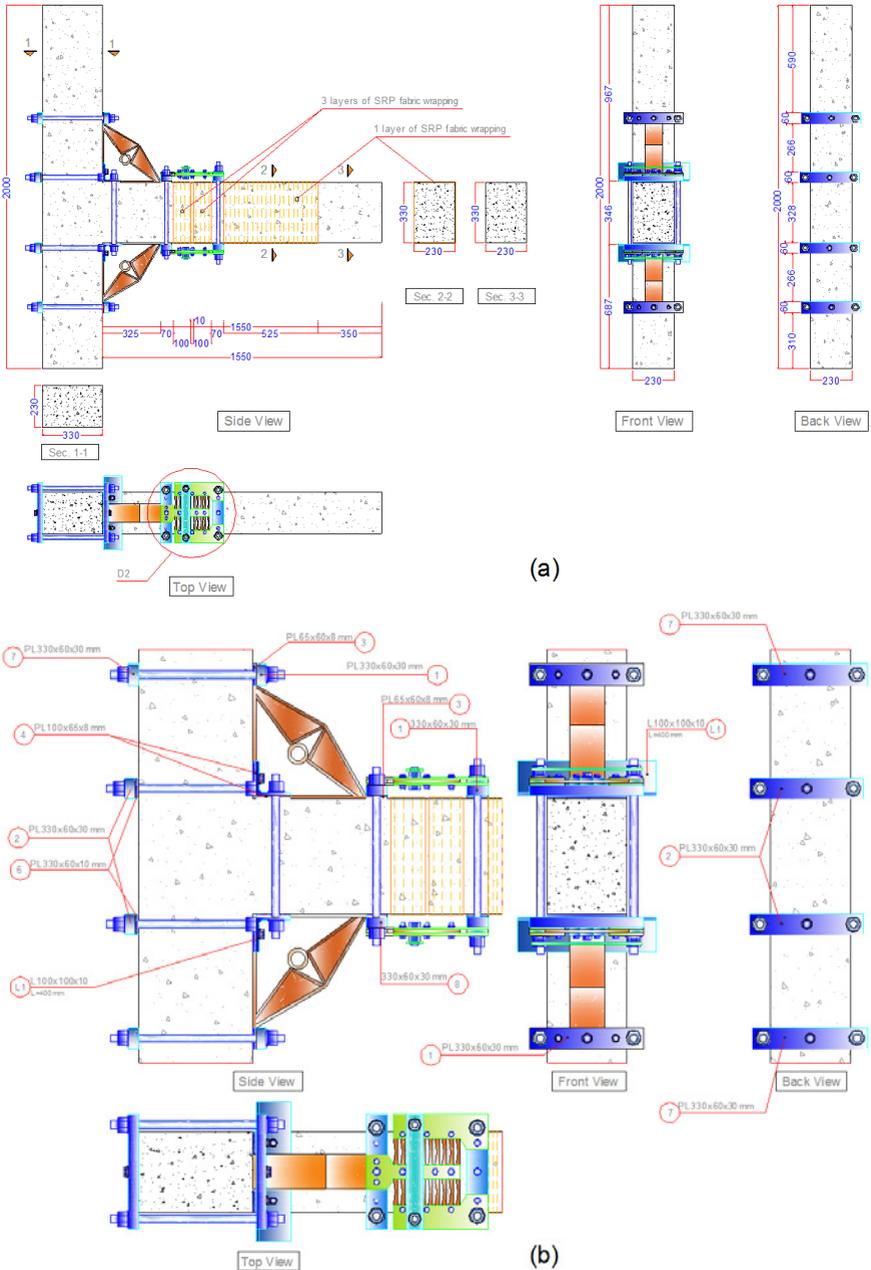
Fig. 4.39: Retrofitting of the Bond Deficient specimen (BD) by Multi Functional Corbels (HMFC) H3 and Harmonica Damper Plates (HHDP) D' through RT2, (BD-H3-D)

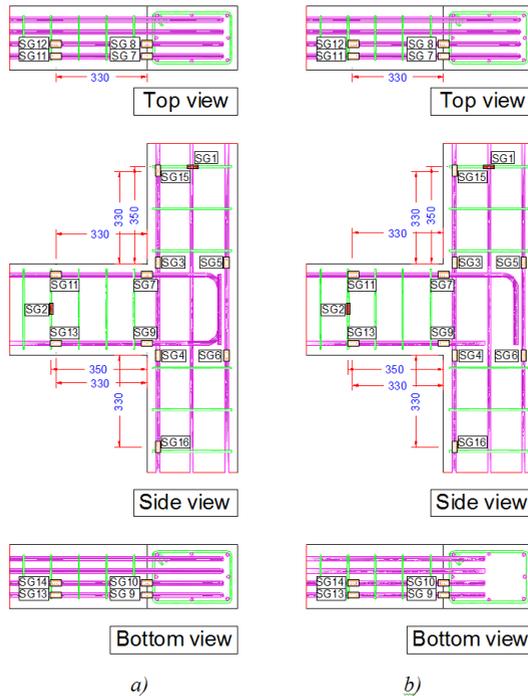
- Monitoring the reinforcing bars of retrofitted specimens: Sixteen strain gauges were used in every retrofitted specimen of BD-H1, SD-H2-D, and BD-H3-D, (Fig. 4.49).

Fig. 4.49: Location of strain gauges of reinforcing bars for the retrofitted specimens: a) for SD-H2-D, b) for BD-H1 and BD-H3-D

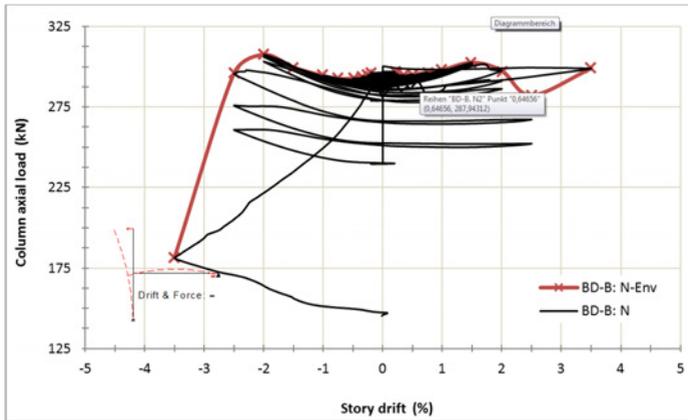
Fig. 4.56: Imposed column axial load versus drift of specimen BD-B

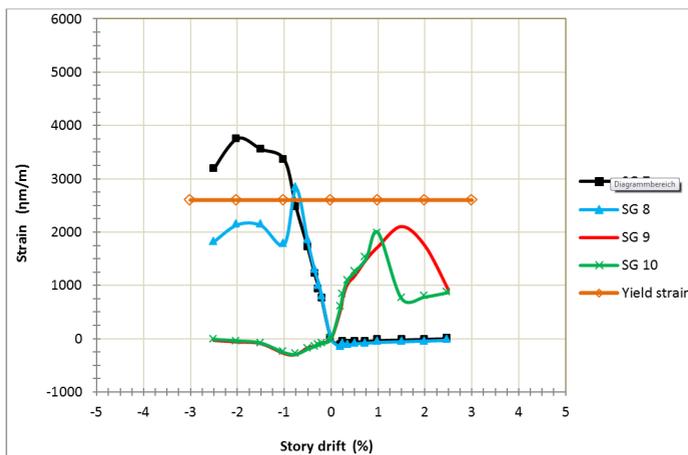
Fig. 4.57: The envelope diagram for Max. strain of beam longitudinal bars at the beam-column interface versus story drift of specimen BD-B

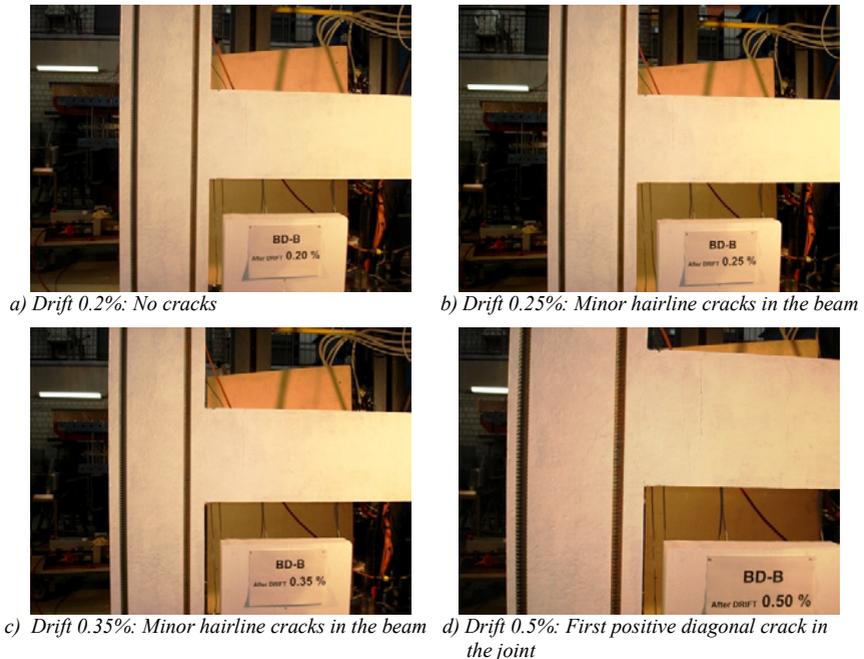
Fig. 4.58: (continued)

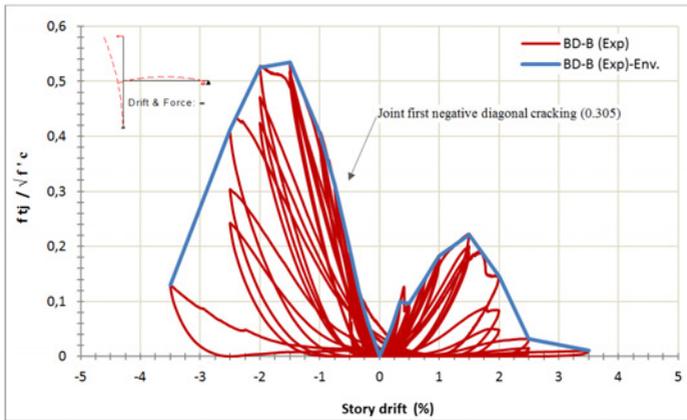
Fig. 4.59: The relationship between joint principal tensile stress ( $f_{tj}/\sqrt{f'_c}$ ) and story drift of specimen BD-B

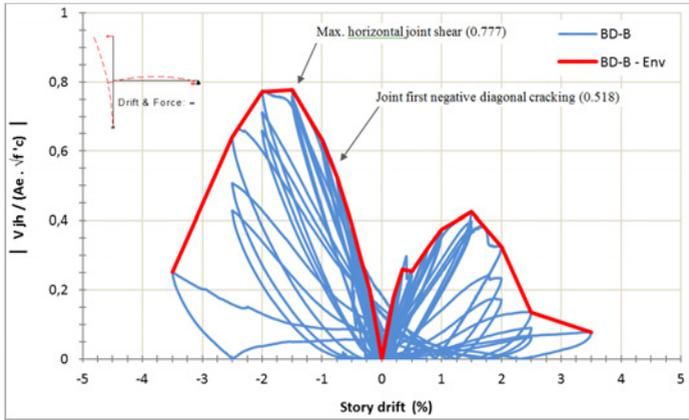
Fig. 4.60: The relationship between absolute value of (joint horizontal shear stress)  $|V_{jh}/(A_e\sqrt{f'_c})|$  and story drift of specimen BD-B

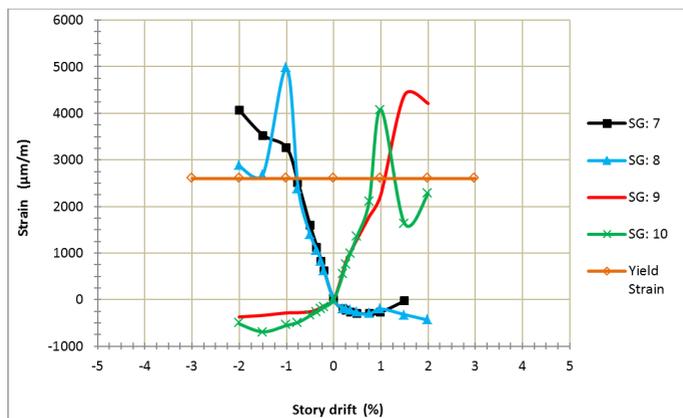
Fig. 4.67: The envelope diagram for Max. strain of beam longitudinal bars at the beam-column interface versus story drift of specimen SD-B

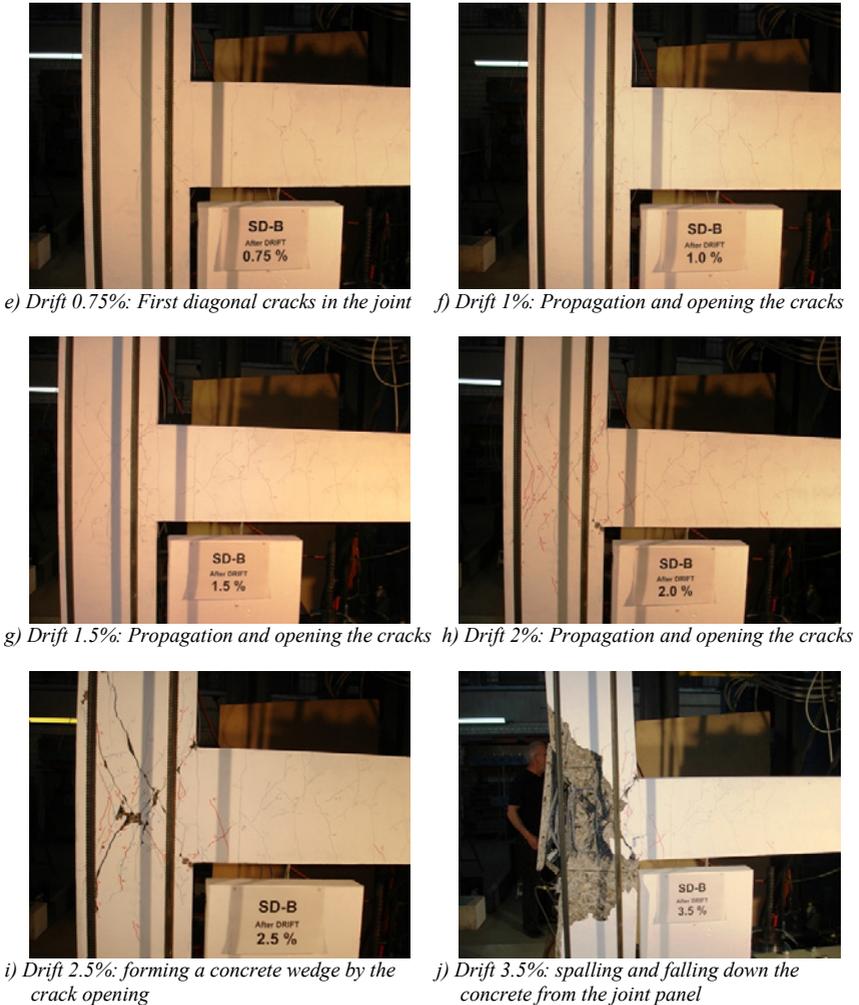
Fig. 4.68: Crack patterns and damage mode sequence of specimen SD-B at different levels of drifts

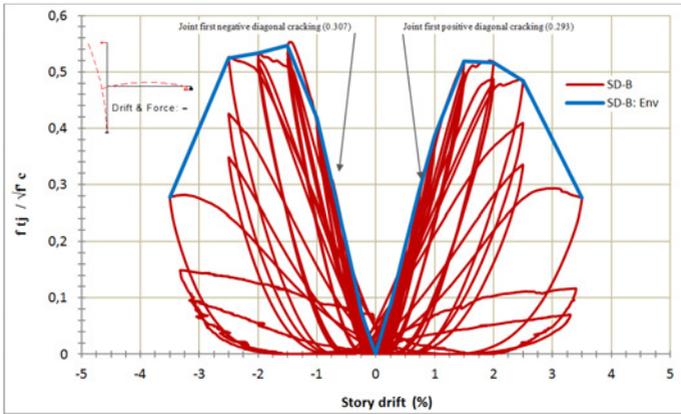
Fig. 4.69: The relationship between joint principal tensile stress ( $f_{tj}/\sqrt{f'_c}$ ) and story drift of specimen SD-B

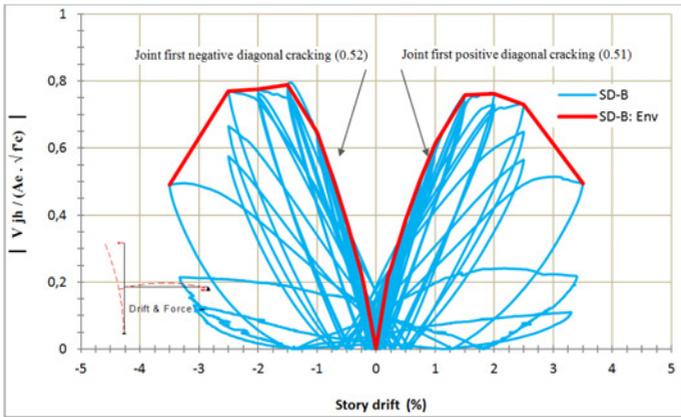
Fig. 4.70: The relationship between absolute value of (joint horizontal shear stress)  $| V_{jh} / (A_e \sqrt{f'_c}) |$  and story drift of specimen SD-B

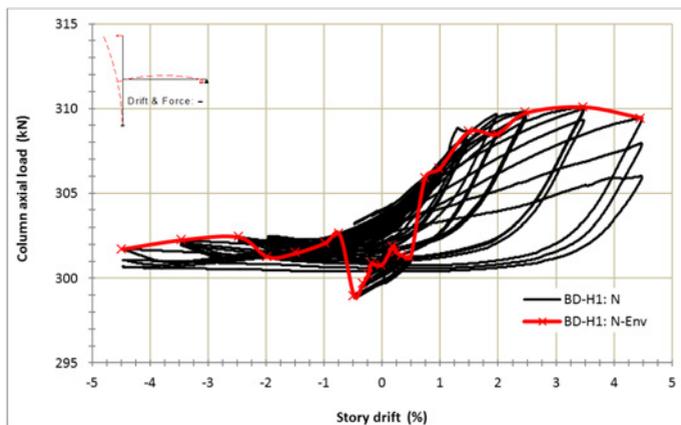
Fig. 4.75: Imposed column axial load versus drift of specimen BD-H1

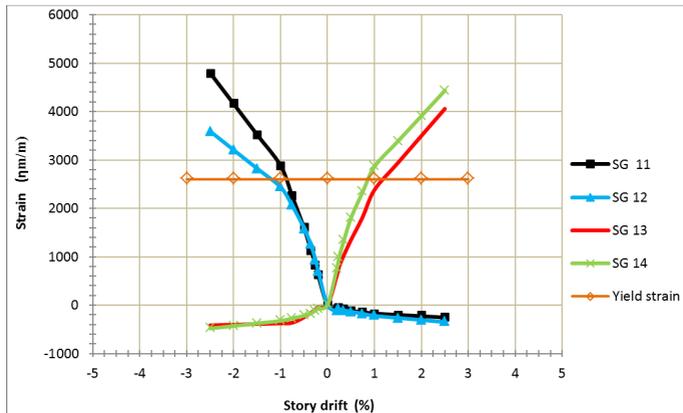
Fig. 4.77: The envelope diagram for Max. strain of beam longitudinal bars at the end of HMFC versus story drift of specimen BD-H1

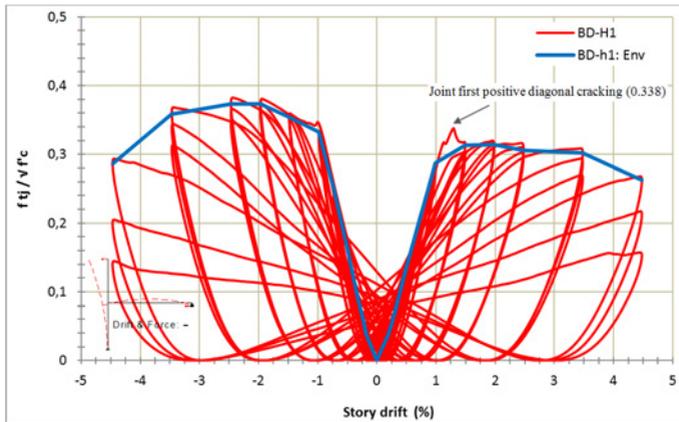
Fig. 4.79: The relationship between joint principal tensile stress ( $f_{tj}/\sqrt{f'_c}$ ) and story drift of specimen BD-H1

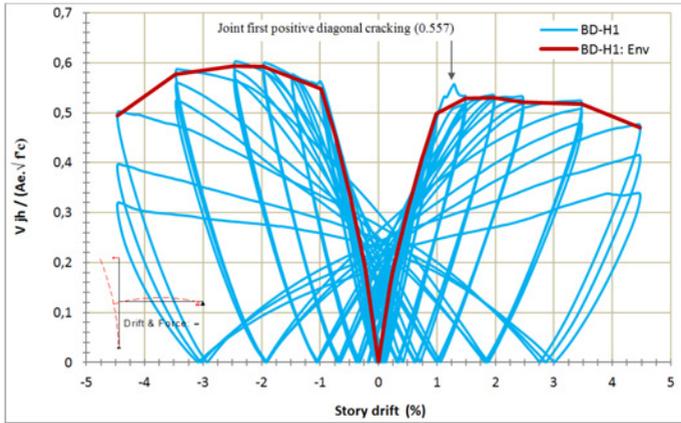
Fig. 4.80: The relationship between absolute value of (joint horizontal shear stress)  $|V_{jh}/(A_e\sqrt{f'_c})|$  and story drift of specimen BD-H1

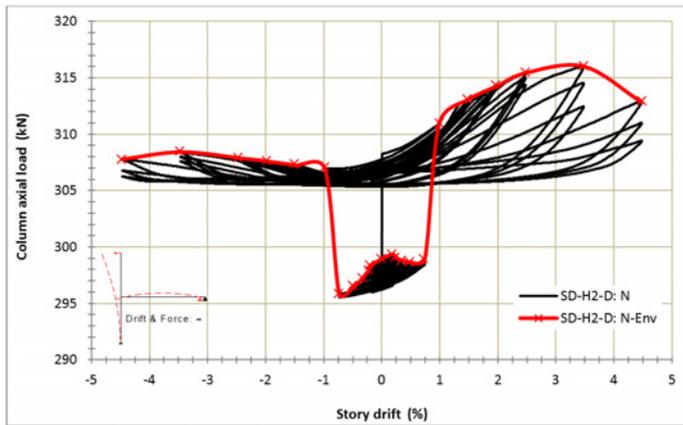
Fig. 4.88: Imposed column axial load versus drift of specimen SD-H2-D

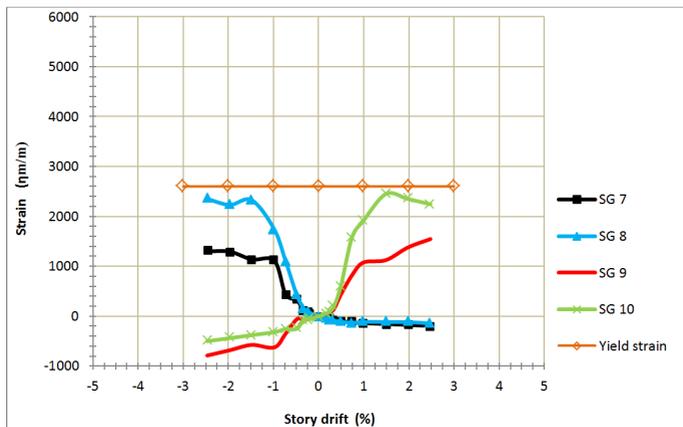
Fig. 4.89.: The envelope diagram for Max. strain of beam longitudinal bars at the beam-column interface versus story drift of specimen SD-H2-D

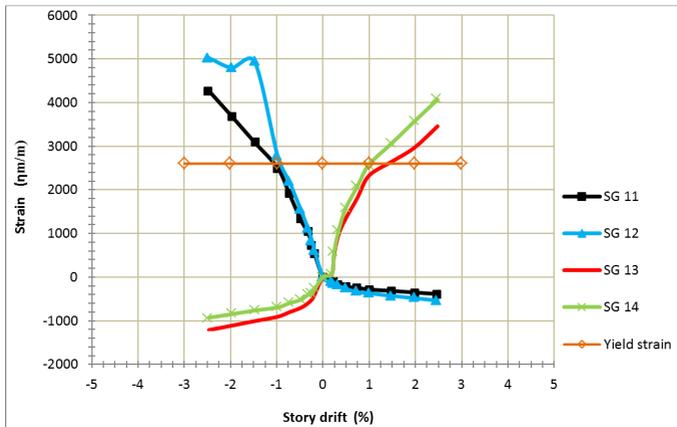
Fig. 4.90: The envelope diagram for Max. strain of beam longitudinal bars at the end of HMFC versus story drift of specimen SD-H2-D
