Mahdi Hayatrouhi

# Strengthening of reinforced concrete beam-column joints to increase seismic resistance

des Instituts für Massivbau der Leibniz Universität Hannover  
Herausgeber:  
Univ.-Prof. Dr.-Ing. Steffen Marx  
Leibniz Universität Hannover – Institut für Massivbau  
Heft 9, Februar 2014

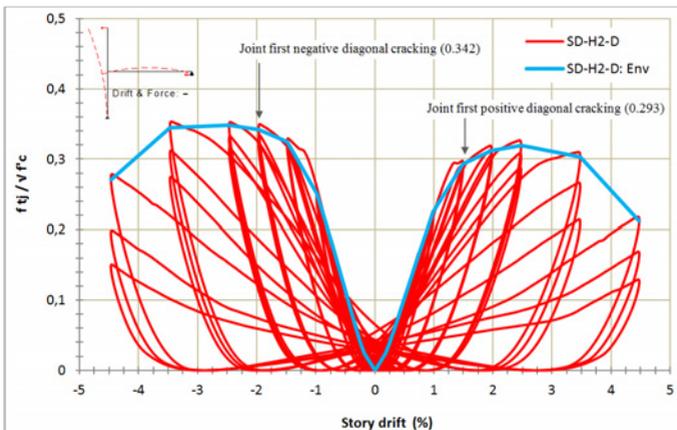
Fig. 4.92: The relationship between joint principal tensile stress ( $f_{tj}/\sqrt{f'_c}$ ) and story drift of specimen SD-H2-D

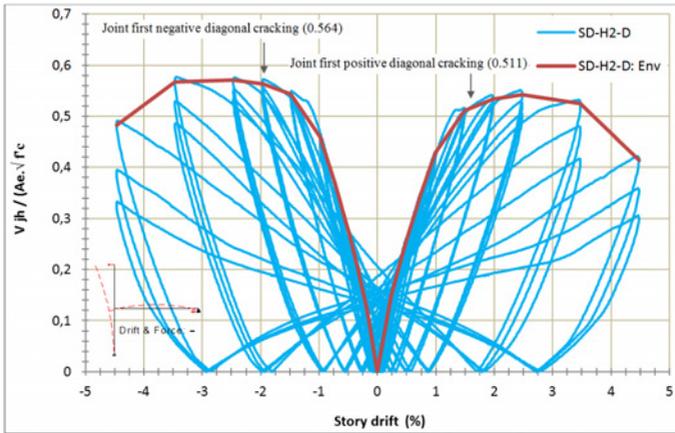
Fig. 4.93: The relationship between absolute value of (joint horizontal shear stress)  $|V_{jh}/(A_e\sqrt{f'_c})|$  and story drift of specimen SD-H2-D

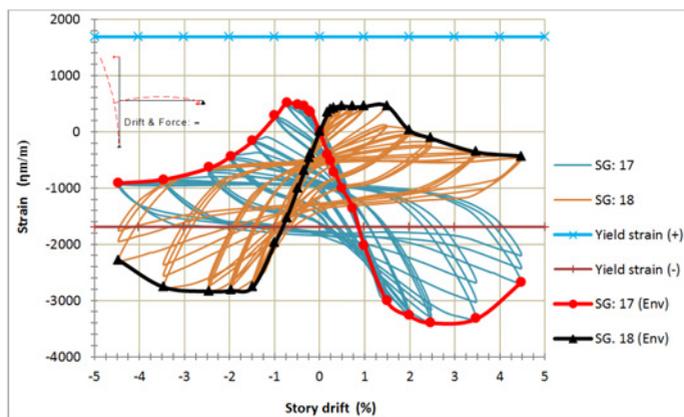
Fig. 4.96: The Hysteretic and envelope diagram for strain of top and bottom HMFCs versus story drift of specimen SD-H2-D

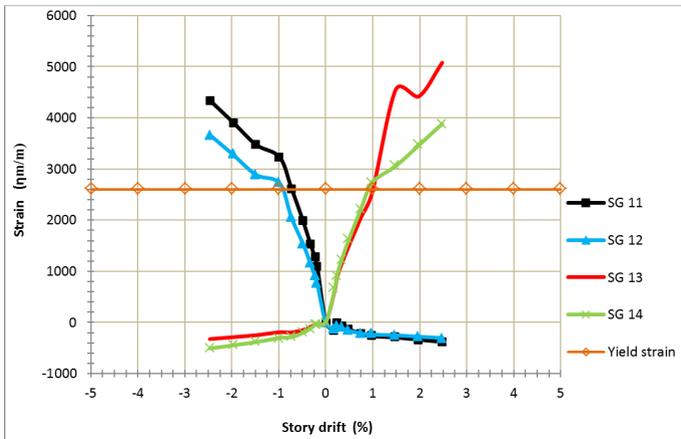
Fig. 4.103: The envelope diagram for Max. strain of beam longitudinal bars at the end of HMFC versus story drift of specimen BD-H3-D

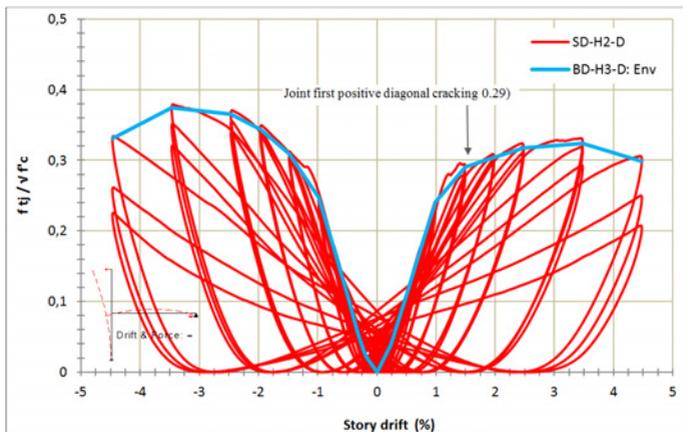
Fig. 4.105: The relationship between joint principal tensile stress ( $f_{tj}/\sqrt{f'_c}$ ) and story drift of specimen BD-H3-D

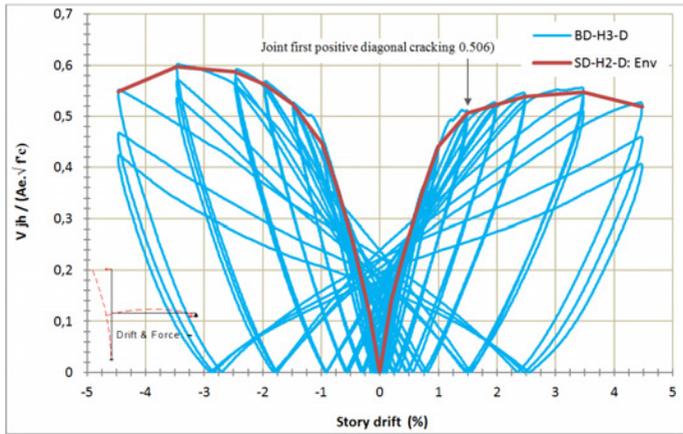
Fig. 4.106: The relationship between absolute value of (joint horizontal shear stress)  $|V_{jh}/(A_e\sqrt{f'_c})|$  and story drift of specimen BD-H3-D

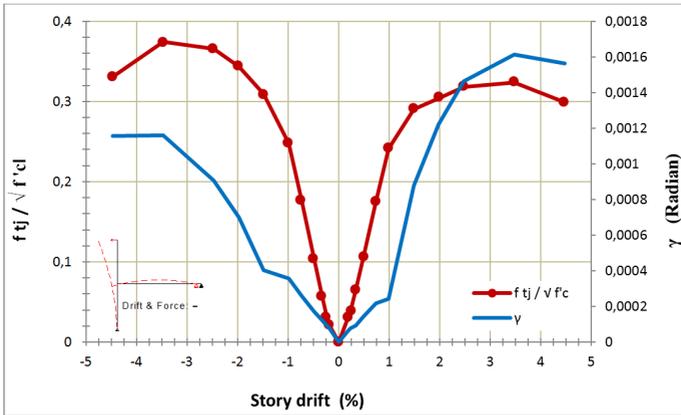
Fig. 4.107: The relationship among joint principal tensile stress ( $f_{tj}/\sqrt{f'_c}$ ), story drift, and joint shear deformation ( $\gamma$ ) of specimen BD-H3-D

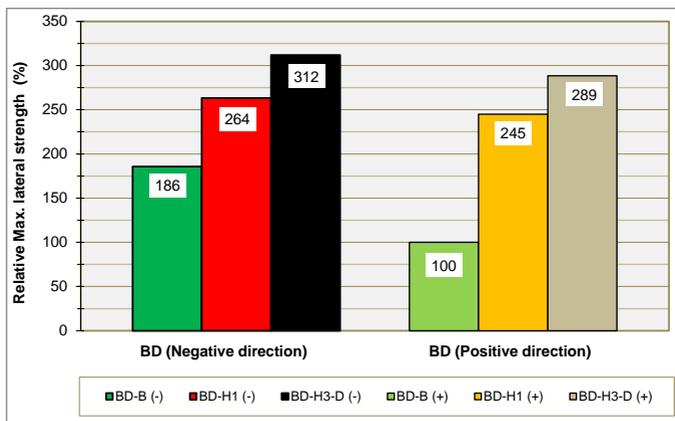
Fig. 4.115: Comparison the relative story shear strength in the negative and positive directions of the category of BD

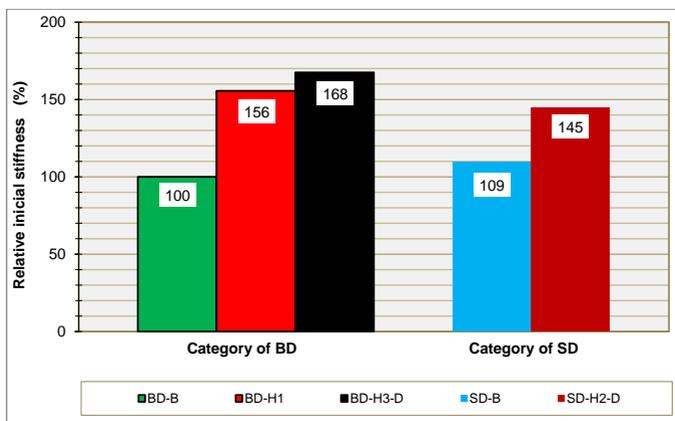
Fig. 4.122: Relatively comparison of initial stiffness in all specimens

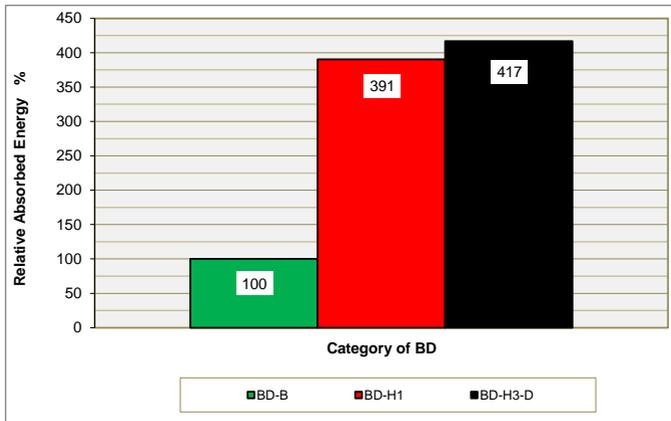
Fig. 4.123: Comparison the energy dissipations in the category of BD

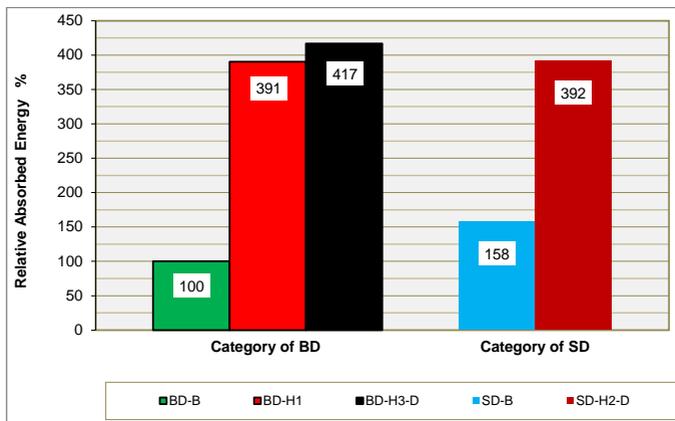
Fig. 4.125: Comparison the energy dissipations in all specimens

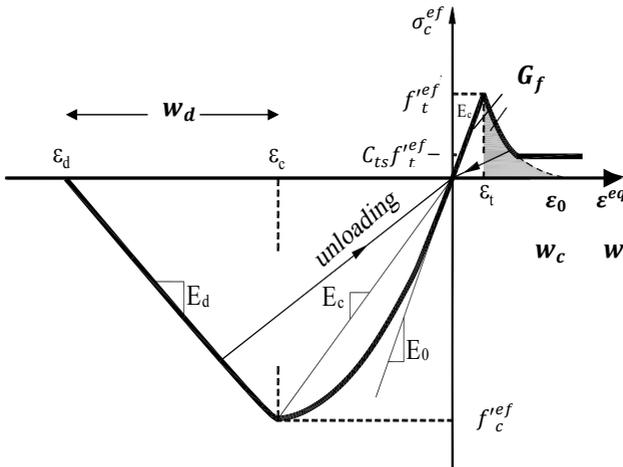
Fig. 5.1: Uniaxial constitutive stress-strain law and softening law for concrete

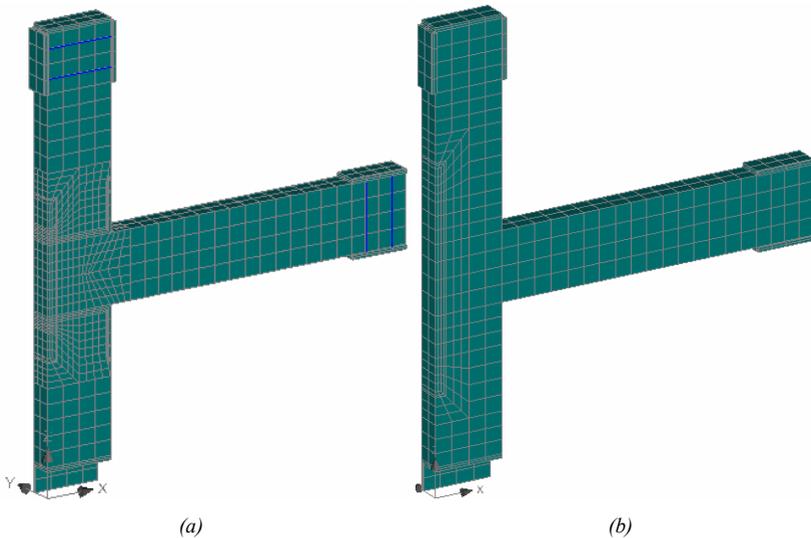
Fig. 5.8: Numerical model for: a) BD-B; b) SD-B

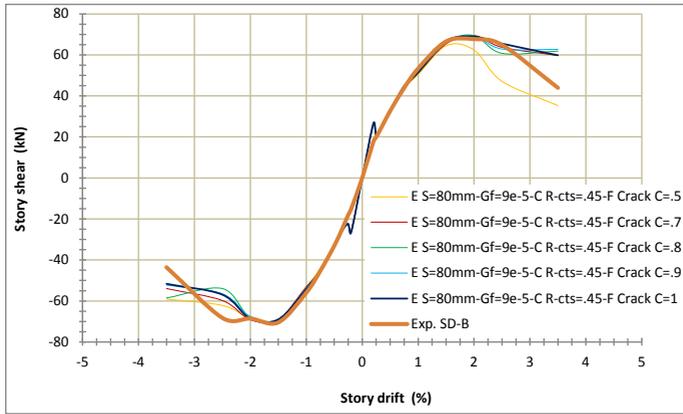
Fig. 5.14: Envelope lateral strength-drift diagram for different smeared cracking models

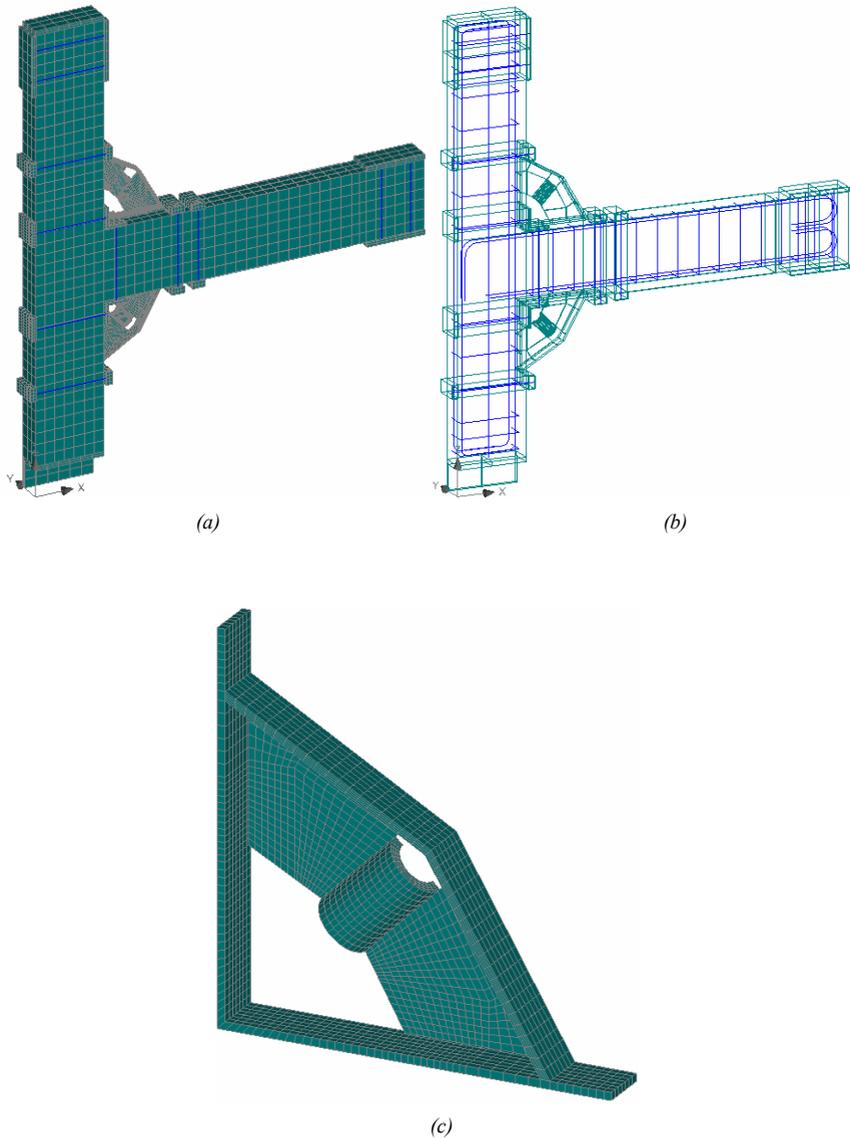
Fig. 5.15: Numerical model for BD-HI: a) General finite element mesh, b) Reinforcement, c) Multi Functional Corbel , HMFC (HI)

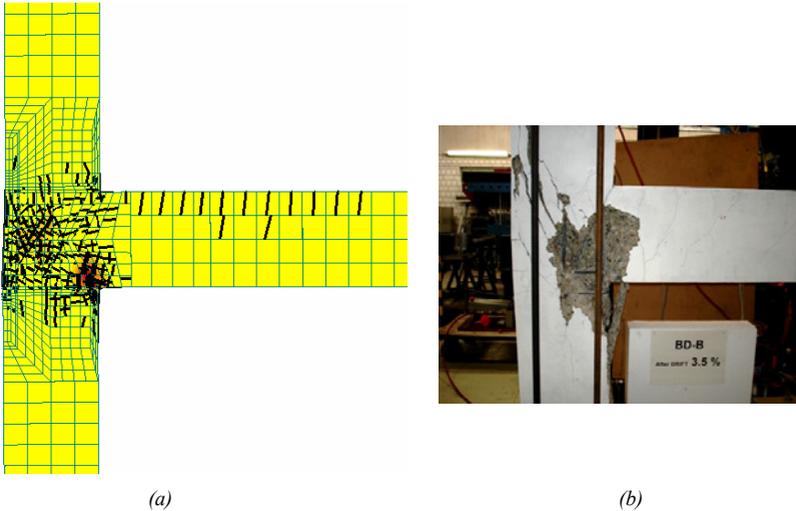
Fig. 5.21: Comparison of crack pattern for reference unit BD-B from  
a) numerical analysis and b) experimental test

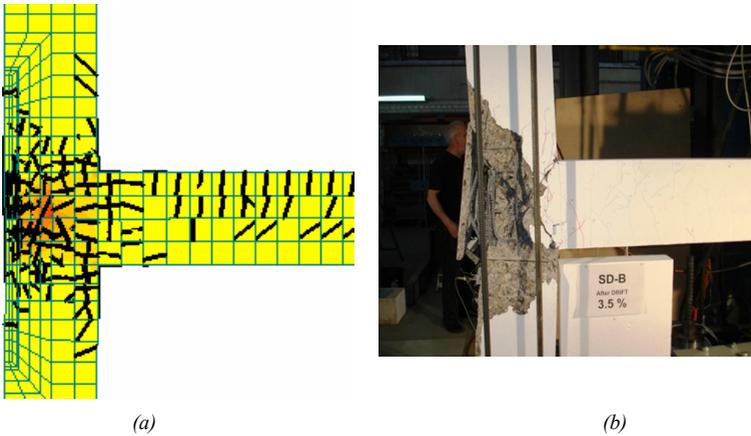
Fig. 5.25: Comparison of crack pattern for reference unit SD-B from  
a) numerical analysis and b) experimental test

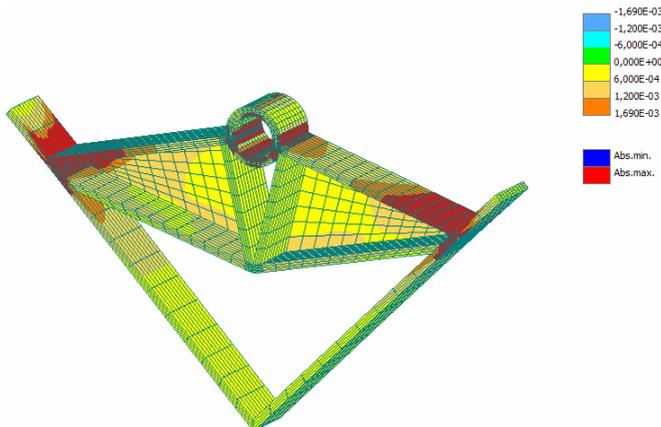
Fig. 5.33: Principal yield strain pattern for HMFC (H2) in retrofitted specimen SD-H2-D

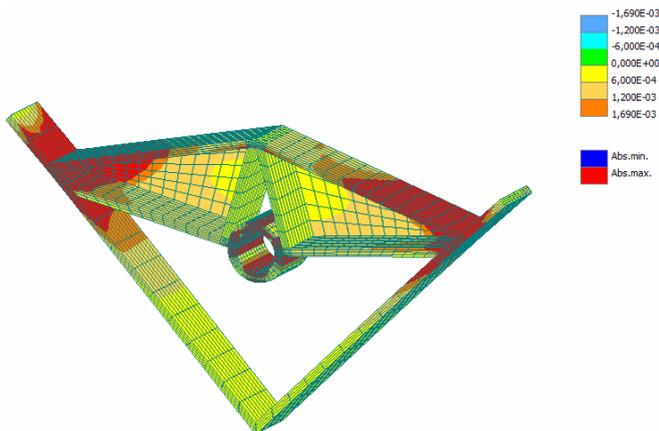
Fig. 5.38: Principal yield strain pattern for HMFC (H3) in retrofitted specimen BD-H3-D

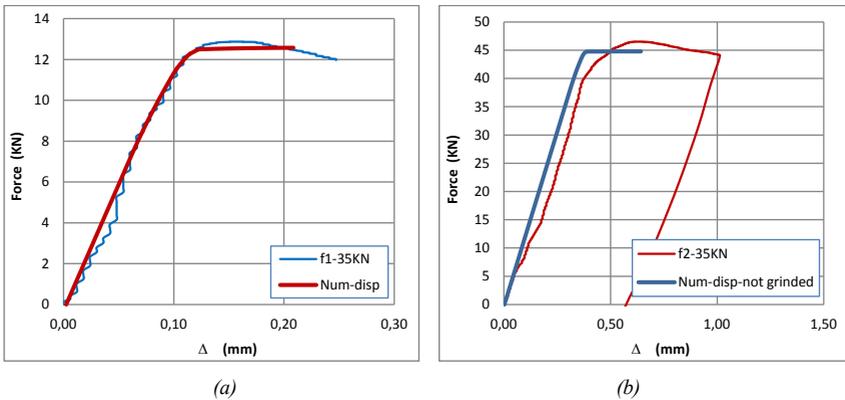
Fig. 5.42: Comparison of load-slip curves of steel-concrete friction in test and simulation: a) for grinded surface of concrete; b) for not grinded surface of concrete

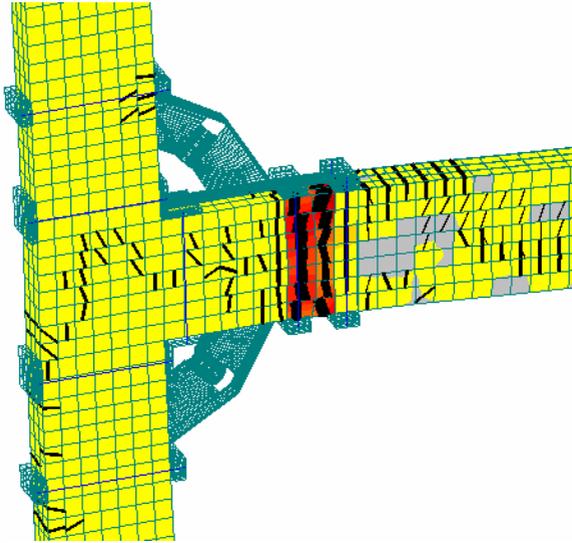
*Fig. 5.43: Crack pattern of developed new upgrading method, Retrofitting Technique 3 (RT3) for numerically analysed specimen BD-H1-F*

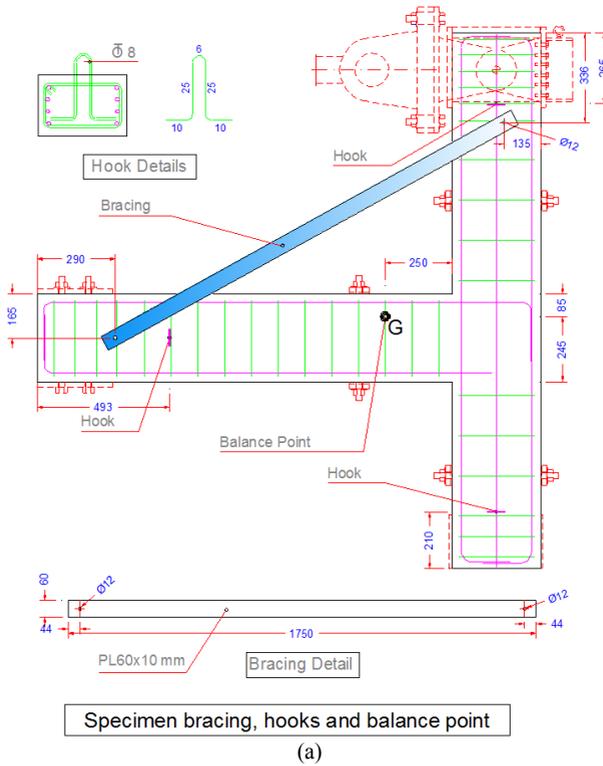
Fig. A.3: a) Specimen bracing, b) Formwork and bracing

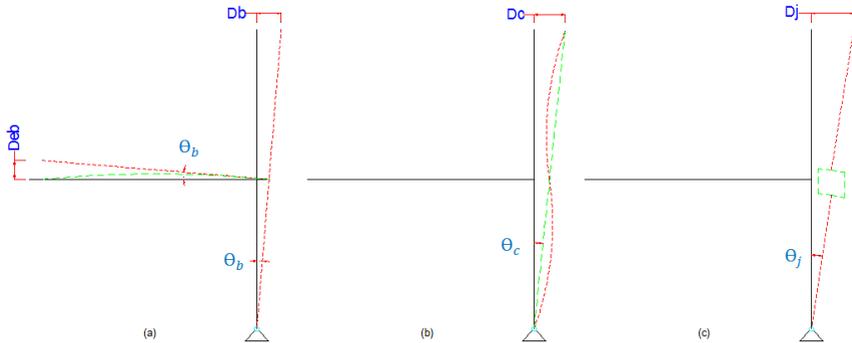
Fig. D.3: Contribution of beam, column and joint to the total lateral displacement
