7. Nonhuman Agency

7.1 Introduction

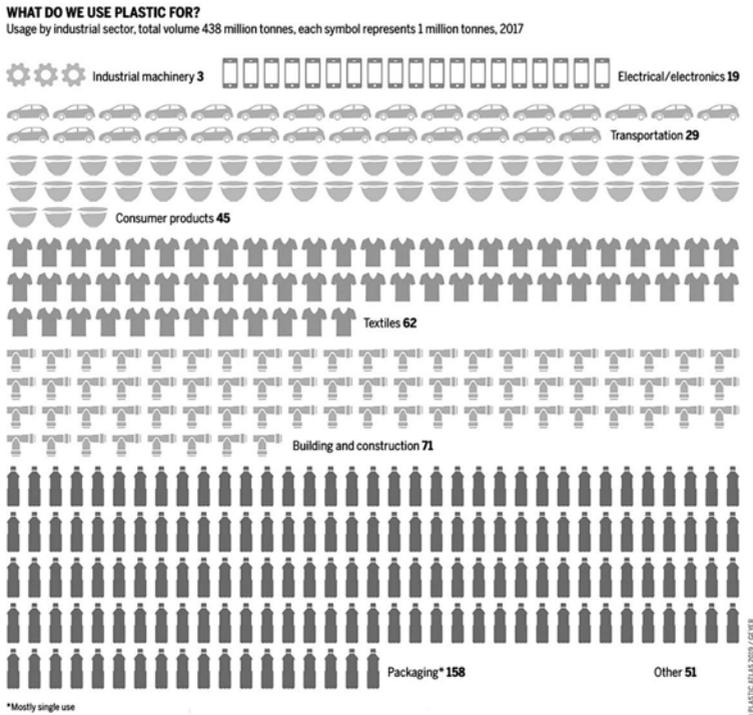
Figure 7.1: The distribution of plastic production per sector in 2017

In 2017, 71 million tons of plastic were used worldwide in the building and construction sector (Fuhr and Franklin 2019). Referring to this amount of production, its indestructible mass impact on environmental degradation is undeniable. Due to its durability, solidity, and lightweight properties, PVC is widely used in building technologies; however, the average lifespan of a PVC window frame is between 20 and 30 years. In recycling processes, PVC's thermoplastic nature supposedly allows the material to be heated and molded or extruded many times without losing its technical properties. However, according to the report titled "Window of Opportunity" in 2003 by the World Wildlife Fund (WWF), PVC frames have many negative impacts on the environment:

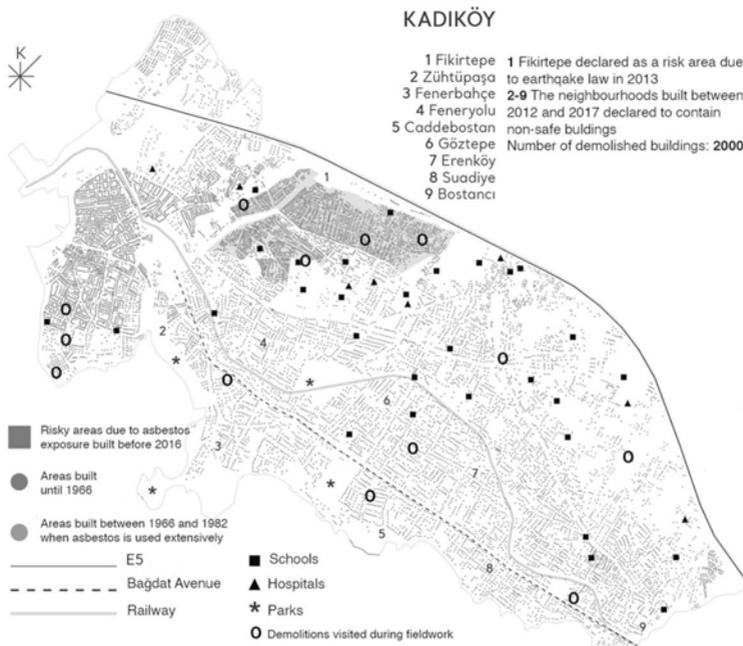
Figure 7.2: Risk map due to asbestos exposure from demolitions in Kadıköy- Istanbul

Depending on the date of the construction, building materials containing asbestos were heavily used in some buildings in Kadıköy from the 1950s to the 1990s (Odman 2019). In her study, Odman creates a risk map of Kadıköy (Figure 7.2) based on production statistics, construction dates, and current demolition sites. This map overlaps with the sites and depots I visited in Kadıköy, and it especially overlaps with Fikirtepe, where large-scale demolitions occurred. The demolition sites were places where asbestos fibers were potentially mixing into the air and affecting the health of the workers and neighboring residents. The map also shows public areas (marked in red) that are located close to Asbestos exposure risk. The authorities ignore the dangers revealed by this map.

Working in old apartment blocks in Kadıköy, *çıkmacıs* often end up working with some components made of asbestos. The workers were not thoroughly informed about asbestos' effects on human health and did not use any protective outfits or masks. When I asked them if the building was checked for asbestos, they did not have any information. In the Turkish demolition regulations, it is stated that asbestos abatement should be done. In any case, the authorities did not inspect the buildings during my field visits.

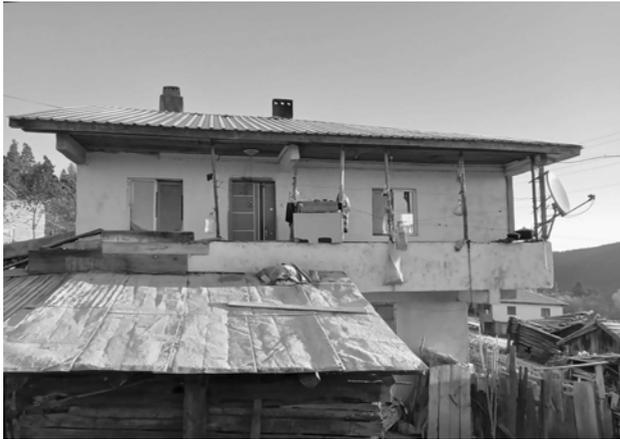
Figure 7.3: West façade of the dwelling with a metal door salvaged from Istanbul

After finishing the load-bearing concrete structure, he sent the dimensions of the windows and door frames to the construction workers so they could make the façade and door openings (Figure 7.3 and 7.4). He said they were lucky that the construction was still going on when he found the components; otherwise, he probably would have had to knock down some walls. In this way, he could fit the frames to the openings. The size of the kitchen is arranged according to the size of the cupboards (Figure 7.5). They completed the roof with old wooden beams salvaged from the former house. The roof was then covered with insulated metal panels. Apart from the concrete structure and clay bricks, most parts of the house came from reclaimed materials. In the following section, I will discuss a different rural dwelling in a different village because the availability of second-hand materials determined the construction development. The frugality of the owners offers an excellent example of the ethical meaning of 'buying second-hand'.

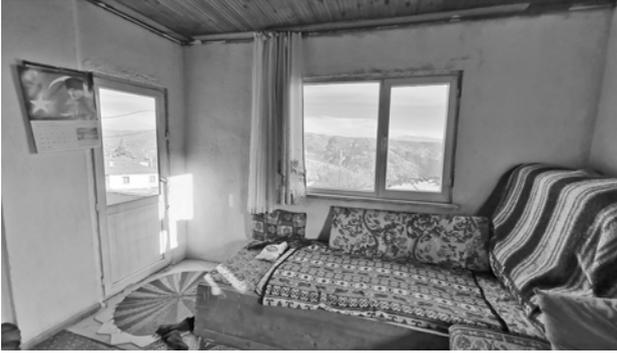
Figure 7.4: Second-hand façade elements

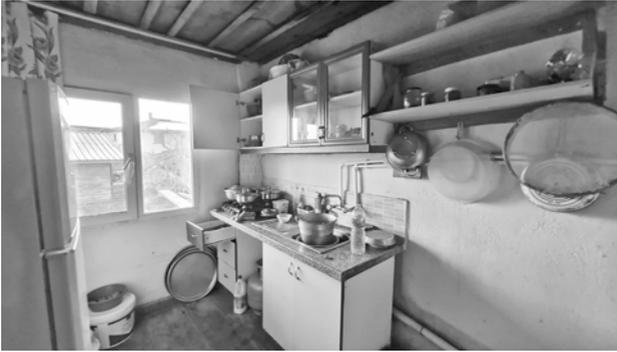
Figure 7.5: Second-hand kitchen cupboards

Eventually, he bought kitchen cupboards, a kitchen counter with a sink, four interior doors, six PVC window frames (100x150 cm), two small toilet PVC window frames (40x40 cm), and one PVC balcony door. If he purchased them new, he would have paid 5 to 8 times more, he admitted. He was still looking for a metal door for the entrance and vinyl parquet flooring. Due to his limited financial resources, he was only able to make a few small remodeling repairs to his flat in Istanbul. But here, in his family village in Kastamonu, he was able to entirely rebuild his family house.

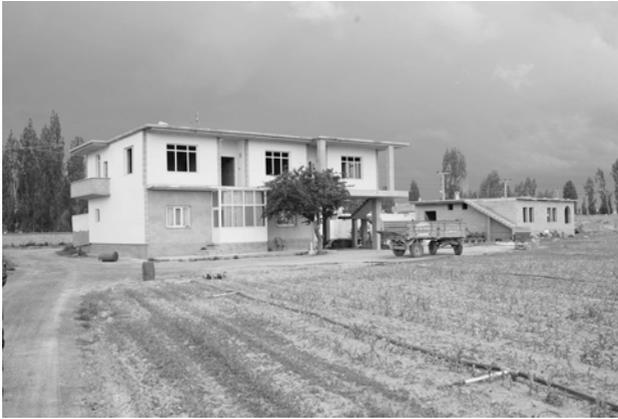
Figure 7.6: Two houses and agricultural land in Yazıhüyük

During my field visit, Engin, the scrap collector who I met in Istanbul (see Ch. 5.3.2), showed me his relative Mehmet's farmhouse (Figure 7.6). Engin said that the traditional construction method used to be stone masonry. However, currently, the villagers built the houses with reinforced concrete structures because it was cheaper and more practical. A local craftsman helped Mehmet with the construction. The new building provided additional space for Mehmet's extended family, which consisted of four brothers, their wives, and their parents. After marriages in the family, they made additions to the existing building. Additionally, a one-story house was built on the farmland. The construction was achieved by incremental process depending on the availability of second-hand materials and financial resources.

The two houses were positioned at the edges of the privately-owned agricultural land. The construction phases were at different stages. The ground floor was occupied in the older one, and a floor was added above the existing roof. The construction of the first floor was still in progress. The new house next to the old one was not occupied yet, and only the rough construction of the ground floor was finished. Even though the people were from the same family, the constructions were financed and managed separately.

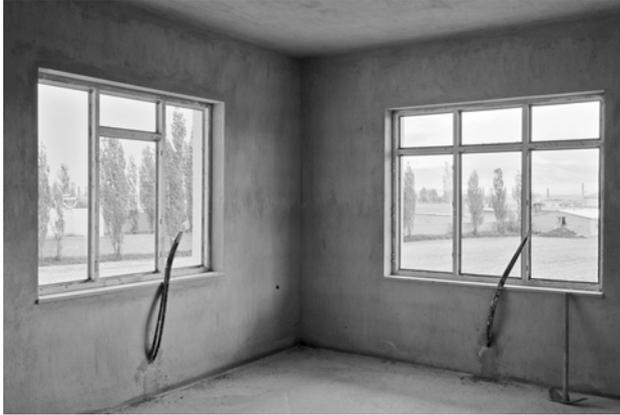
Figure 7.7: PVC window frames from Istanbul in Yazıhüyük

The newly built first floor had seven rooms, and the floor plan was 70 meter-square. The ground floor was 45 meter-square. It was planned to be larger than the ground floor to create an open garage space that could also be used for storage. Plus, balconies were added to the second floor. A new exterior staircase was installed to provide vertical access between the two levels. For the façade of the first floor, second-hand window frames were used. The frames used to belong to an apartment in Istanbul. Engin explained that he sold the frames before Mehmet started to put up the exterior walls. Therefore, he could determine the dimensions of the façade openings (Figure 7.7). Engin responded:

The building façade shows different histories. The ground floor was constructed 40 years ago and it had smaller window frames and was built with load-bearing stone walls. Mehmet said the ground floor went through a renovation ten years ago. They replaced the old wood frames with PVC frames and added an extension to the entrance made of plastic profiles. The adjacent house with a single floor was also constructed by the same incremental logic.

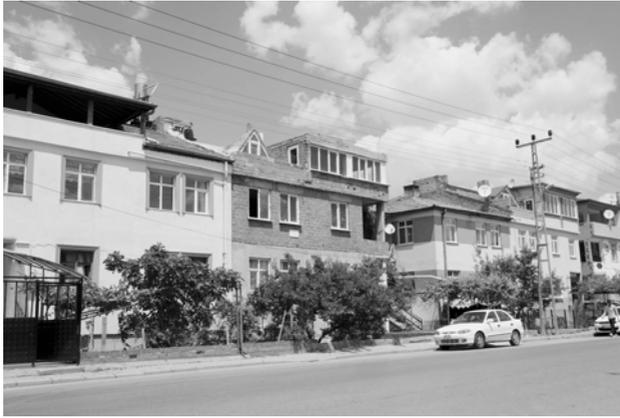
Figure 7.8: Eskişehir Bađlan district in Kayseri

At first, Kayseri houses could not be built higher than one story; right before the 1998 local elections, the height limit became two stories; later, prior to the 2002 elections, the height limit was raised first to three stories and then to four (ibid) (Figure 7.8). Within these changing zoning decisions, the residents were responsible for financing and constructing the houses. According to the second-hand supplier, Özcan, the construction took place incrementally; first, the dwellers built the main concrete structure of the ground floor, leaving reinforcement bar sprouts over the roof; later, they put up the walls on the ground floor and started living there, then they completed the other floors. Occasionally, they could not finish the exterior wall plaster because of a lack of financial resources. Currently, the district remains unfinished, and dwellers

are trying to lower the construction costs by using inexpensive materials and components.

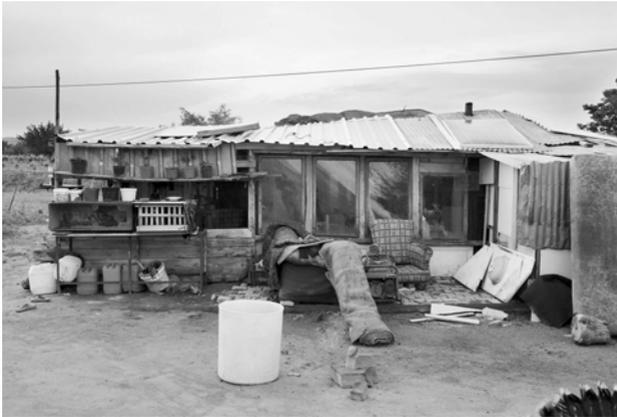
Figure 7.9: Makeshift vineyard shed in Ürgüp

In different parts of rural Kayseri province, locally reclaimed materials were adopted to construct vineyard sheds and farming shelters (Figure 7.9). Özcan explained that wood reclaimed from the roofs of old houses was used chiefly in the vineyards. In the other places visited in the area, I observed that such materials were used for the small-scale construction of sheds and small shelters. The legal status of such small constructions remains ambiguous.

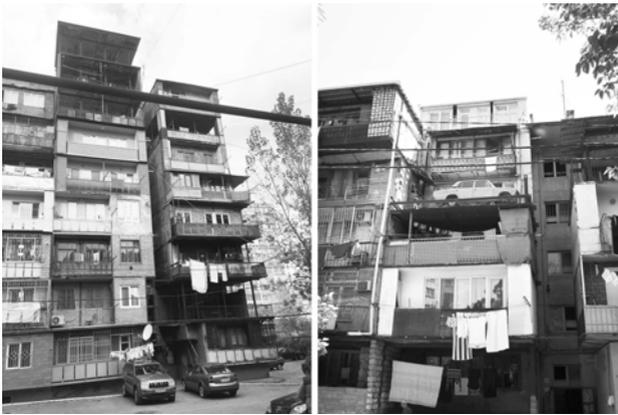
Figure 7.10: Building extensions: kamikaze loggias and rooftops additions in Gldani

chitectural interventions: enlarging private spaces to make them communal areas and adding extensions to flats (Figure 7.10). Public spaces were captured and informally privatized for individual gardens, commercial shops, and parking spaces. External ‘parasitic architecture’ attachments, known as ‘Kamikaze Loggias’, began springing up all over Tbilisi during the years of political chaos between 1991 and 1995 (Elettra and Gurgenidze 2018; Wainwright 2018).

These loggias in the form of outdoor platforms connected to existing floors can extend the plan of flats up to 40 square meters (Secchi and Spita 2018). They are built over steel-bar-frame structures installed next to the buildings and weakly connected to their reinforced concrete block walls. The lower floors are sometimes equipped with a private staircase. Alternatively, the extensions function as terraces or are closed by the owners to obtain one or two more rooms. The owners use their own aesthetic criteria to decide the window sizes and other architectural details of each loggia without any worry about zoning restrictions or other limitations. This all results in a fairly impressive display: a complete freedom of architectural style, material, and color. Consequently, an architecture has emerged in Tbilisi that is unique among post-Soviet cities.

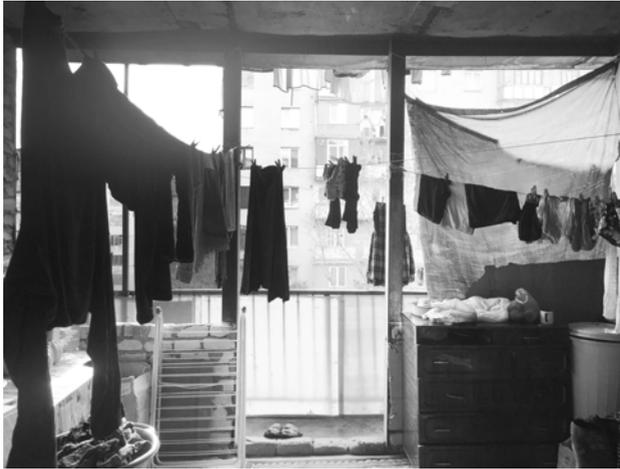
Figure 7.11: Unfinished facade in Gldani

For the last 18 years, the alteration of the original architectural plans in Gldani can mainly be detected in the altered façades of the housing blocks. The façades consist of different sizes of modified openings with old and new window frames. They were constructed with various kinds of bricks and plaster. The façade itself reflects the construction history by its combination of original Soviet elements and new second-hand additions.

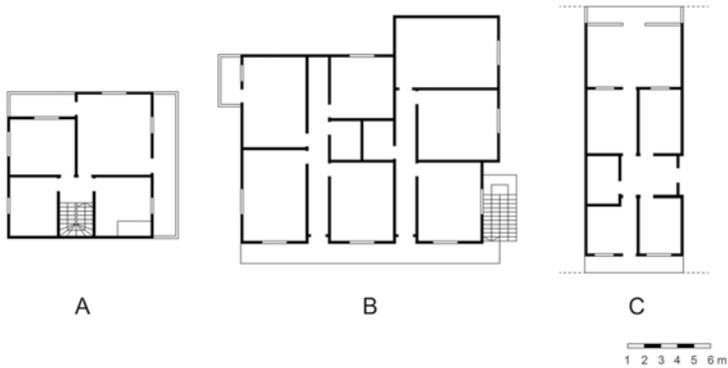
Figure 7.12: Plan A-Susuz, Plan B-Yazlıhüyük, Plan C-Tbilisi
