Rebalancing the Ruin

Critical-Creative Approaches to Restoration-Conservation

Florina Pop

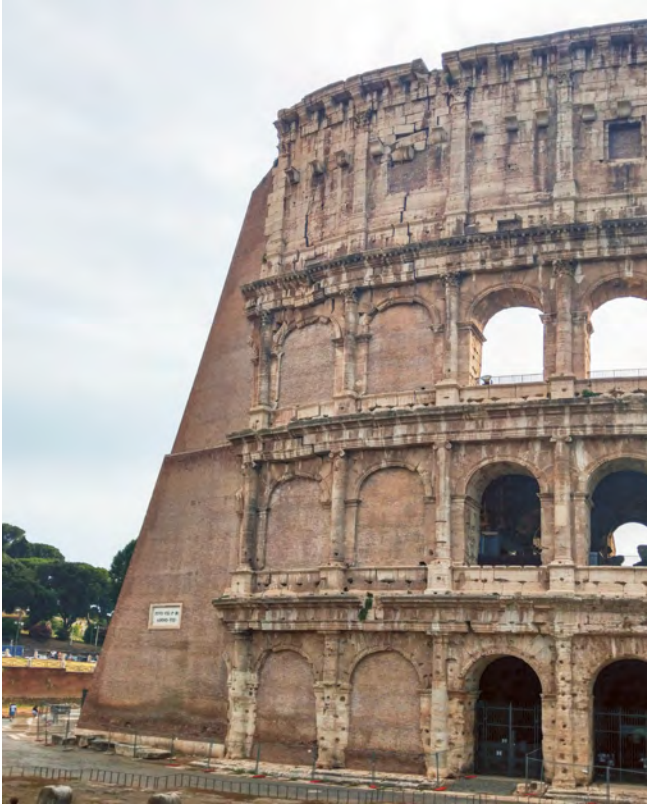
Fig. 1: Colosseum Rome – Raffaele Stern's reused brick buttress with the preservation of the appearance of crumbling arches, photo 2021.

Raffaele Stern froze the travertine blocks in their state of imminent collapse by walling in the arches, avoiding their disassembly and reassembly, which

would have implied a rather elaborate and costly operation.³ The intervention conserved the original state of the cracks and the lowering of the keystone blocks, still visible today, as if preserving the effect of the earthquake. The intervention merely stopped the collapse without attempting to complete the monument, thereby proving to be a very modern form of respect for the ancient monument (see Fig. 1).⁴

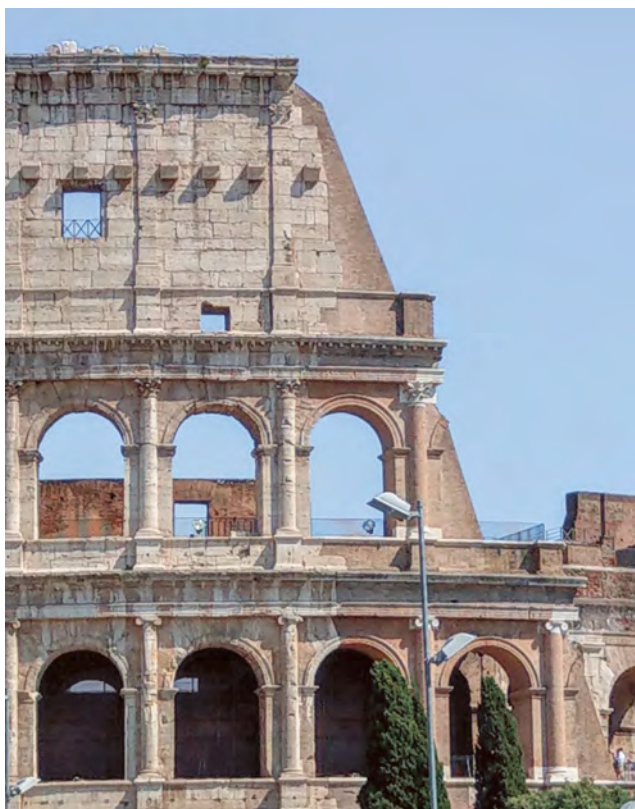
Fig. 2: Colosseum Rome – Giuseppe Valadier’s arch buttress repeating the original forms of the monument, photo 2021.

In 1820 Giuseppe Valadier was commissioned to consolidate the western outer ring facing the Forum. His design proposed a buttress imitating the ancient structure of the arches, reconstructed in plastered brick to complement the original ones in travertine (see Fig. 2). Furthermore, Valadier claimed that his method could eventually be applied to rebuild the entire monument.⁵ This second restoration of the Colosseum, completed in 1826, anticipated what would

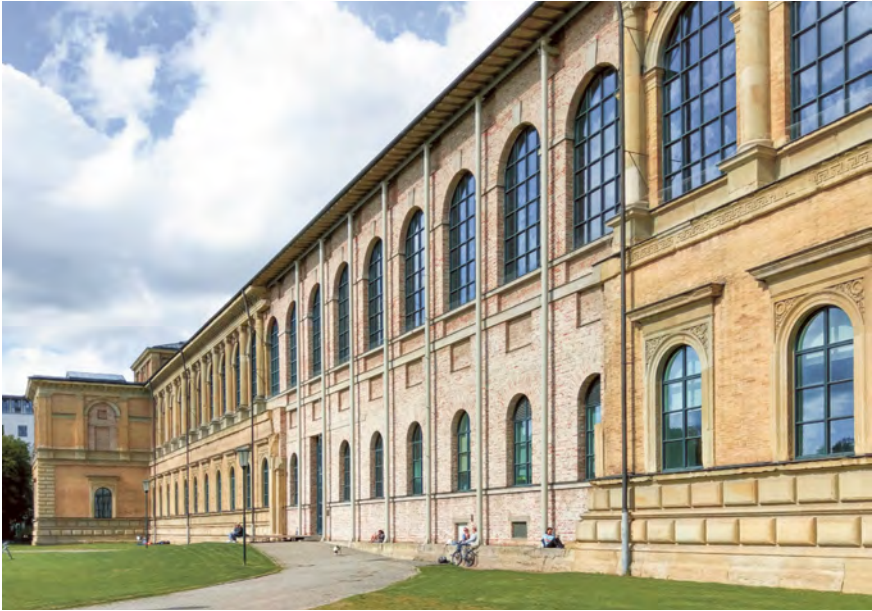
Fig. 3: Alte Pinakothek Munich – Hans Döllgast’s intervention on the south façade consisting of a structure of steel columns supporting the roof and the subsequent closure of the gap with re-used bricks, photo 2021.

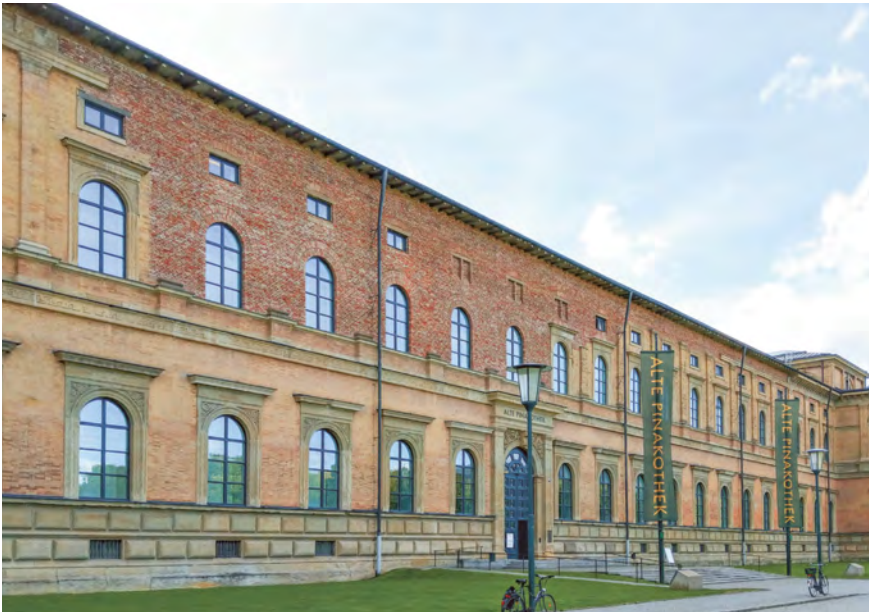
Fig. 4: Alte Pinakothek Munich – Hans Döllgast’s reintegrated north façade with bare re-used bricks and lack of decorative elements, photo 2021.

and cost-effectiveness by means of concrete plans, while the advocates of demolition and reconstruction could not even take a decision about the location of the new building. Döllgast developed several design proposals and received an initial official planning contract for securing the ruin. This led to stabilising the south façade and to temporarily propping up the roof with steel supports, leaving the gap open. As a consequence of this first operation and the need to close the void, Döllgast designed a bold proposal for a glass curtain wall in 1953. This solution, contrasting to the existing building fabric, would also have had a strong impact on the interior, but due to the high cost and technical and climatic constraints, this proposal was not seriously considered.¹³ A year later, it was decided to close the gap with a brick wall, as this was the most cost-effective solution (see Fig. 3). On the north façade, Döllgast closed the gap with re-used bricks from other war-damaged buildings and completed the original fabric in a reduced form without decoration. By 1955, the work on the exterior façade was completed and the interior work began; two years later the museum was inaugurated (see Fig. 4).¹⁴

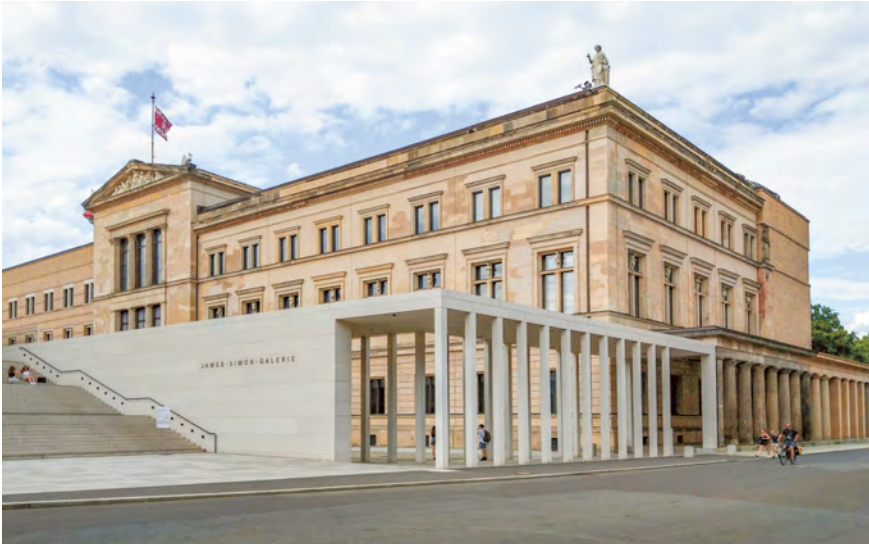
Fig. 5: Neues Museum Berlin – half-reconstructed south-west façade with the recent entrance to the James Simon Gallery in the foreground, David Chipperfield Architects, photo 2021.

bombs.²⁰ It was the only one of the five museums on the island that was not reopened after 1945, remaining in a ruinous state of direct weathering for more than sixty years. The decision to rebuild the museum had been in preparation since the 1960s and was finally taken during GDR times, exactly fifty years after the beginning of the Second World War, on 1 September 1989.²¹ In 1993, an international architecture competition was announced for the completion of the Neues Museum and the recreation of the connections to the neighbouring museum buildings, the Pergamon and the Altes Museum. The second competition phase was won by David Chipperfield Architects in collaboration with Julian Harrap (see Fig. 5). Restoration works began in 1998 and the museum was reopened on 16 October 2009.²²

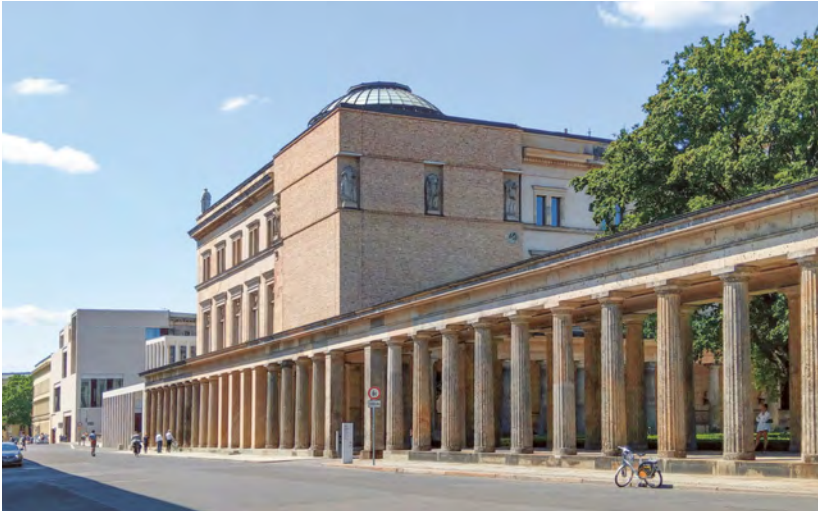
Fig. 6: Neues Museum Berlin – south-east façade with newly built corner risalto and rebuilt south colonnade, David Chipperfield Architects, photo 2021.

The architectural concept involved filling in the original volume with the aim of merging old and new into a new entity, leaving traces of war damage visible. As Döllgast had done previously, the architectural filling of the void was done with simplified forms of the original decoration that nevertheless maintain the rhythm and volume of the original building (see Fig. 6). The new intervention

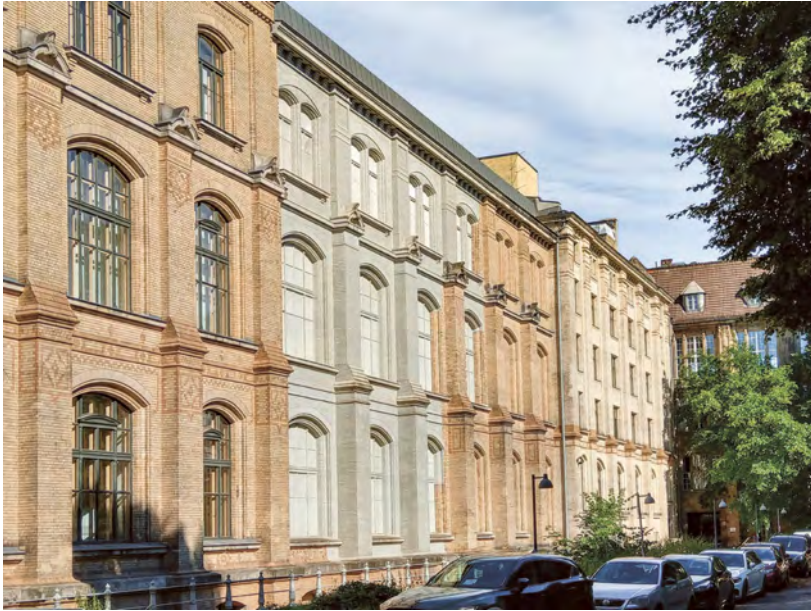
Fig. 7: Natural History Museum Berlin – restored east wing, Diener & Diener Architekten, photo 2021.

The spaces in the restored wing house the museum’s wet collection, containing light-sensitive exhibits that require a controlled environment. The animal specimens stored in alcohol-filled jars are displayed as an open, walk-in archive for visitors and researchers alike. To ensure a controlled environment for the exhibits, the building envelope is sealed and the new façade elements are completely opaque. The windows, which are blind to the outside, fit into the rhythm of the original façade openings and are in dialogue with the preserved original façade segments, which were consistently bricked up (see Fig. 7).²⁸

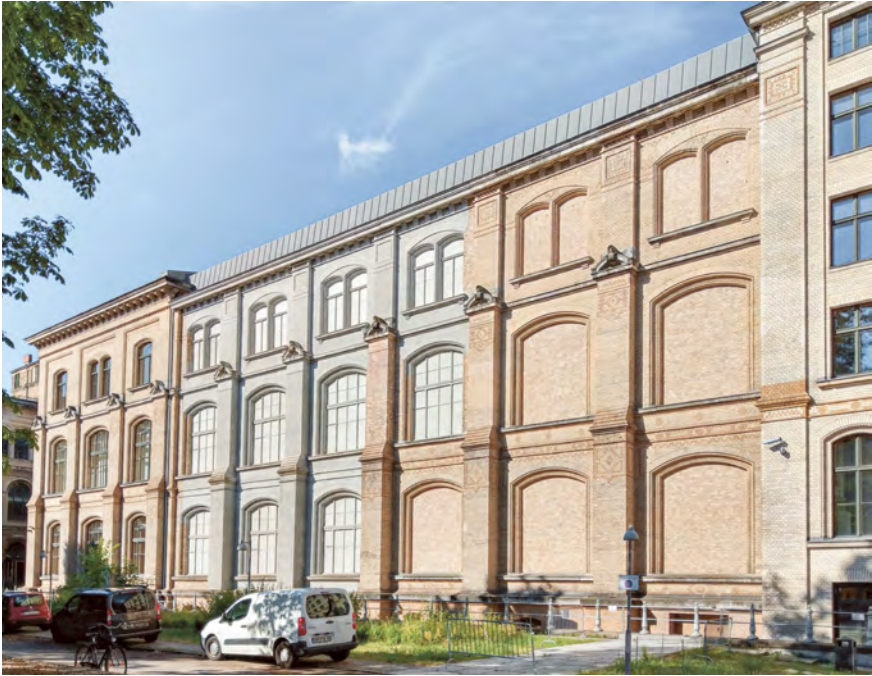
Fig. 8: Natural History Museum Berlin – reintegration of the missing gap by mimetic repetition of the original structure in visible cast concrete, Diener & Diener Architekten, photo 2021.

The contemporary intervention stages the filling of the gap in the façade through a mimetic repetition of the old masonry. Casts were made from the fragments of the original façade, from which prefabricated gray concrete elements of various sizes were produced.²⁹ The different colouring of the façade through the various materials creates an effect of beneficial disturbance. The concept of distinguishing contemporary material from the existing original substance is reminiscent of Hans Döllgast's work, while the decision to repeat the original forms is reminiscent of Giuseppe Valadier's work on the western outer ring of the Colosseum.

This intriguing and bold proposal lies somewhere between a critical reintegration of the gap and a mimetic redesign that stages a new whole, blending old and new building fabric while preserving the memory of the building's destruction during the war (see Fig. 8). Diener & Diener's intervention in Berlin speaks a contemporary language in its materiality mirroring the technological possibilities of its time, yet in terms of appearance, it remakes the original form. This could be a proof of loyalty to the surviving fragments of the original building, or a safety measure to lower the risk of the intervention becoming unbalanced due to the chromatic and material difference from the original fabric.
