## Chapter 7. Outcomes of planning instruments for POPS

### 7.1. Teheran-ro, Seoul

## 7.2. Mediaspree area, Berlin

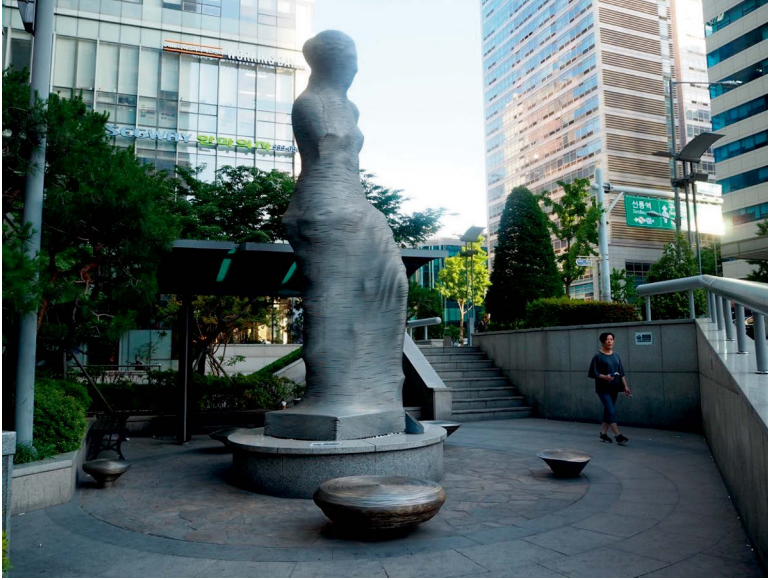
*Figure 7.5a Photographs for POPS Case 1: POPS during the day*

This POPS is well maintained in the sense that it is usable, clean and safe. It provides a litter receptacle and has no fly tipping or fly posting. Its amenities are kept to desired standards. Aside from the litter receptacle, it provides basic amenities such as pergola and bench, and a piece of artwork stands at its centre. This artwork seems to be relatively large for the size of POPS; however, according to the observation, many people use the lower part as a seat. A drinking fountain is installed, but this is blocked from use. Signage is installed at one of the entrances. Although it does not include information like area size, list of amenities, hours of use or person in charge (as suggested by the Seoul POPS Provision Guideline), it does indicate that the space is for citizens to use. Lighting is lacking; however, the area remains bright until 10p.m.

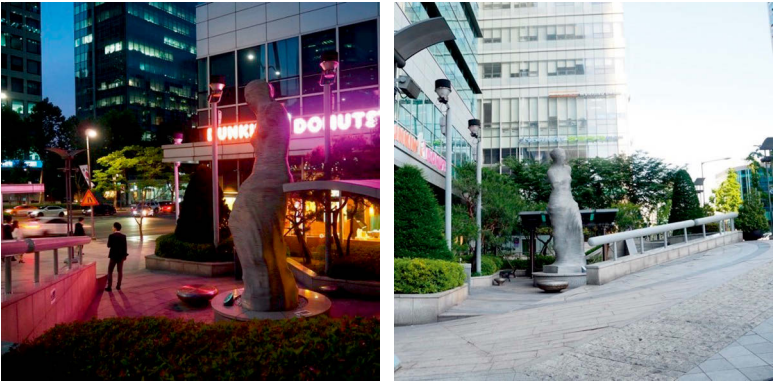
*Figure 7.5b, c Photographs for POPS Case 1: POPS during the night and entrance to POPS*

In terms of physical accessibility, parts of the POPS front onto sloping streets and are hence accessible via stairs. Another entrance is at the same level as the adjoining sidewalk with barrier-free pavement and good connection to the adjacent street. The POPS is a plaza of the sunken type and is surrounded by a wall that makes it less visible from the sidewalk while providing a sense of cosiness for those who use the space (although this is purely due to topography). Hence, three points are given to each indicator for the dimension of accessibility.

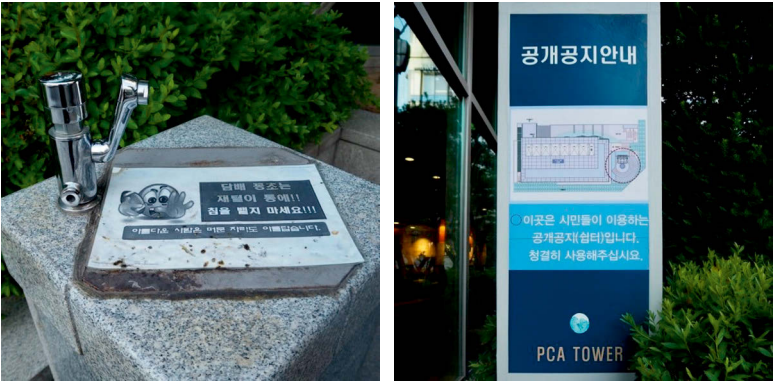
*Figure 7.5d, e Photographs for POPS Case 1: Drinking fountain blocked from use and signage indicating POPS*

due to light from the adjoining Dunkin Donuts outlet. Regarding practice of control, a sign indicates “cigarette butts in the litter receptacle”; this is the only rule on behaviour. This does not reduce the publicness of the POPS, as it tries to exclude anti-social behaviours only. In sum, three points are given to each indicator for the dimension of maintenance.

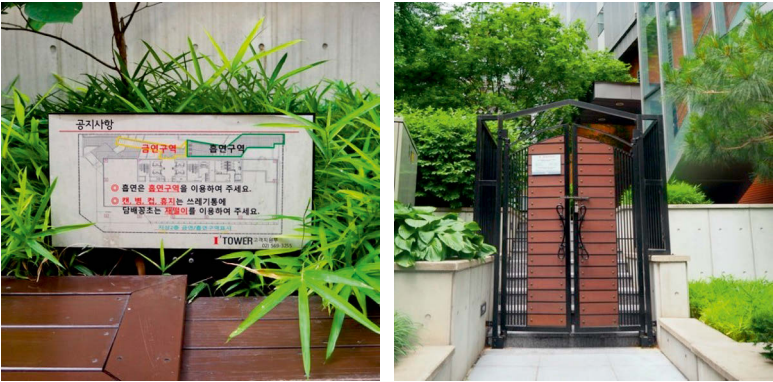
Figure 7.14b, c Photographs for POPS Case 4: Sign indicating smoking and non-smoking areas and closed gate to POPS

In terms of maintenance, both POPS are usable, clean and safe. They have no fly tipping or posting. The amenities are kept to desired standards. However, a marked difference was observed in the provision of amenities between the two POPS. While the one situated in front of the building offers no amenities, except for a signage, the other POPS offers benches, planting, shelter and a litter receptacle so that office workers – the main users of the space – can take a rest. Both POPS have signage, yet this does not include information about amenities or the person in charge (as suggested by Seoul POPS Provision Guideline). Regarding practice of control, the POPS in front of the building has a sign indicating it is a smoking-free area. This may not reduce publicness, as it tries to exclude anti-social behaviours only. On the other hand, other signs indicating the use of camera surveillance 24/7 may give the sense of control. The POPS behind the building includes a sign delineating smoking and non-smoking areas, and another indicating that rubbish should be thrown in the litter receptacle. To sum up, three points are given for cleanliness, and two points are given for provision of amenities as well as practice of control.

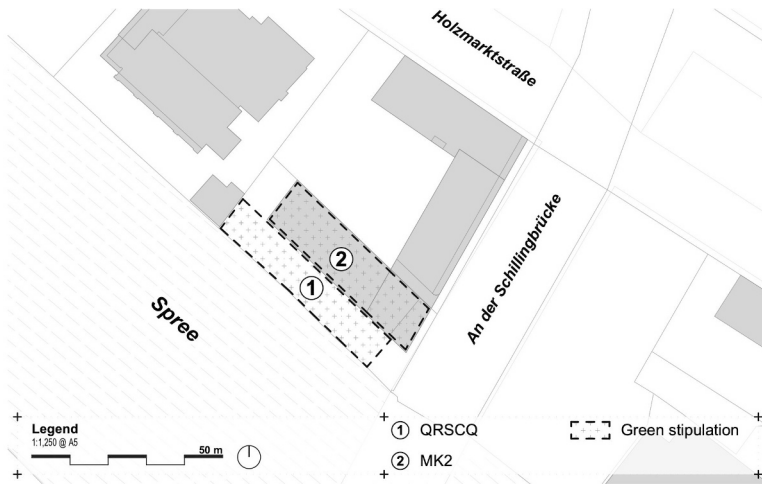
Figure 7.17 Stipulations in graphic form regarding green stipulation at POPS Case 5

- **No. 8:** The area QRSCQ is to be planted in a way that creates the impression of a riverside promenade. Plantings are to be preserved.
- **Recommendation:** When applying this written stipulation, it is recommended to use the following list of plants. Tree species – *Salix alba*, *Acer platanoides*, *Tilia cordata* and *Quercus robur*. Shrub species – *Cornus mas*, *Corylus avellana*, *Euonymus europaeus*, *Prunus padus* and *Rhamnus frangula*.

- **No. 9:** The areas for planting are to be designed horticulturally and maintained. Plantings are to be preserved. This also applies when underground garages are provided under these areas. [...] The obligation for planting does not apply to paths and squares.

In addition to easement, green stipulation is exercised (see Figure 7.17). A green ordinance sets arrangements for greening the riverside path, open space and flat roofs. The continuation and design of promenade along the river Spree is a key goal of the B-Plan V-61. It sets out the legal framework for greening the riverside path (see written stipulation no. 8). The riverside area, as part of the long promenade, shall 'characterise the Friedrichshain-side waterfront in a uniform design and contributes to the visual identity of the waterfront' (Bezirksamt FHKR von Berlin, 2000b). According to the design guidelines by GuD Geotechnik und Dynamik Consult GmbH, a double row of trees is envisaged to divide spaces between building, paths and the riverside. When planting, plant species that correspond to the local flora, and which respect the site condition, are to be chosen. As a recommendation, a list of tree and shrub species taken from the design guidelines and landscape planning related expert contribution is provided. The green ordinance outlines the requirements for greening and the preservation of the previous open space

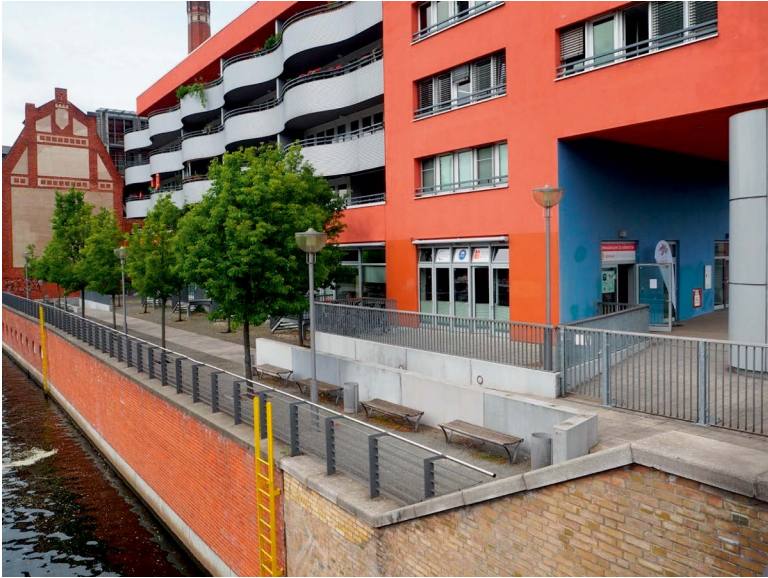
*Figure 7.20a Photographs for POPS Case 5: POPS along the river*

POPS Case 5 was visited three times during the day in November 2017 as well as in May and July 2018. The site analysis reveals that all three POPS are well cared for; they are usable, clean and safe. They have no fly tipping or posting, and the amenities are kept to desired standards. In terms of amenities, benches, planting, lighting and litter receptacle are provided in the POPS at riverside, and trees create the impression of a riverside promenade. The other two POPS do not offer any amenities; given the lack of space, they are not suitable for amenities. On the gate, there is a posting with the name of a security company, but other postings of rules were not found. Three points are hence given for the dimension of maintenance.

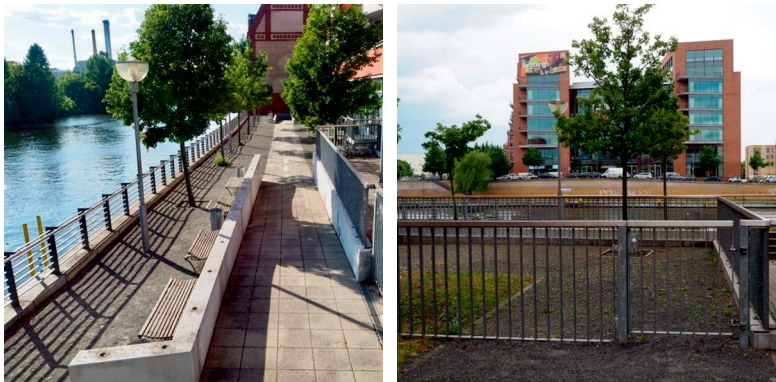
*Figure 7.2Ob, c Photographs for POPS Case 5: Amenities provided on POPS and fence and locked gate to POPS*

In terms of accessibility, the POPS along the riverside is currently blocked by fences and two gates, both of which are currently closed. Without a key, no one can enter the POPS. The small POPS on the west border of the area is physically but not visually accessible, as it is far from the sidewalk and one must cross the courtyard to get there. It is worth remembering here that this POPS is intended for the potential continuation of the promenade with neighbouring property in the future. POPS as a pedestrian space is open to the public. However, since physical accessibility in POPS Case 5 is generally low, only one point is given. Visual accessibility is adequate; hence, three points are given.
