Chapter 7. Outcomes of planning instruments for POPS

7.1. Teheran-ro, Seoul

7.2. Mediaspree area, Berlin

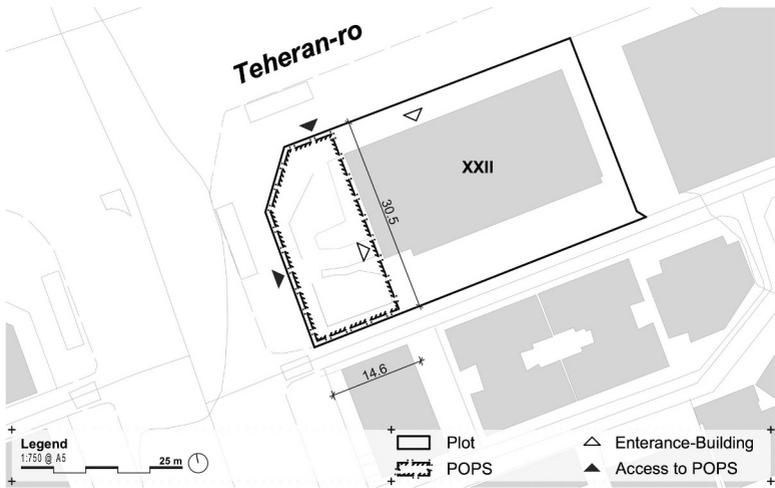
Figure 7.4 POPS Case 1 site map

POPS Case 1 is located at an intersection of two main roads: Teheran-ro and Eonju-ro. As a result, there is a high pedestrian flow on the adjoining side-walks. POPS Case 1 was visited several times in June 2017 – on weekdays and on weekends, between 7 a.m. and 11 p.m. – to analyse and evaluate it based on maintenance, accessibility and inclusiveness.

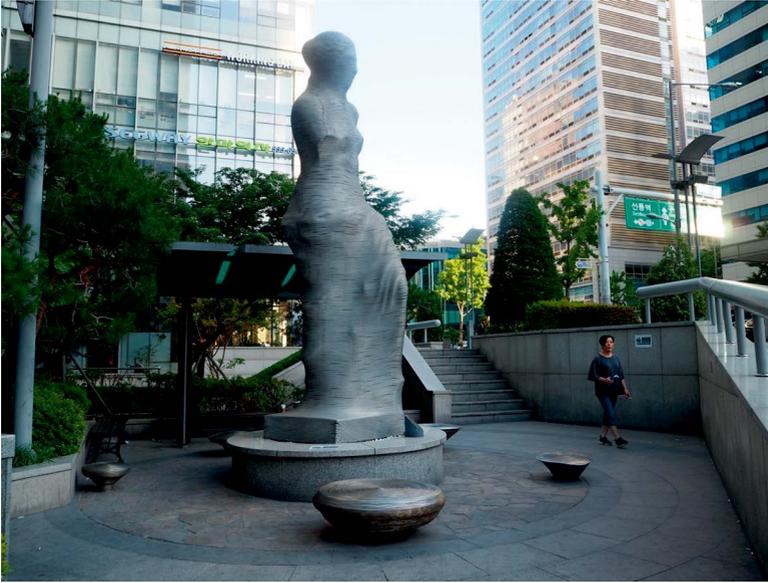
Figure 7.5a Photographs for POPS Case 1: POPS during the day

This POPS is well maintained in the sense that it is usable, clean and safe. It provides a litter receptacle and has no fly tipping or fly posting. Its amenities are kept to desired standards. Aside from the litter receptacle, it provides basic amenities such as pergola and bench, and a piece of artwork stands at its centre. This artwork seems to be relatively large for the size of POPS; however, according to the observation, many people use the lower part as a seat. A drinking fountain is installed, but this is blocked from use. Signage is installed at one of the entrances. Although it does not include information like area size, list of amenities, hours of use or person in charge (as suggested by the Seoul POPS Provision Guideline), it does indicate that the space is for citizens to use. Lighting is lacking; however, the area remains bright until 10p.m.

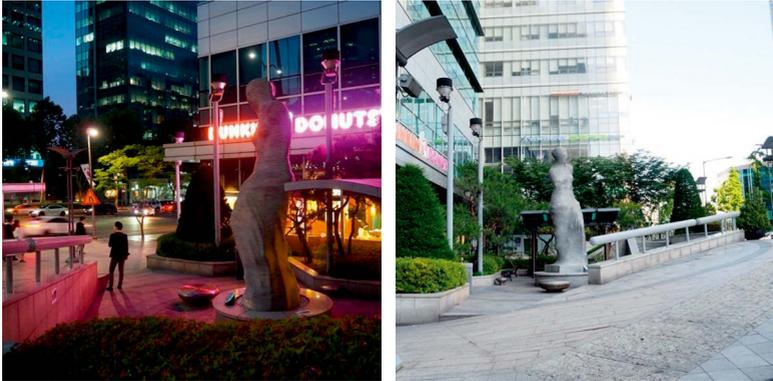
Figure 7.5b, c Photographs for POPS Case 1: POPS during the night and entrance to POPS

due to light from the adjoining Dunkin Donuts outlet. Regarding practice of control, a sign indicates “cigarette butts in the litter receptacle”; this is the only rule on behaviour. This does not reduce the publicness of the POPS, as it tries to exclude anti-social behaviours only. In sum, three points are given to each indicator for the dimension of maintenance.

In terms of physical accessibility, parts of the POPS front onto sloping streets and are hence accessible via stairs. Another entrance is at the same level as the adjoining sidewalk with barrier-free pavement and good connection to the adjacent street. The POPS is a plaza of the sunken type and is surrounded by a wall that makes it less visible from the sidewalk while providing a sense of cosiness for those who use the space (although this is purely due to topography). Hence, three points are given to each indicator for the dimension of accessibility.

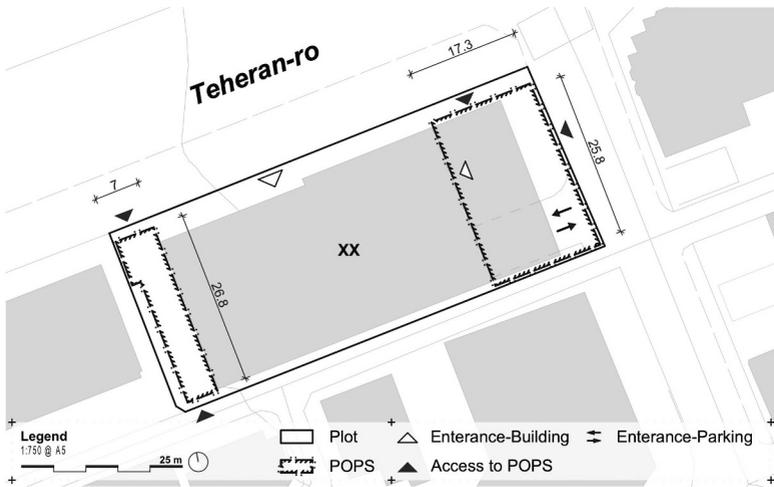
Figure 7.7 POPS Case 2 site map

POPS Case 2 is divided into two spaces and is located at two corners of the building. One of them has a piloti structure and thus has a roof, while the other is an open space. POPS Case 2 was visited several times in June 2017 – on weekdays and on weekends, between 7 a.m. and 11 p.m. – to analyse and evaluate it based on maintenance, accessibility and inclusiveness.

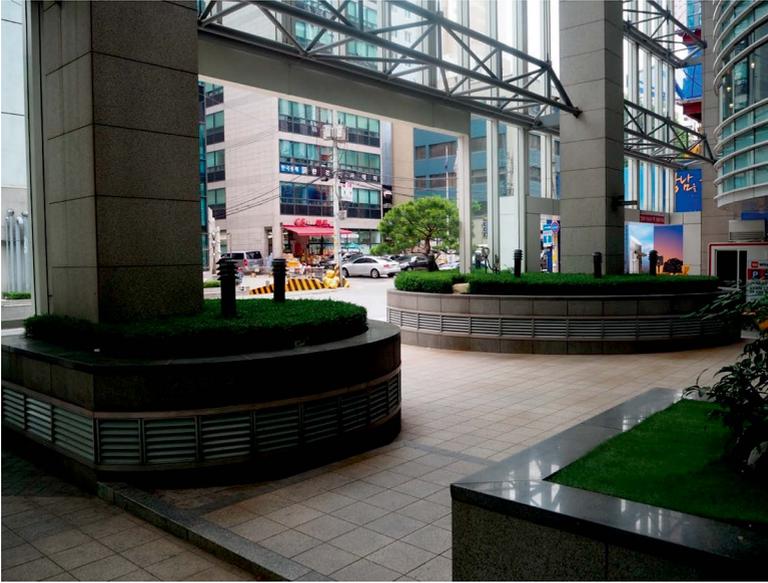
Figure 7.8a Photographs for POPS Case 2: POPS with piloti structure

Regarding maintenance, both POPS are usable, clean and safe. They have no fly tipping or posting. Yet, they provide fewer amenities than Case 1. The POPS with the piloti structure does not provide any amenities except for lighting and a signage; it does not even contain seats. The other POPS provides seating and planting but does not have any signage. Interestingly, neither POPS provides litter receptacles. In both POPS, signs indicate that they are smoking-free areas. This does not reduce the publicness of either POPS, as they are attempting to exclude anti-social behaviours only. Hence, three points are given for cleanliness and practice of control; two points are given for provision of amenities.

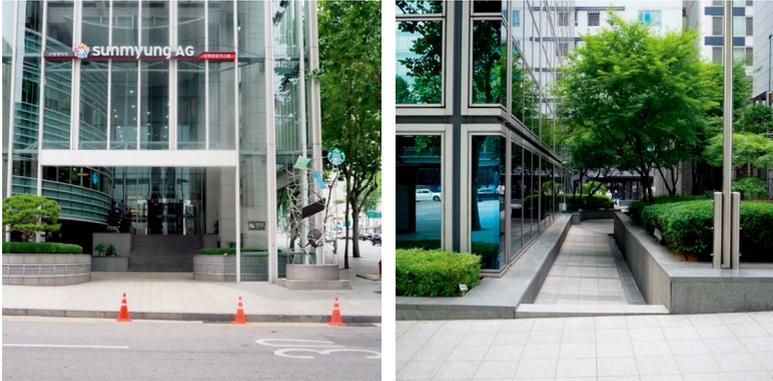
Figure 7.8b, c Photographs for POPS Case 2: Entrance to POPS with piloti structure and second corner POPS

In terms of accessibility, both POPS are easily accessible from Teheran-ro and are barrier-free. The one with the piloti structure is situated in front of one of the entrances to the building, where there is a constant flow of people. Thus, three points are given for both physical and visual accessibility.

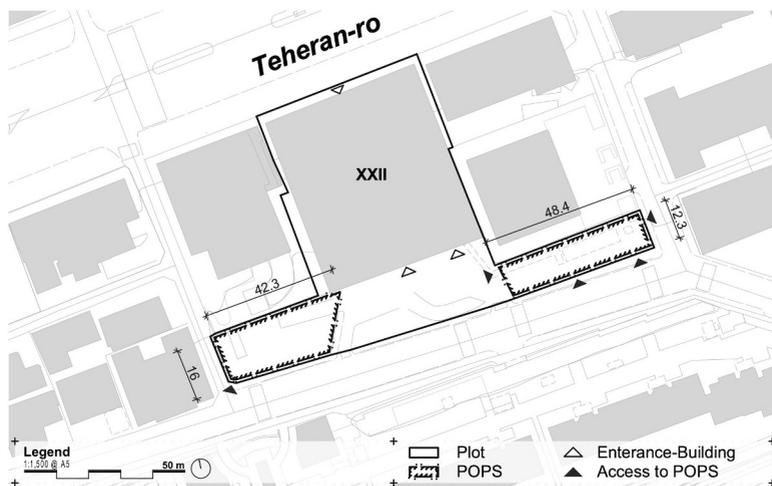
Figure 7.10 POPS Case 3 site map

POPS Case 3 is divided into two spaces. Unlike Cases 1 and 2, neither POPS adjoins Teheran-ro; they are situated behind the building, although both are connected to one of the entrances. POPS Case 3 was several times in June 2017 – on weekdays and on weekends, between 7 a.m. and 11 p.m. – to analyse and evaluate it based on maintenance, accessibility and inclusiveness.

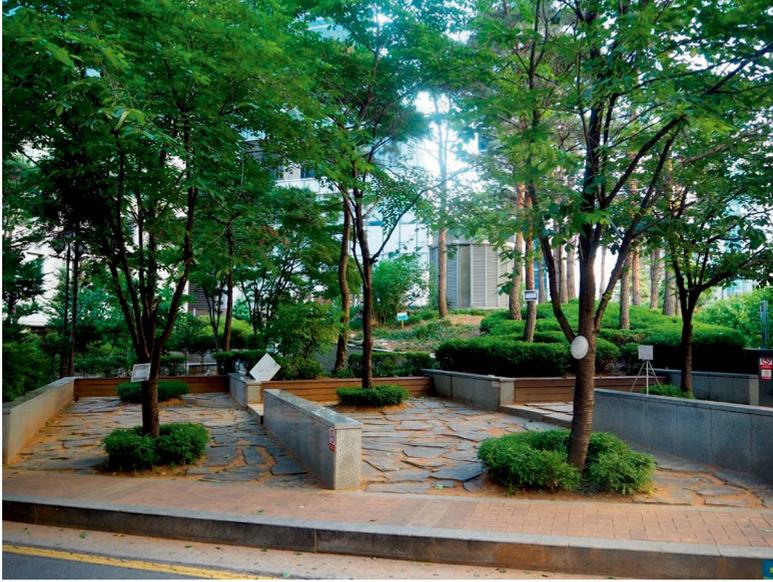
Figure 7.11a Photographs for POPS Case 3: POPS with resting area

In terms of maintenance, both POPS give the impression that they are well cared for. Both are usable, clean and safe. They have no fly tipping or posting, and their amenities are kept to desired standards. The POPS provide amenities like benches, planting, artwork and lighting. Following a conflict between smokers and non-smokers, a smoking area was designated in one of the POPS (Interviewee 16). Smoking is forbidden outside this designated area. Apart from smoking, the POPS are used for rest; indeed, one of the POPS has many trees providing comfort, shade and textural variety. Signage is provided in both POPS. Although the signage does not include information like area size, amenities, hours of use or person in charge (as suggested by the Seoul POPS Provision Guideline), it still indicates that these spaces are for citizens to use. Signs also indicate that the POPS are smoking-free areas except for the designated smoking area. This may not reduce publicness, as it tries to exclude anti-social behaviours only. However, other signs that indicate the use of camera surveillance 24/7 may give the sense of control. Hence, three points are given for cleanliness and provision of amenities; two points are given for practice of control.

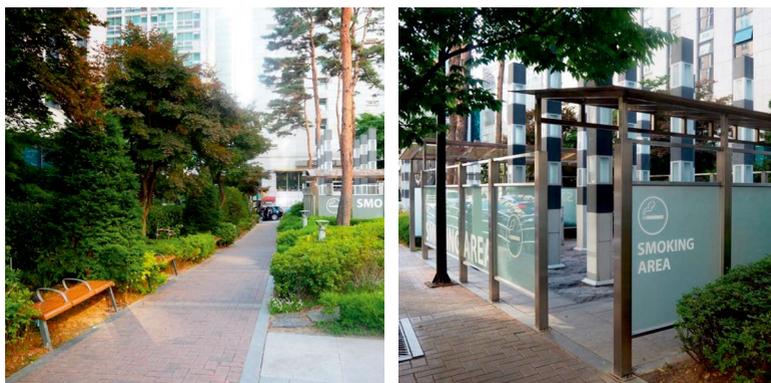
Figure 7.11b,c Photographs for POPS Case 3: POPS with resting area and designated smoking area

For inclusiveness, both POPS are mainly used for taking a rest, smoking or having a conversation. Interviewee 16 was sceptical about other uses, not only due to the design of the POPS but also due to multiple ownership: 'It is generally difficult to meet an agreement'. Nevertheless, according to the observation, POPS Case 3 was the most actively used POPS with a wide range of groups of people: not only office workers but also residents, the elderly, and so on, possibly due to the adjoining residential area. Another reason may be the division of use: while one POPS is mainly used by smokers as it has a designated area for smoking, the other is a smoke-free area and has a different

character with more benches and planting. Interviewee 16 admitted that this minor intervention has created less conflict between smokers and non-smokers. The fact that both POPS are clean, provide amenities and are adequately accessible could be another contributing factor. As there is lighting (though not everywhere), both areas are used at night as well. Although use may be dependent on weather and season, three points are nonetheless given for the dimension of inclusiveness.

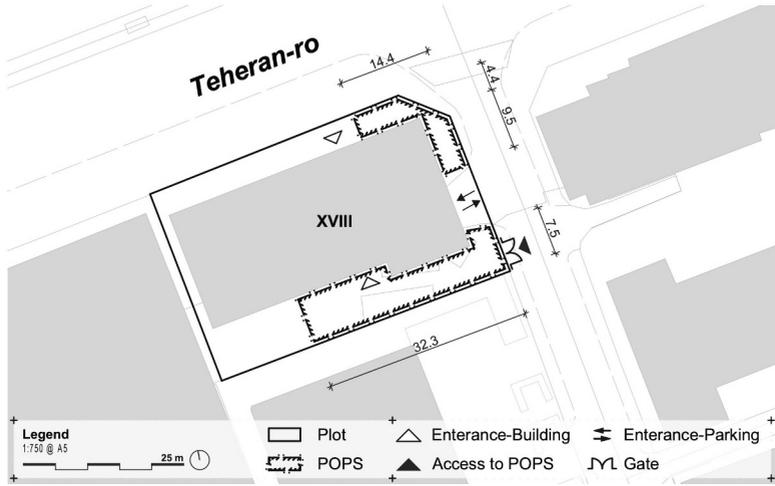
Figure 7.13 POPS Case 4 site map

POPS Case 4 is also divided into two spaces. One is located in front of the building and adjoins Teheran-ro; the other is behind the building. POPS Case 4 was visited several times in June 2017 – on weekdays and on weekends between 7 a.m. and 11 p.m. – to analyse and evaluate it based on maintenance, accessibility and inclusiveness.

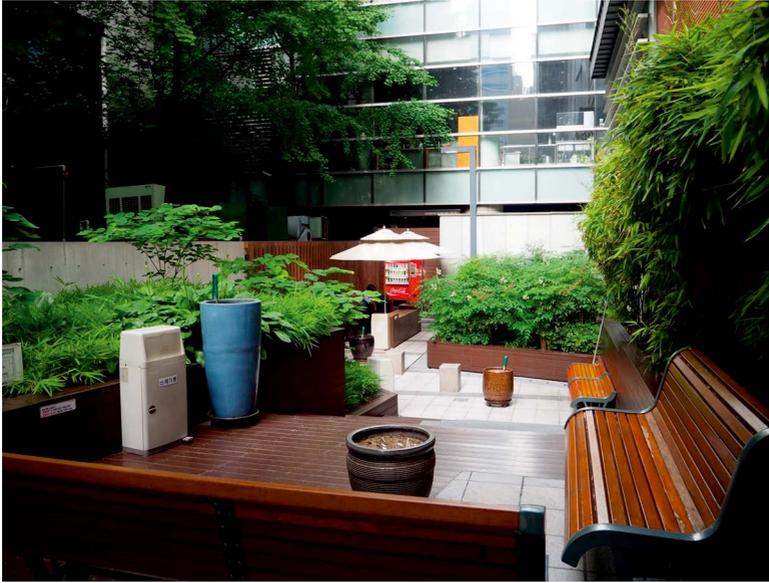
Figure 7.14a Photographs for POPS Case 4: Hidden POPS behind the building

For accessibility, the POPS in front of the building is connected to the sidewalk on Teheran-ro, meaning it is both physically and visually accessible. It is of the pedestrian space type, while the other POPS is a plaza behind the building that is almost invisible due to its narrow entrance. The gate is open between 7 a.m. and 7 p.m. only. During the night, access is only possible through the lobby where there is a security guard. Hence, two points are given for physical and visual accessibility.

For inclusiveness, the POPS in front of the building is simply too small and narrow to accommodate any use. It provides no amenities apart from a signage. In fact, according to the observation, it is less used regardless of time or weather. The POPS behind the building, meanwhile, is mainly used by office workers from the building for taking a rest and smoking. It is especially busy during lunchtime on working days. Although it is clean and provides amenities, due to its location and lower visibility, it does not have the potential

to be used by other groups beyond the office workers. As a result, this POPS may be less used during the night or on weekends. Hence, one point is given for inclusiveness.

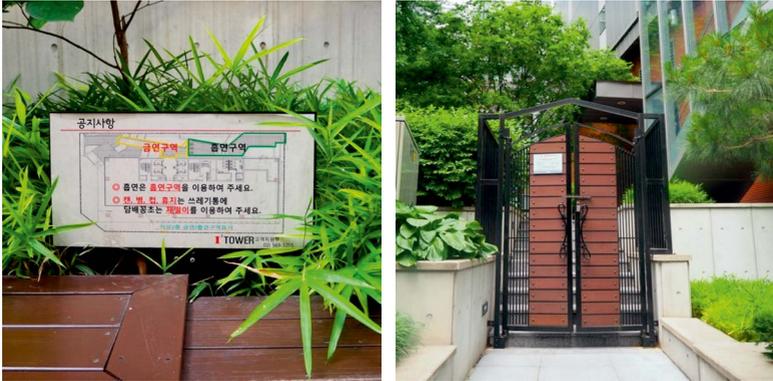
Figure 7.14b, c Photographs for POPS Case 4: Sign indicating smoking and non-smoking areas and closed gate to POPS

In terms of maintenance, both POPS are usable, clean and safe. They have no fly tipping or posting. The amenities are kept to desired standards. However, a marked difference was observed in the provision of amenities between the two POPS. While the one situated in front of the building offers no amenities, except for a signage, the other POPS offers benches, planting, shelter and a litter receptacle so that office workers – the main users of the space – can take a rest. Both POPS have signage, yet this does not include information about amenities or the person in charge (as suggested by Seoul POPS Provision Guideline). Regarding practice of control, the POPS in front of the building has a sign indicating it is a smoking-free area. This may not reduce publicness, as it tries to exclude anti-social behaviours only. On the other hand, other signs indicating the use of camera surveillance 24/7 may give the sense of control. The POPS behind the building includes a sign delineating smoking and non-smoking areas, and another indicating that rubbish should be thrown in the litter receptacle. To sum up, three points are given for cleanliness, and two points are given for provision of amenities as well as practice of control.

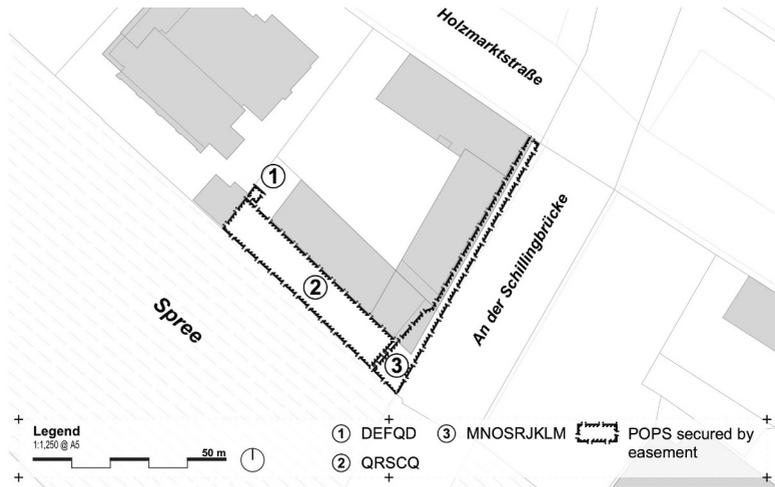
Figure 7.16 Stipulations in graphic form regarding easement at POPS Case 5

- **No. 11:** Public right of way is set for the area MNOSRJLM and DEFQD.
- **No. 14:** Public right of way is set for the area QRSCQ along the river Spree with a width of at least 3.5 m (revised on Sep. 25, 2000).

As illustrated in Figure 7.16, public right of way is established on the riverside (see written stipulation no. 14) to make the area publicly accessible. Public right of way is also established along the street An der Schillingbrücke (see written stipulation no. 11) to offer space for pedestrians, as well as at the north-west border of the area for the possible continuation of the promenade with neighbouring property in the future (see written stipulation no. 11). Public right of way is supposed to be entered accordingly in the land registry as easement.

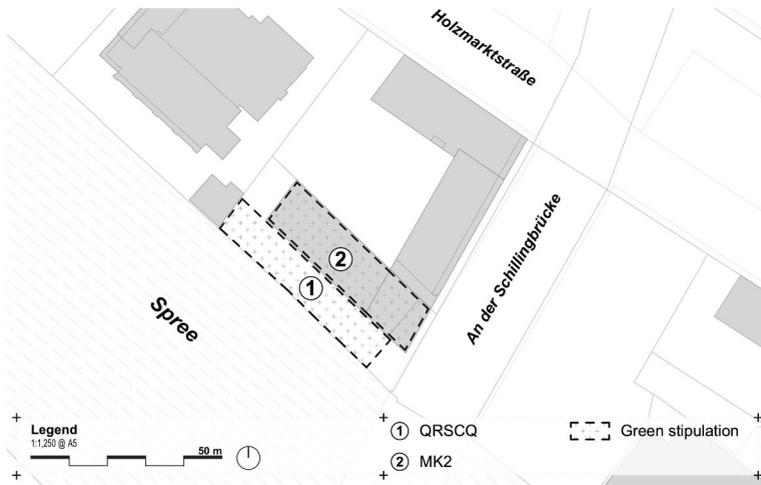
Figure 7.17 Stipulations in graphic form regarding green stipulation at POPS Case 5

- **No. 8:** The area QRSCQ is to be planted in a way that creates the impression of a riverside promenade. Plantings are to be preserved.
- **Recommendation:** When applying this written stipulation, it is recommended to use the following list of plants. Tree species – *Salix alba*, *Acer platanoides*, *Tilia cordata* and *Quercus robur*. Shrub species – *Cornus mas*, *Corylus avellana*, *Euonymus europaeus*, *Prunus padus* and *Rhamnus frangula*.

- **No. 9:** The areas for planting are to be designed horticulturally and maintained. Plantings are to be preserved. This also applies when underground garages are provided under these areas. [...] The obligation for planting does not apply to paths and squares.

- **Recommendation:** When applying this written stipulation, it is recommended to use the list of plants attached to written stipulation no.8.
- **No. 10:** In the core area MK2, flat roofs of buildings with an area of more than 200 m² are to be greened; this does not apply to technical facilities or to lighting surfaces or roof terraces.

In addition to easement, green stipulation is exercised (see Figure 7.17). A green ordinance sets arrangements for greening the riverside path, open space and flat roofs. The continuation and design of promenade along the river Spree is a key goal of the B-Plan V-61. It sets out the legal framework for greening the riverside path (see written stipulation no. 8). The riverside area, as part of the long promenade, shall ‘characterise the Friedrichshain-side waterfront in a uniform design and contributes to the visual identity of the waterfront’ (Bezirksamt FHKR von Berlin, 2000b). According to the design guidelines by GuD Geotechnik und Dynamik Consult GmbH, a double row of trees is envisaged to divide spaces between building, paths and the riverside. When planting, plant species that correspond to the local flora, and which respect the site condition, are to be chosen. As a recommendation, a list of tree and shrub species taken from the design guidelines and landscape planning related expert contribution is provided. The green ordinance outlines the requirements for greening and the preservation of the previous open space

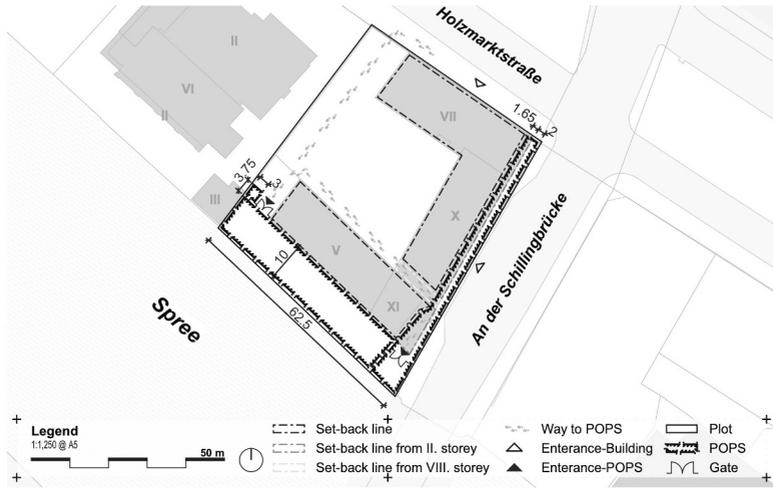
Figure 7.19 POPS Case 5 site map

POPS Case 5 was visited three times during the day in November 2017 as well as in May and July 2018. The site analysis reveals that all three POPS are well cared for; they are usable, clean and safe. They have no fly tipping or posting, and the amenities are kept to desired standards. In terms of amenities, benches, planting, lighting and litter receptacle are provided in the POPS at riverside, and trees create the impression of a riverside promenade. The other two POPS do not offer any amenities; given the lack of space, they are not suitable for amenities. On the gate, there is a posting with the name of a security company, but other postings of rules were not found. Three points are hence given for the dimension of maintenance.

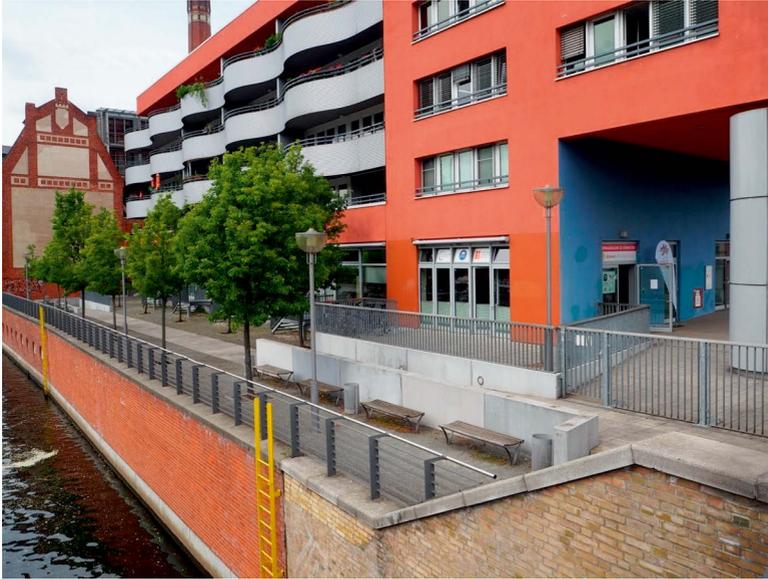
Figure 7.20a Photographs for POPS Case 5: POPS along the river

For inclusiveness, the POPS as a pedestrian space is used for walking. The POPS along the riverside is used for sitting, taking a break and having a conversation since there are amenities for these purposes. Due to its location, people can also enjoy the river view. This POPS is large enough to accommodate other uses. As it is an open space without a roof, it may be used less during the winter. Due to the closure, however, it was impossible to observe who was actually using the area and how. Hence, two points are given for this dimension.

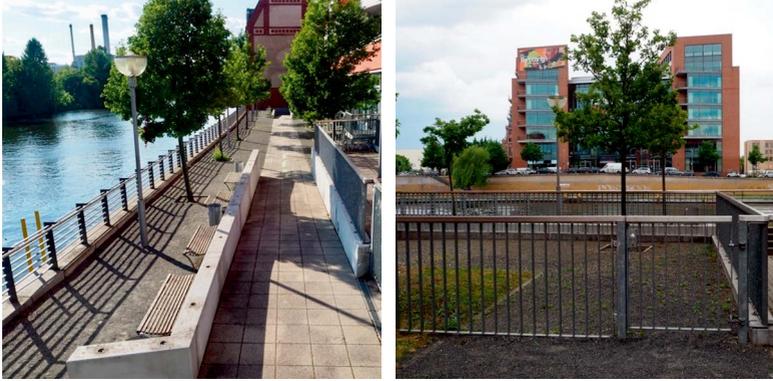
Figure 7.2Ob, c Photographs for POPS Case 5: Amenities provided on POPS and fence and locked gate to POPS

In terms of accessibility, the POPS along the riverside is currently blocked by fences and two gates, both of which are currently closed. Without a key, no one can enter the POPS. The small POPS on the west border of the area is physically but not visually accessible, as it is far from the sidewalk and one must cross the courtyard to get there. It is worth remembering here that this POPS is intended for the potential continuation of the promenade with neighbouring property in the future. POPS as a pedestrian space is open to the public. However, since physical accessibility in POPS Case 5 is generally low, only one point is given. Visual accessibility is adequate; hence, three points are given.

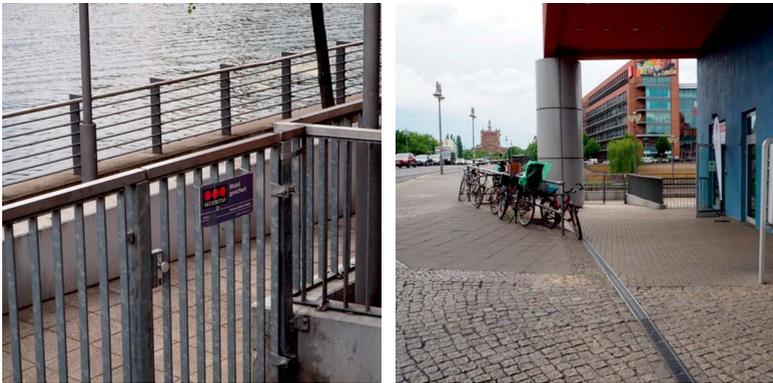
Figure 7.2Od, e Photographs for POPS Case 5: Security sign and POPS as pedestrian space

In terms of practice of control, there is a low degree of control in Mediaspree area. POPS Case 5 includes a security company sign at the gate, and the gate for POPS Case 8 displays a sign that dogs are not allowed to enter. No surveillance cameras or security guards were observed.

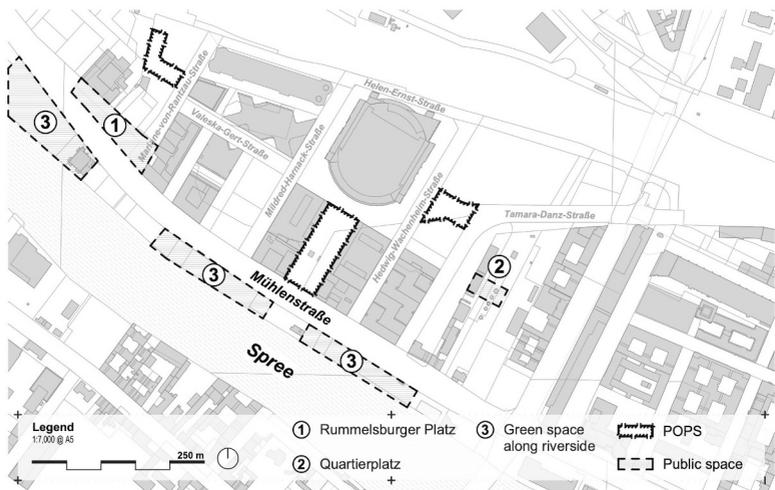
Figure 7.23 Stipulations in graphic form regarding urban development contract at Mercedes-Benz Arena

In addition, an urban development contract was signed between the state of Berlin and the property owners AEG and BSR (see Figure 7.23). In terms of green space, this regulates the provision of a public playground (Quartierplatz). Furthermore, it contains an arrangement on how to consider all plots of land on which public right of way has been arranged. According to the contract, private squares (Drehscheibenplatz, Ostplatz, Arena-Vorplatz and Westplatz) will remain under private ownership, and the respective owner will ensure that the public right of way is entered in the land registry. Furthermore, according to the urban development contract, the state of Berlin is obliged to acquire riverbank area through funds provided by AEG and BSR and to create public green space there. The city shall also use the funds to refurbish Rummelsburger Platz.

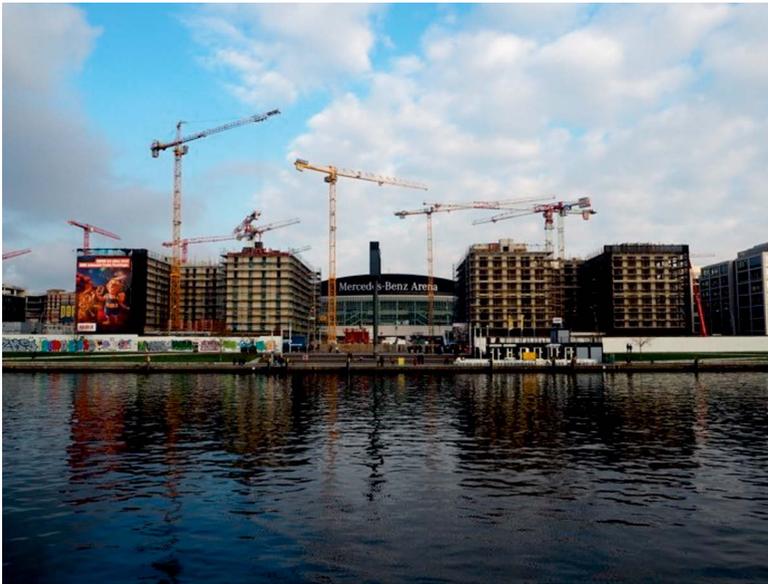
Figure 7.25 Photograph of Mercedes-Benz Arena, 2018

Since the POPS are yet to be completed, they could not be visited and evaluated (based on 2018).

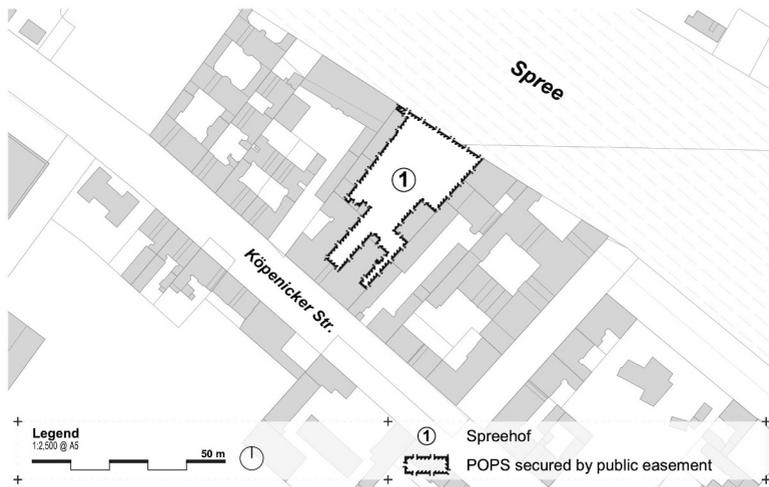
Figure 7.31 Stipulations in graphic form regarding public easement for POPS Case 8

Public easement is established on the riverside (see Figure 7.31). Within the existing building structure, this was the only place that was open to the river. In contrast to previous cases, B-Plan VI-146 does not require any public access; there was no need since public easement had already been established at Köpenicker Straße 8.
