## *Chapter 10: Reforms and the Conflict in Urban Conceptions*

## *Appendix to Chapter 10: Change and Reform in the 19<sup>th</sup> Century*

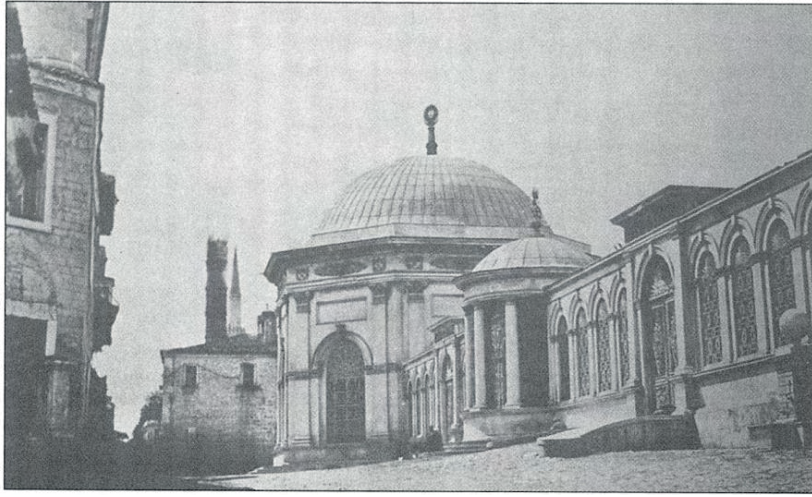
Fig. 82: *The Mahmut II funerary complex (1839) before street widening and levelling.*

After street widening and regularization, with the street level lowered, the basement steps impose a deliberately monumental and rhetoric separation from street level, the whole composition shifts weight from the Ottoman narration of urban space (see previous chapters) to the current Beaux-Arts composition principles of unity and symmetry. Both undercurrents had been active in the design of the building, but now one overcomes the other.

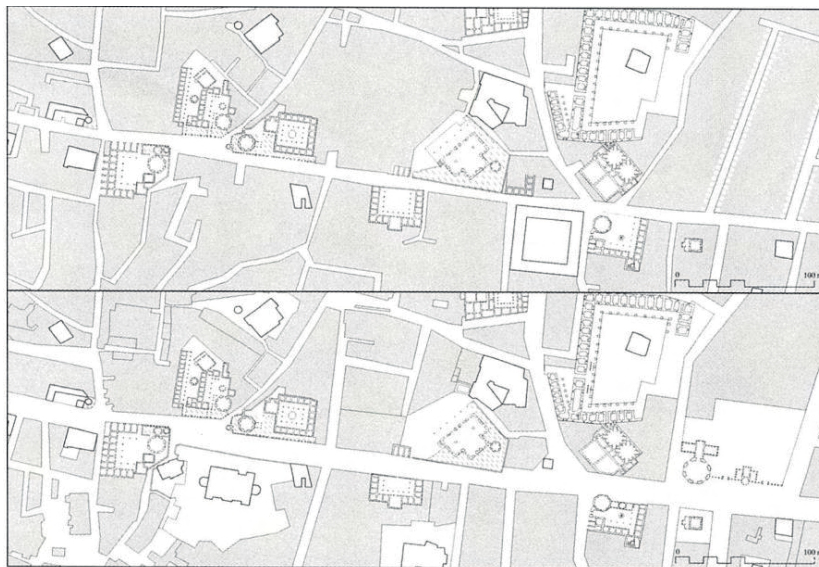
Figs. 83, 84: *The central tract of the Divanyolu before and after street cuts in the second half of the 19<sup>th</sup> century. Above around 1848; below around 1880 (compare with present situation, plate V below).*

During the last four decades of the 19<sup>th</sup> century, many monumental buildings along the Divanyolu were submitted to ugly cuts to enlarge the street (see Appendix). The *medrese* of Kara Mustafa lost its shops; part of the Atik Ali *medrese* was demolished and realigned on the widened street. Shockingly coarse was the chopping off of the corner of the Çemberlitaş Hamam and of a good slice of the Köprülü *medrese* with incongruous façades in Moresque pseudo-Usul-ü-Osmaniye stuck on the bleeding stumps by Barborini<sup>183</sup> along the street line at an impossible angle for the architectural organisms they are supposed to complete. A face-(façade)-saving operation which after a few decades proved insufficient to meet traffic requirements, and was not able, in over 130 years, to recreate the fine

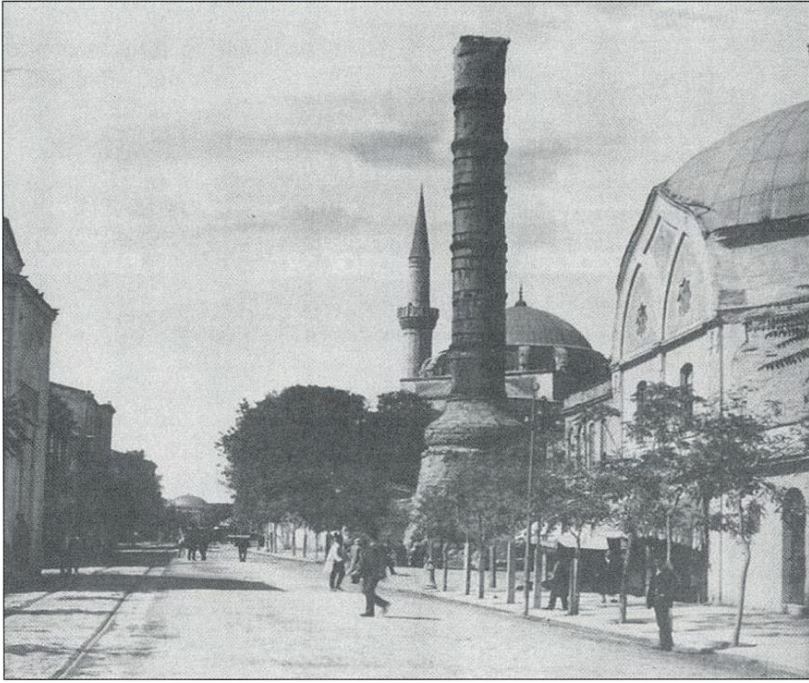
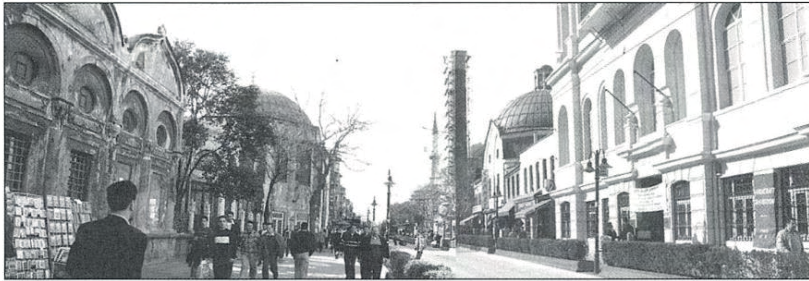
Figs. 85, 86: *The Divanyolu near Çemberlitaş after street widening. Above: the Barborini arrangement of the amputated façade of the Valide Hamam at the end of the 19<sup>th</sup> century. Below: in 2002; to the left can be seen the Barborini redesign of the Köprülü medrese façade on the street.*
