## 5 Experimental Results<sup>1</sup>

## 5.2 Information Modeling

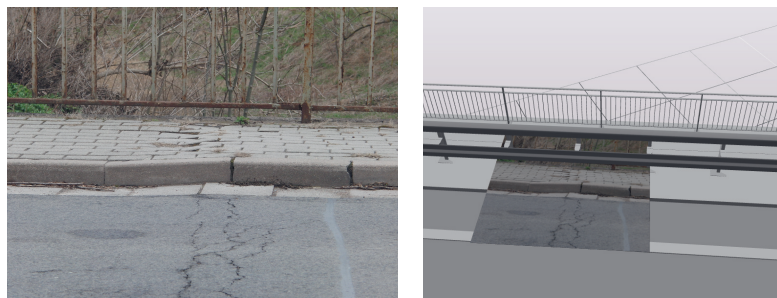
Figure 5.11: Representation of some cracks at the pavement as a texture depicted on a plane.

Figure 5.11 shows some cracks on the pavement of the bridge. Furthermore, there is a bump in the pavement and the side walk. Only by using this photo as a texture, the inspector or engineer can get a quick impression of the defect. Aligning the texture to the 3D model can help the user gather additional information about related or near elements faster compared to studying 2D plans. However, this defect shows the problem of image

rectification for textures. The image, which has been used for the texture, has not been rectified. Hence, the texture shows the slope of the bridge at the position of the sidewalk, which could be misunderstood.

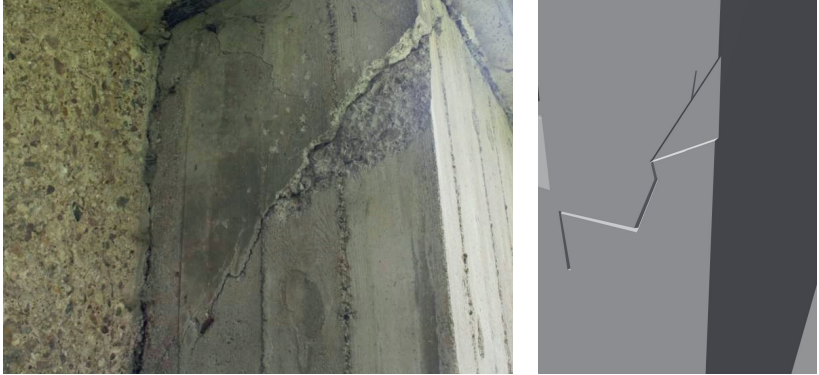
Figure 5.12: Representation of a spalling at the abutment.
